# Asus ZenFone 3 Max Repairability Assessment

Repairability analysis of the Asus ZenFone 3 Max performed on January 5, 2017.

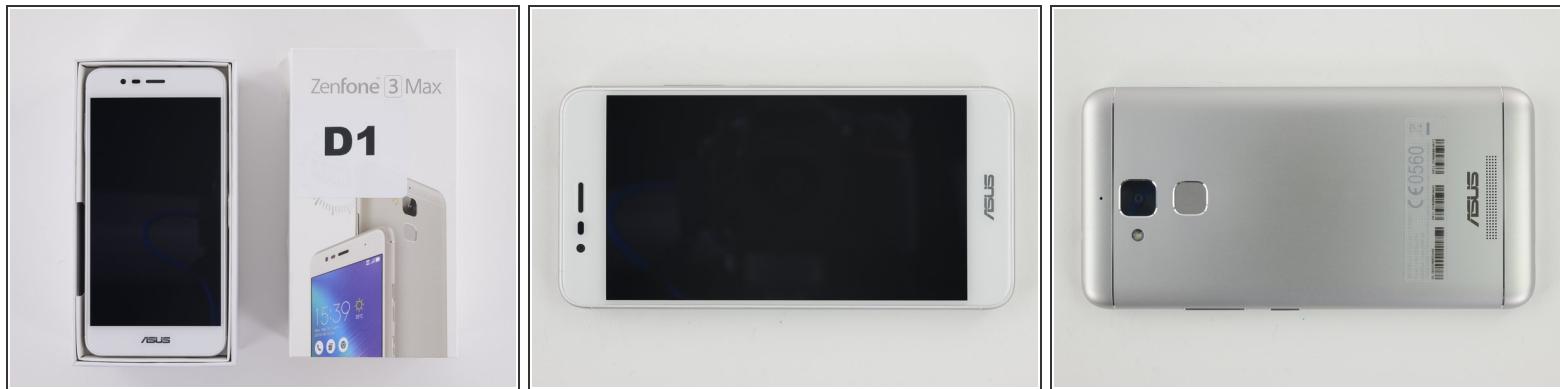
## Step 1 — Asus ZenFone 3 Max Repairability Assessment

- Reference front/back
- *(i)* No glass on the back is nice.

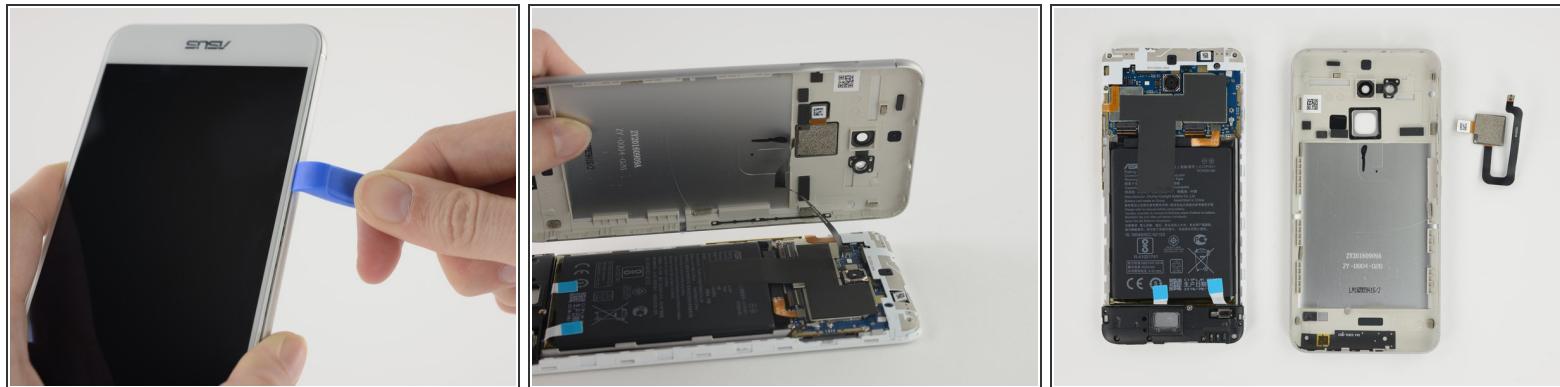
## Step 2

- Super stiff clips around the perimeter of the "bathtub" rear case, hardcore prying required to remove the rear case. Seam is super thin and tough to get tools into.
- Fingerprint sensor cable connects rear case to rest of the phone, makes a little trap when you're opening it up.
  - Not enough slack to lay the rear case on its side to continue working on the phone, sensor cable must be disconnected.
- Fingerprint sensor itself is pretty easy to push out of the rear case. Has a standard press-on connector.
- Side button covers can also be removed at this point.

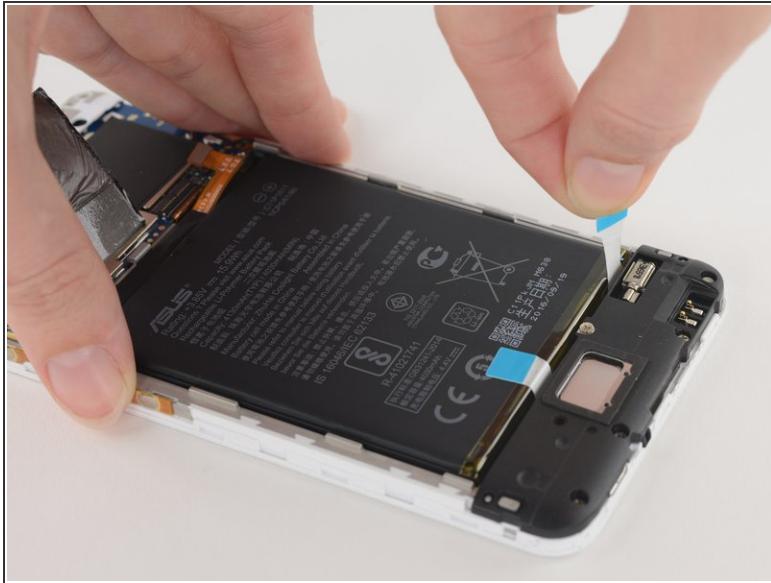
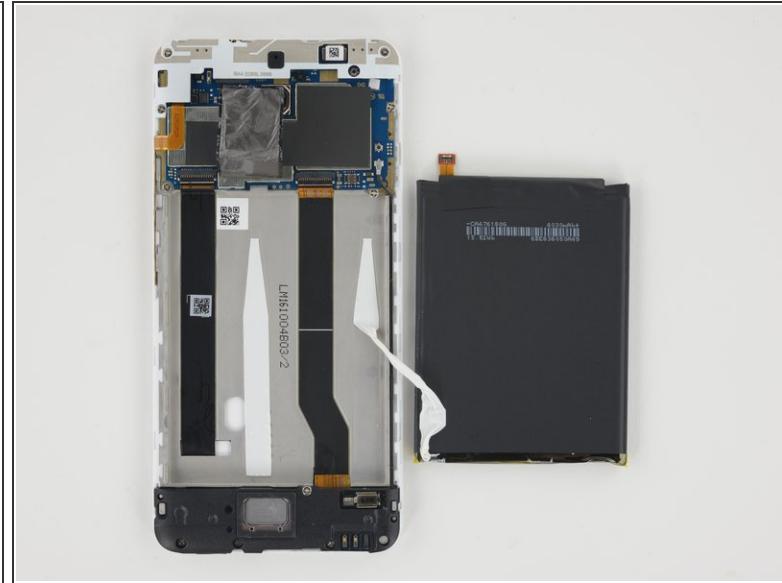
## Step 3

- Battery pull-tab adhesive strips are nice.
- But they broke pretty easily. The right, almost immediately, the left, slightly later
- It was relatively easy to remove the battery, the left adhesive strip was pretty much freed from the batter, the right had to be wrestled off. Could be removed by hand, no tools needed.

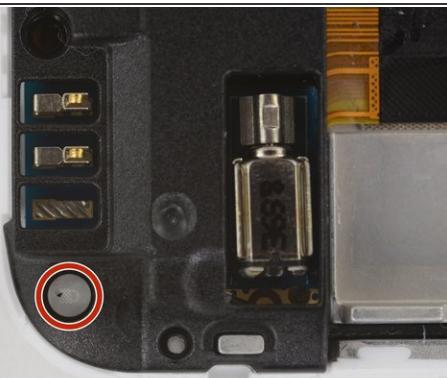
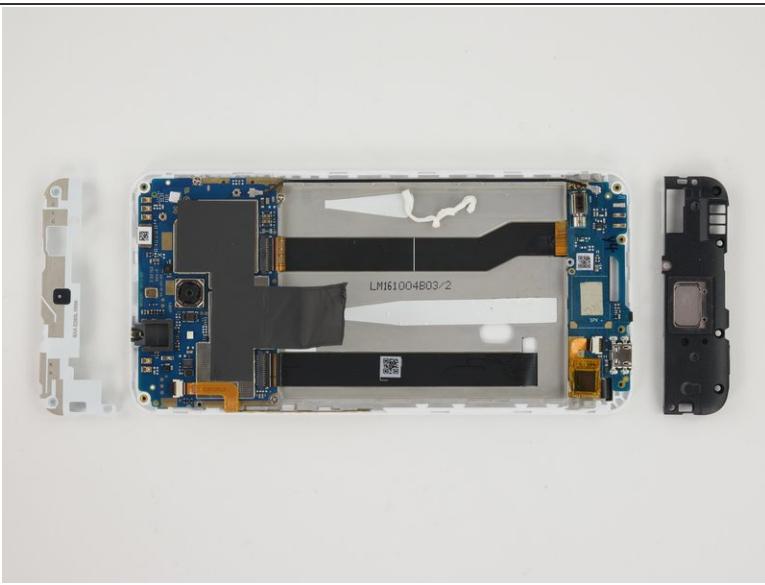
## Step 4

- Phillips #00 screws secure the top antenna frame and lower speaker assembly.
- One screw is hidden under a tamper-evident seal.

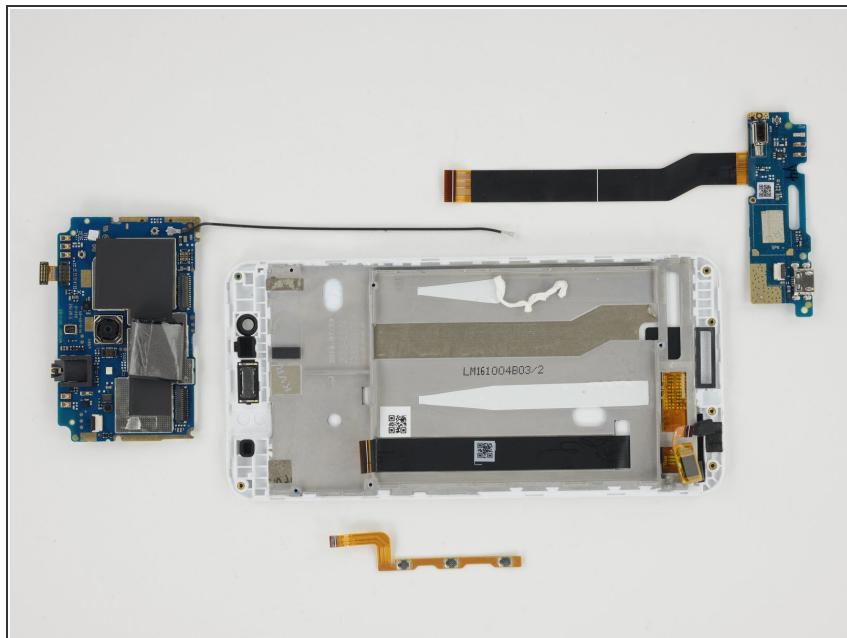
## Step 5

- Daughterboard is thin and adhered fairly solidly to the display assembly, making removal a bit dangerous.
- Vibrator and charging port are soldered to the daughterboard. High-use charging port will someday fail, board is relatively bare, but still pricier than the port alone.
- Button switch cable is adhered, but not too bad.
- Antenna cable immediately accessible.
- Motherboard is also adhered and tough to remove, being in a well in the display assembly.

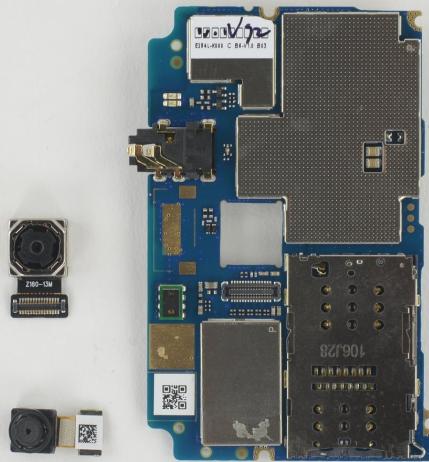
## Step 6

- The cameras can only be freed after motherboard removal.
- The headphone jack is soldered to the board. As is the card slot.

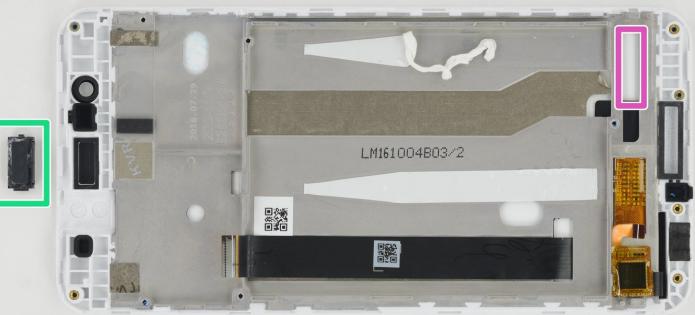
## Step 7

- The only remaining removable component is the earpiece speaker.
- Display assemblies like this (fused display and midframe assembly) make for pricy replacement parts. This component is also the last out, while it's the most in danger of failing from simple falls etc.
- While it is possible to replace just the LCD and digitiser It may be more trouble than it's worth
- To remove the old screen from the assembly heat (freezing might work better, but I have not tried) the screen and press on the screen through this hole, then It's just a matter of lots of heat and scraping.

**⚠** removing the old LCD/digitiser from the assembly with almost certainly destroy it.

**⚠** Removing the LCD/digitiser without scattering broken glass everywhere may not be possible

**⚠** it takes a LOT of heat to remove the LCD/digitiser, you may melt the screen for the earpiece speaker if you are not careful (or even if you are)

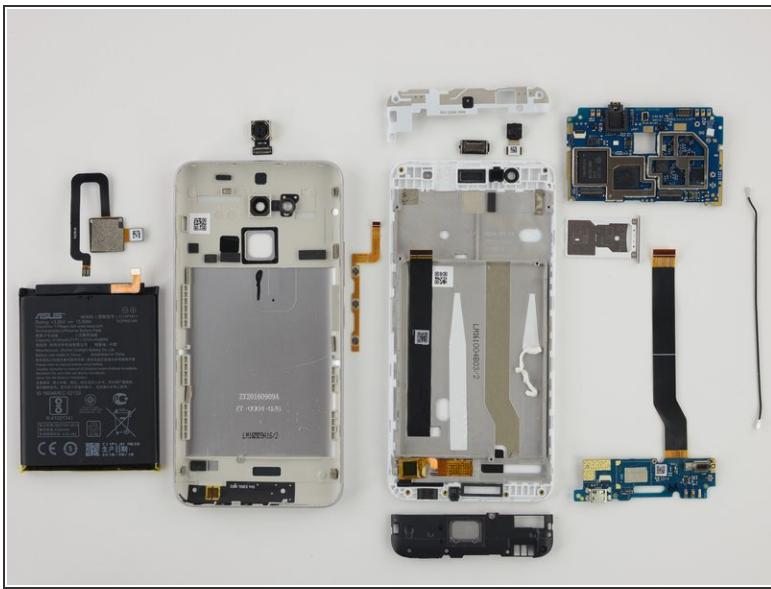
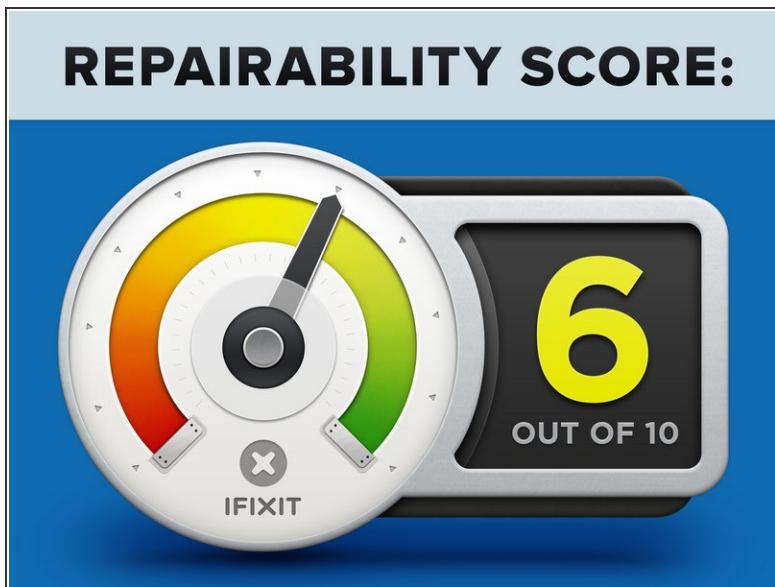
## Step 8

- The Asus ZenFone 3 Max earns a **6 out of 10** on our repairability scale (10 is the easiest to repair):
  - Battery is easily accessible and removable.
  - Parts could be more modular, especially mechanical/high wear components.
  - The opening procedure is extremely tough, clips are stiff and likely to be broken, and the SIM slot bends easily.
  - The single unit display assembly is annoying to reach, and will be a costly part.
