Audio-Technica ATH-S200BT Microphone Hole Fix

Drill a microphone hole for the Audio-Technica ATH-S200BT microphone.

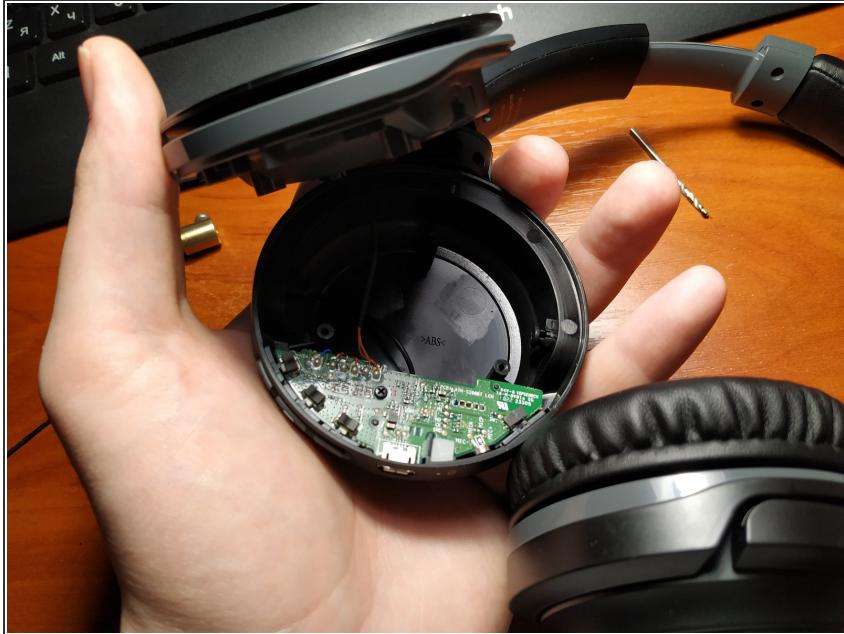
Step 1 — Audio-Technica ATH-S200BT Microphone Hole Fix

- Remove the 3 screws holding the left headphone cup together.

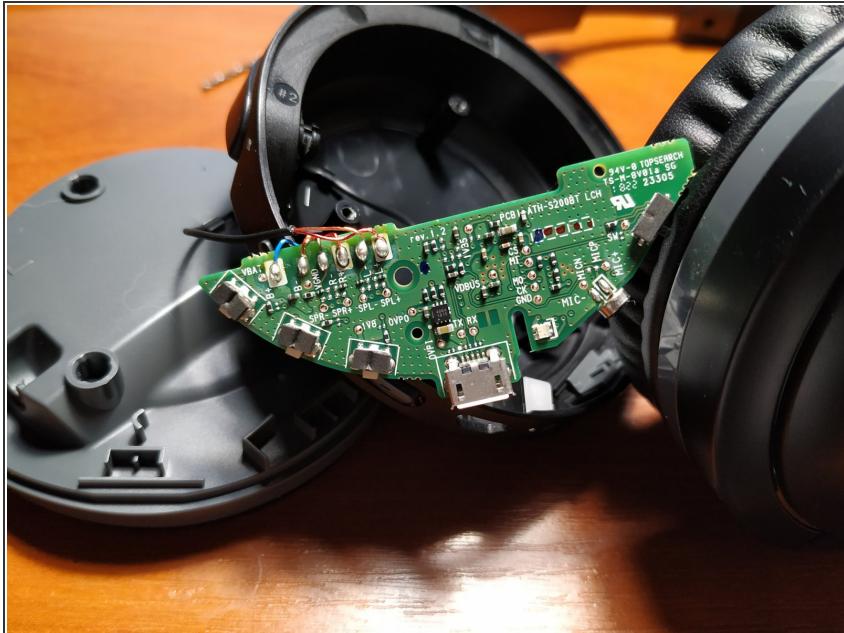
Step 2

- Separate the three enclosure parts by hand.

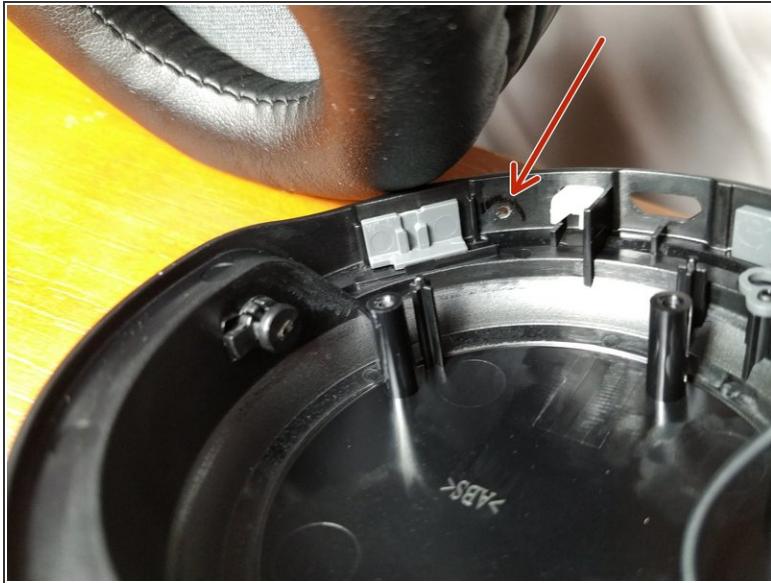
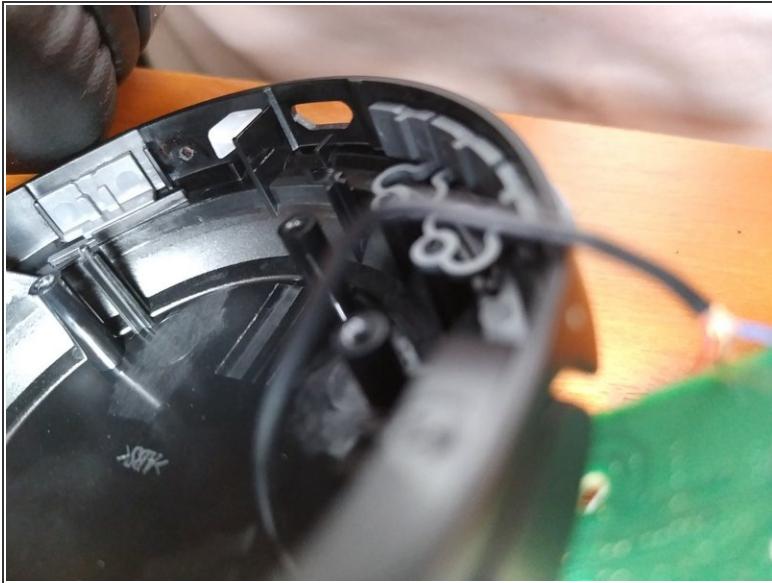
Step 3

- Drill a hole about 1 - 1.5mm hole.

By the default, the headphones have no hole for the microphone so the voice sounds very terrible.

To fix this issue, you should teardown the left monitor and drill a hole about 1 mm hole in front of the mic.

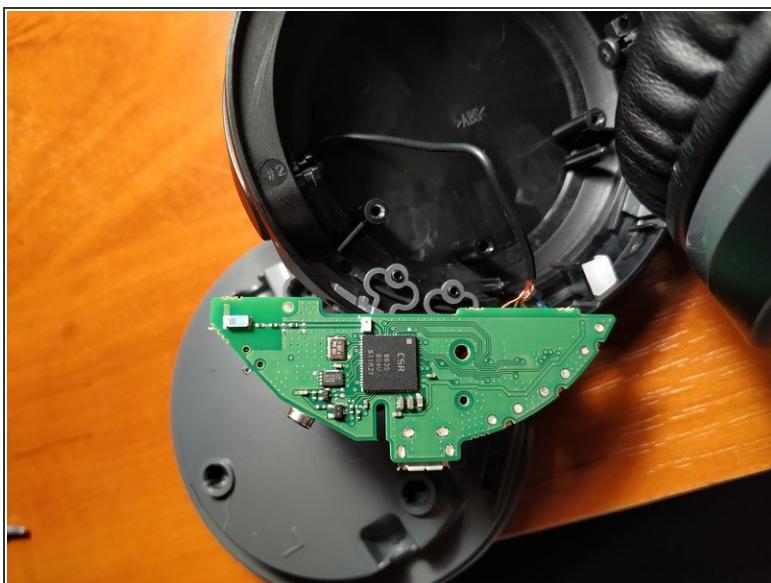
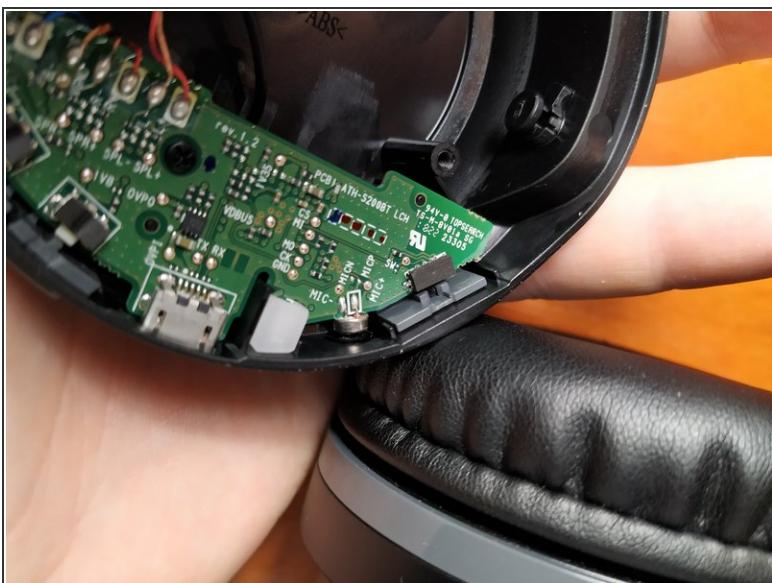
Step 4

- Reassemble the headphone PCB.

To reassemble your device, follow these instructions in reverse order.
