Beats Solo 2 Wire Replacement

We are replacing the internal core wire to fix the right speaker not working.

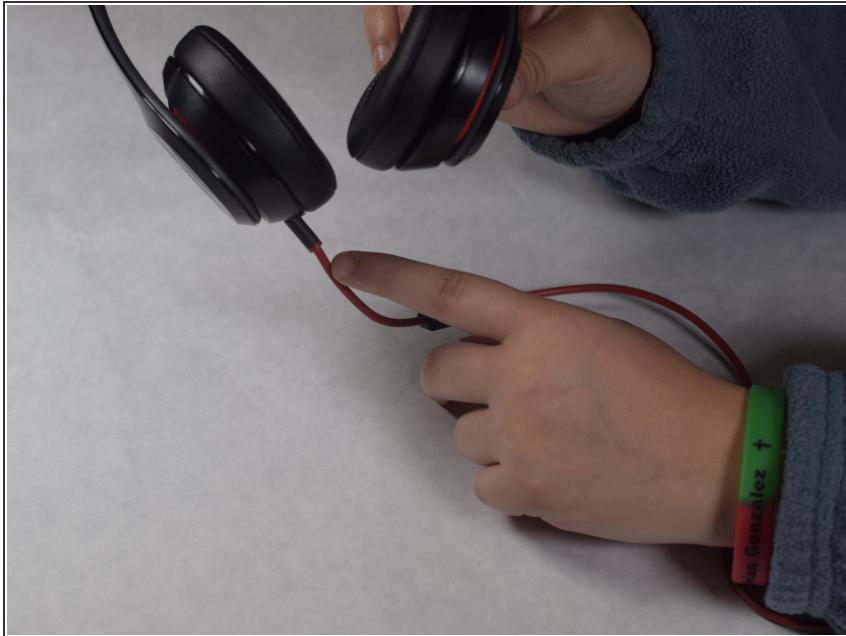
Step 1 — Core Wire

- Pull out the wire from the beats. The wire is a jack wire and requires nothing special to remove.

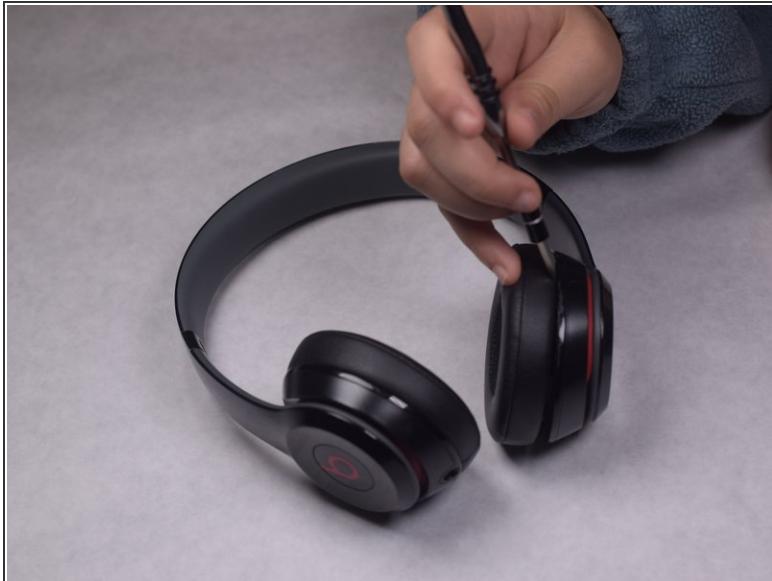
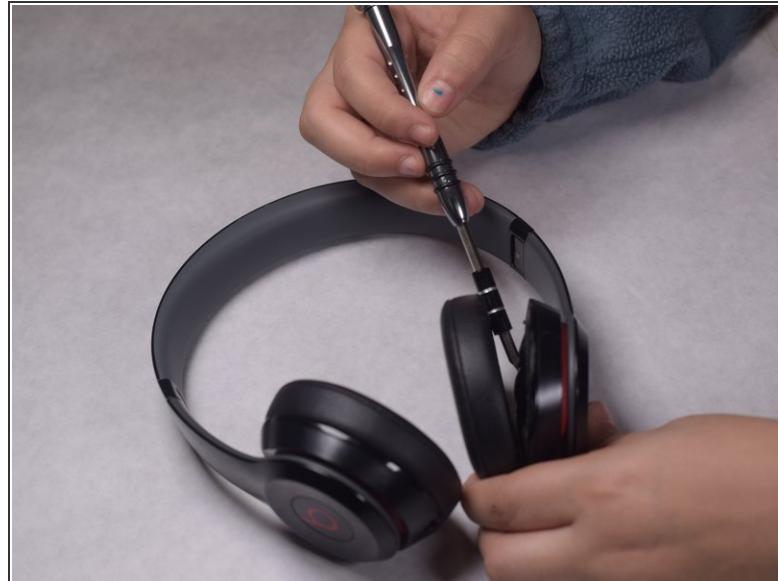
Step 2

- Remove the ear cushions from the headset. The preferred method to do this is to use a screwdriver and pry the cushions off.

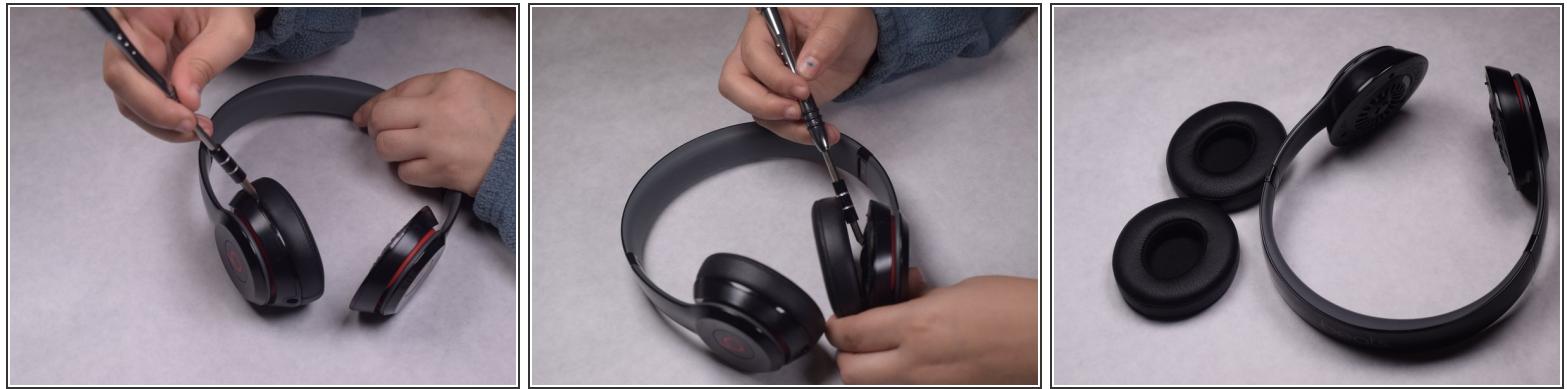
Step 3

- Remove the second cushion until both cushions are removed.

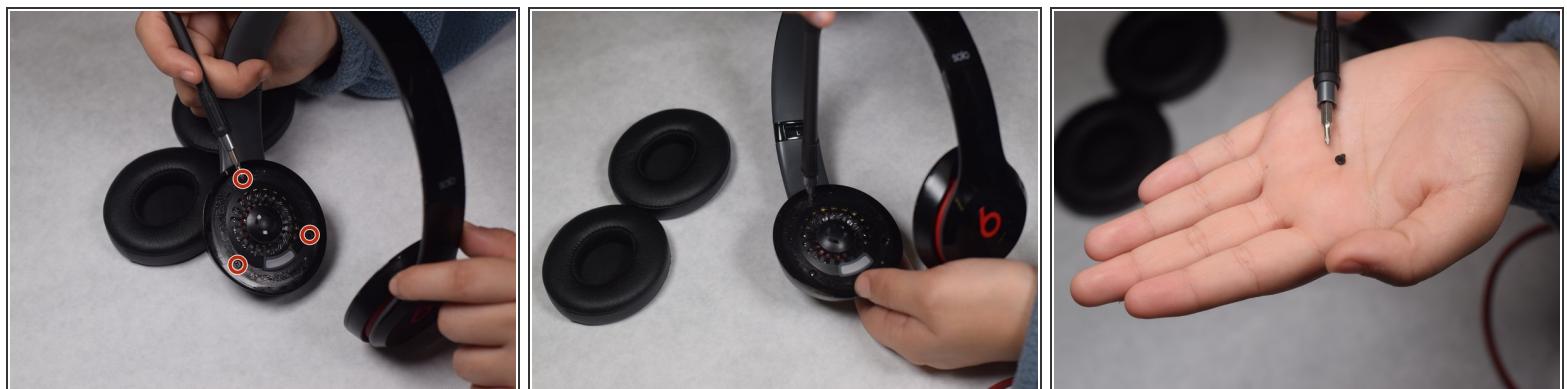
Step 4

- Remove the screws from both ear bases.

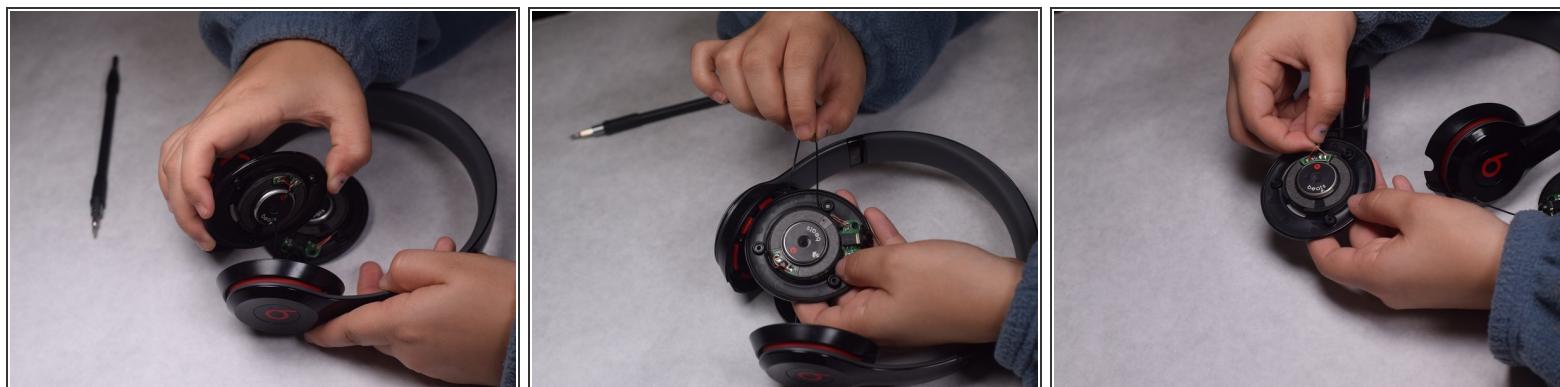
Step 6

- After you have removed the second internal speaker, you can begin the process of removing the wire. BE CAREFUL with this step, make sure you don't pull off the circuit board.

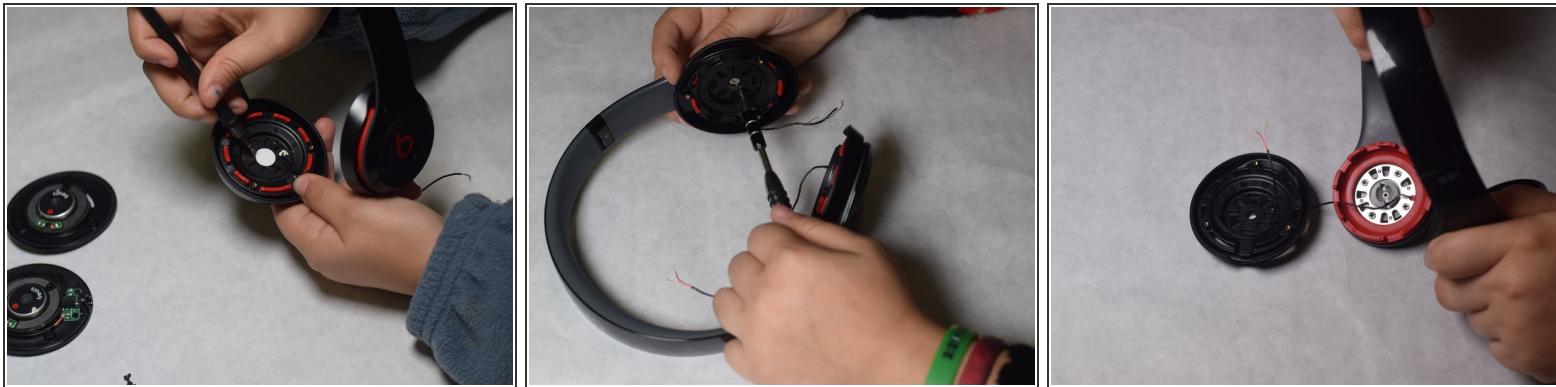
Step 7

- Now we are going to remove the circuit board holder. Take off the white cover to get access to the screw. Then remove the screw and circuit board holder.

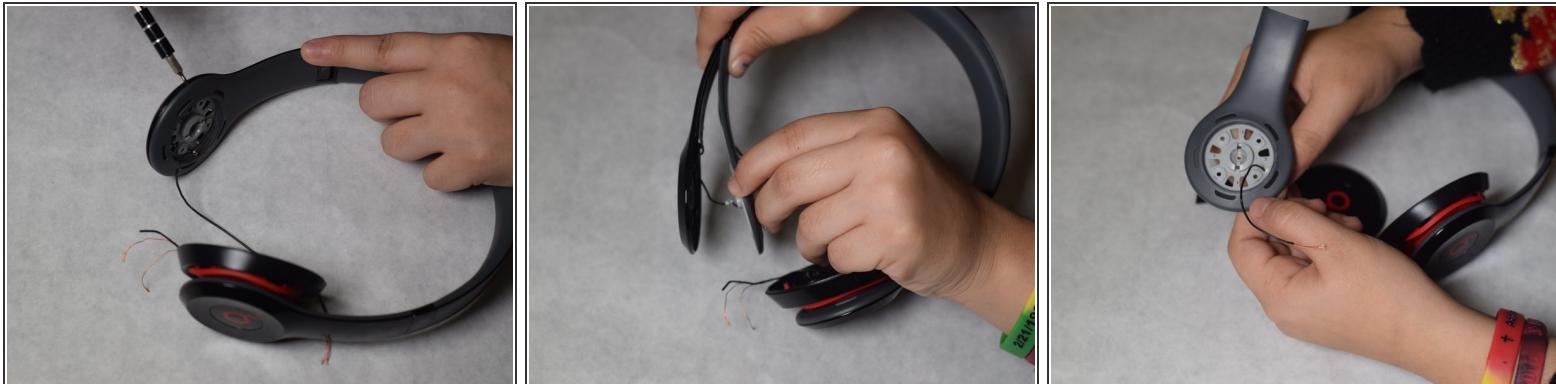
Step 8

- slowly pry away cover
