Bendix Magneto Impuse coupling replacement

Steps to remove the Bendix Magneto impulse coupling.

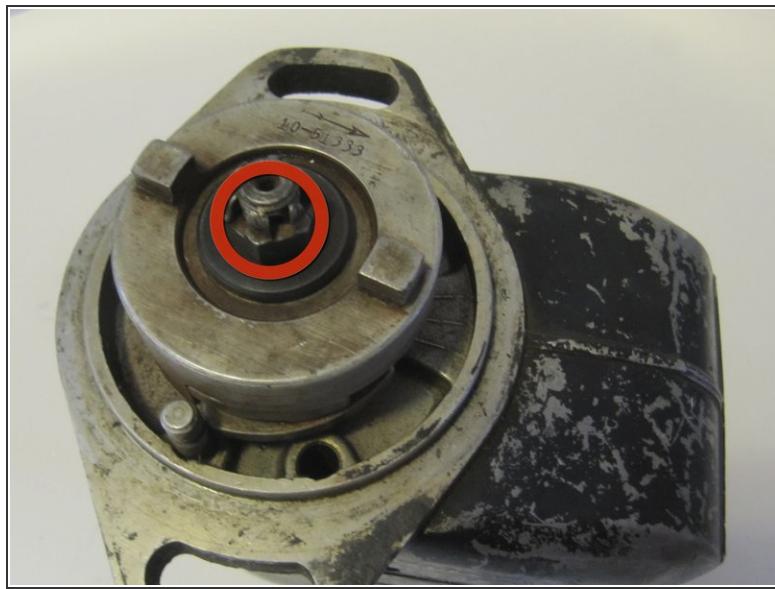
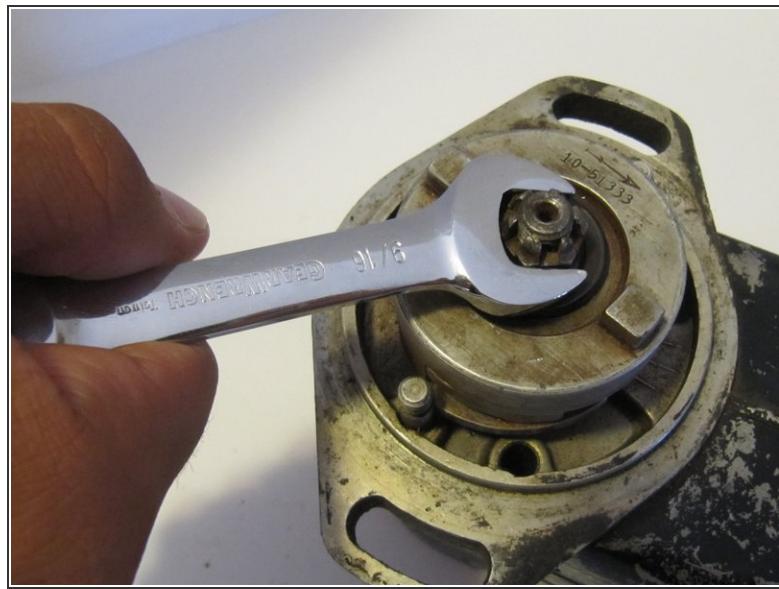
Step 1 — Impulse Coupling

- Use a 9/16 wrench to unscrew the nut on the drive shaft.

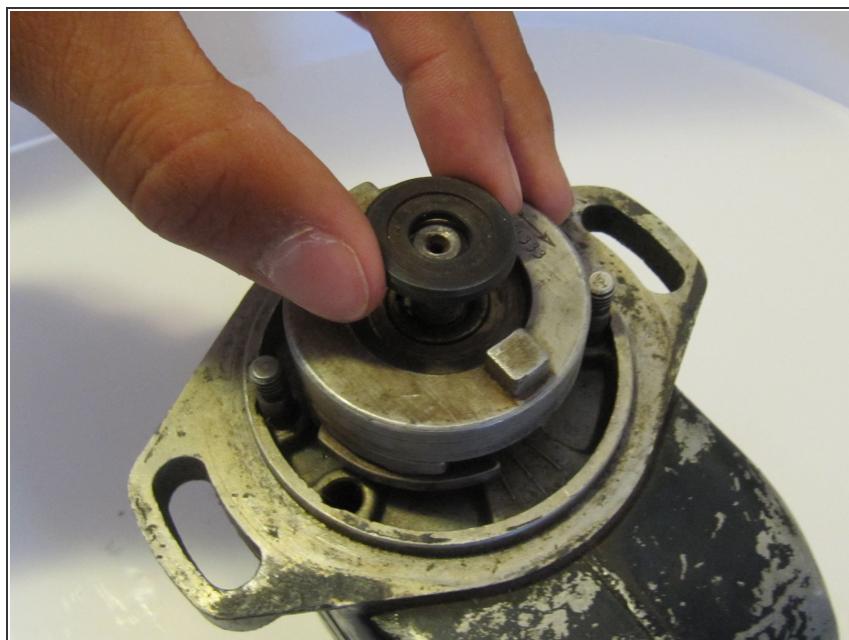
Step 2

- Remove the lock washer underneath the nut.

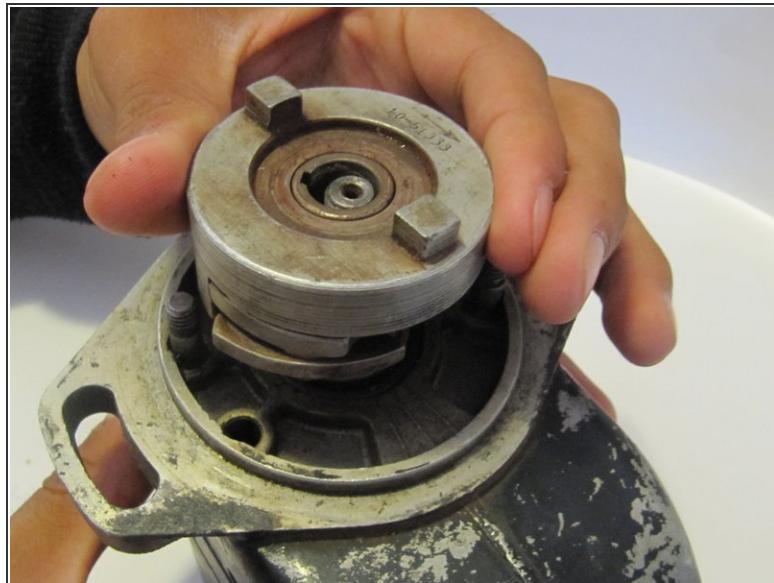
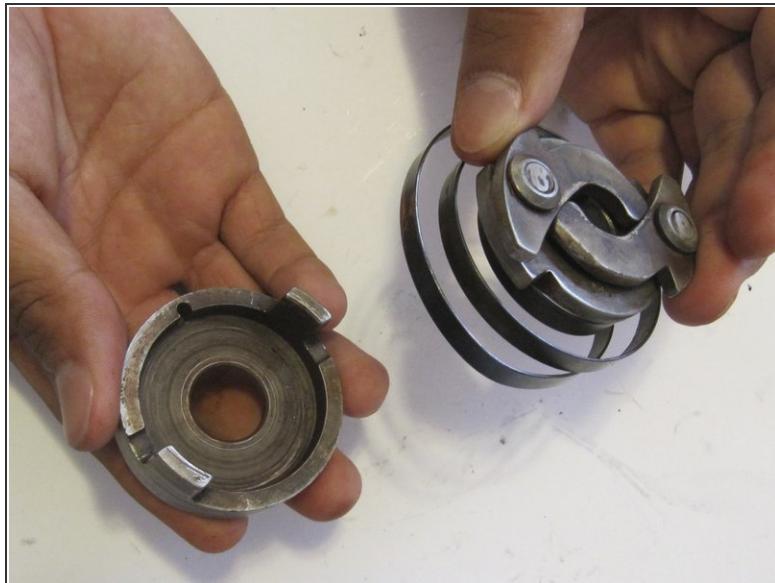
Step 3

- Pull away the impulse coupling.
