Bissell PowerLifter Brush Belt Replacement

This is a quick repair and will ensure that your Vacuum cleaner will work as it should.

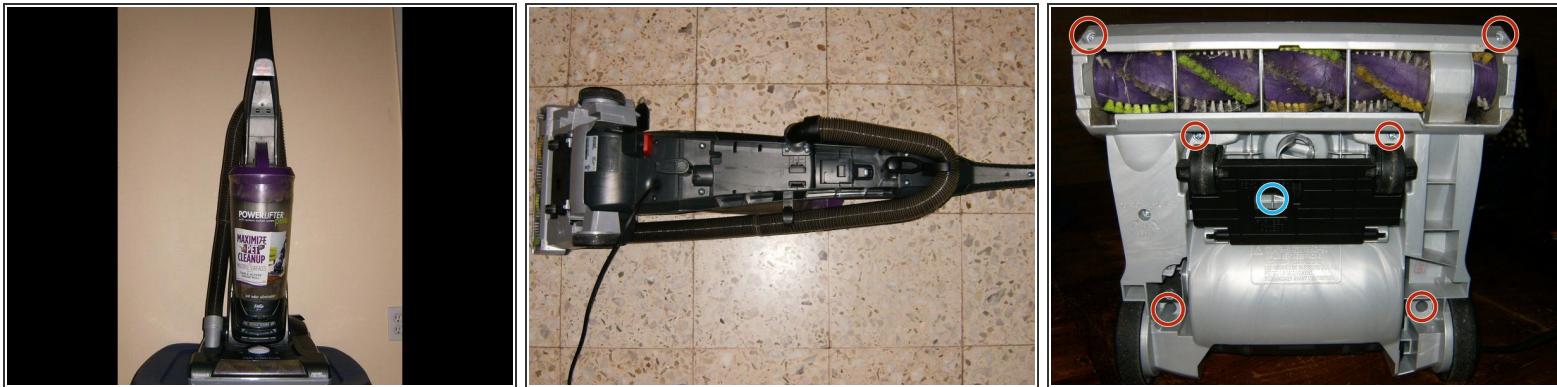
Step 1 — Brush Belt

- Here is the Bissell vacuum cleaner. The front brushes did no longer turn.
- Unplug the vacuum and turn it over so the bottom of the vacuum can be accessed
- There are a total of 7 Phillips head screws that need to be removed.
 - One of these screws is behind the height adjustment plate. It must be removed to gain access.

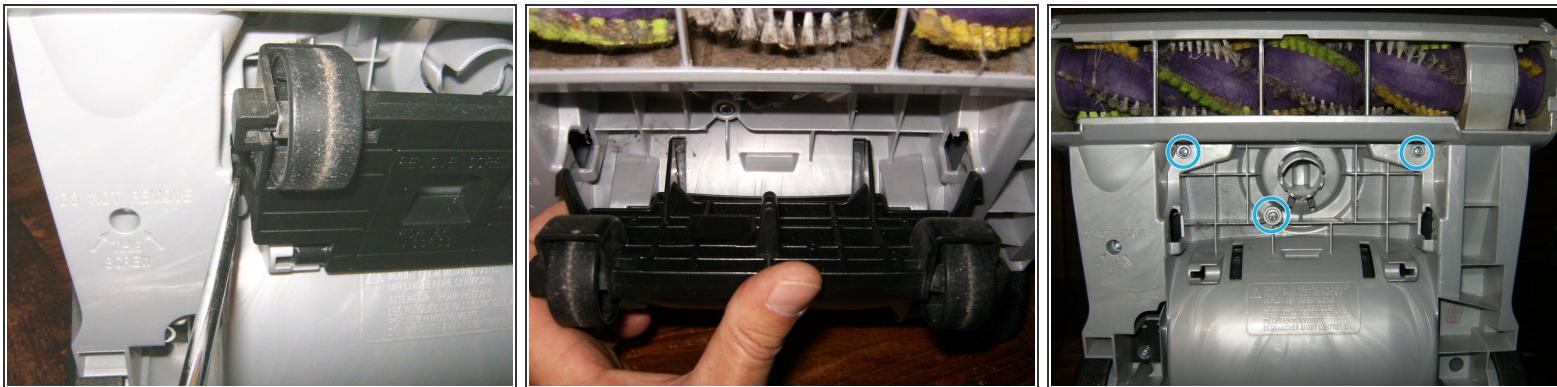
Step 2

- Use a flat tip screwdriver to push the tab from the height adjustment plate inwards to the plate to free it from the vacuum cleaner. Procedure is typical for both sides.
- Remove the height adjustment plate.
- All Phillips head screws can now be removed.

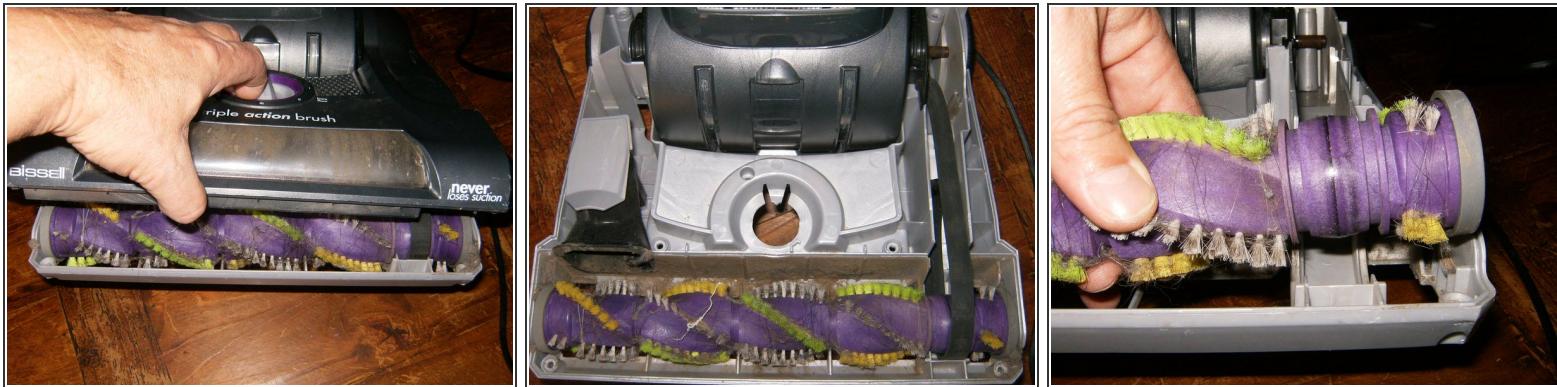
Step 3

- Turn the vacuum around and move the top cover straight up
- Here is the brush assembly with the belt on the right. This belt was definitely broken.
- Remove the brush by pulling it straight out.
