# Canon 7210 Fan Replacement

Replace the cooling fan in case of damage or malfunction.

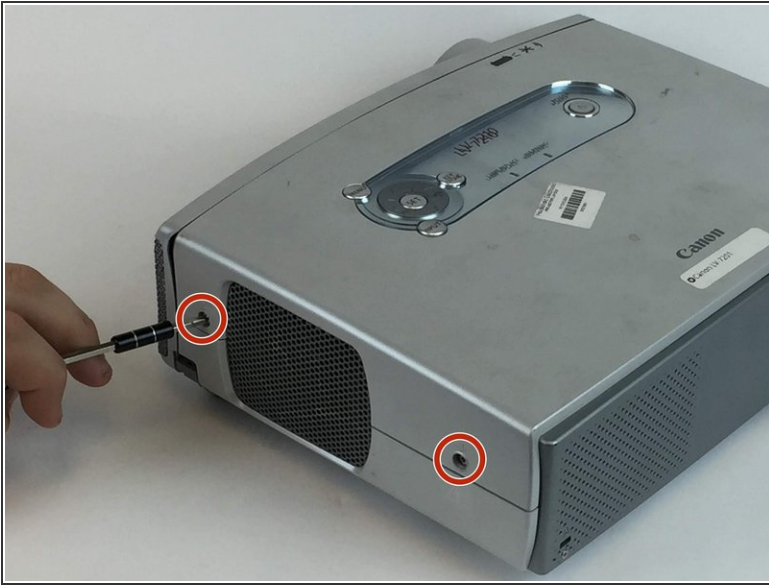
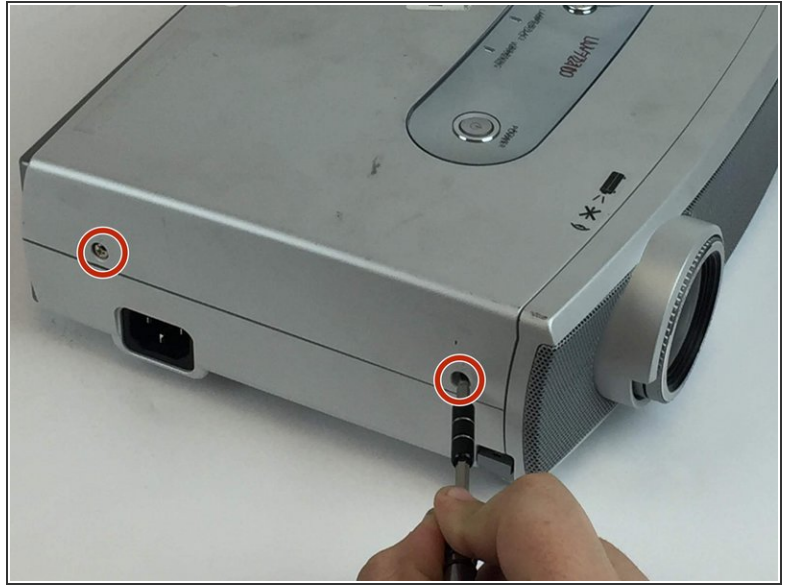
## Step 1 — Exterior Shell

- Remove the 4 exterior 9mm Phillips #0 screws. They are located on the sides of the projector.

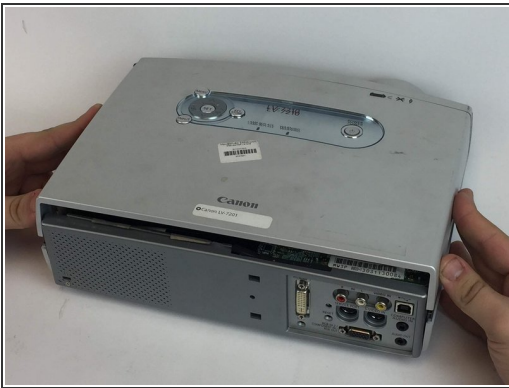
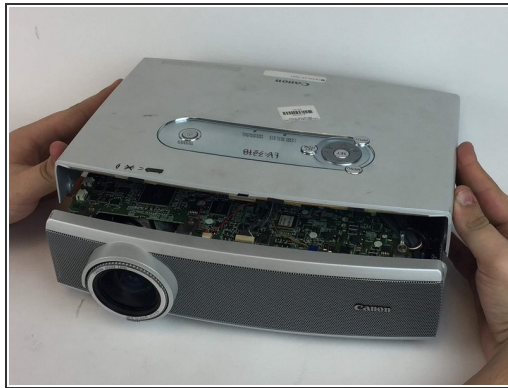
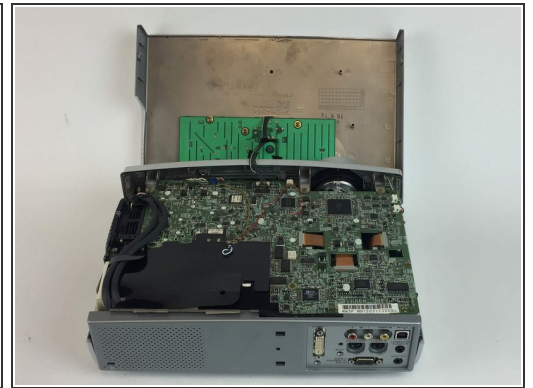
## Step 2

- Gently lift up on the shell with both hands, from the back to the front.
- ⓘ The shell will still be attached by a small cord in the front, so be careful not to tear it loose.

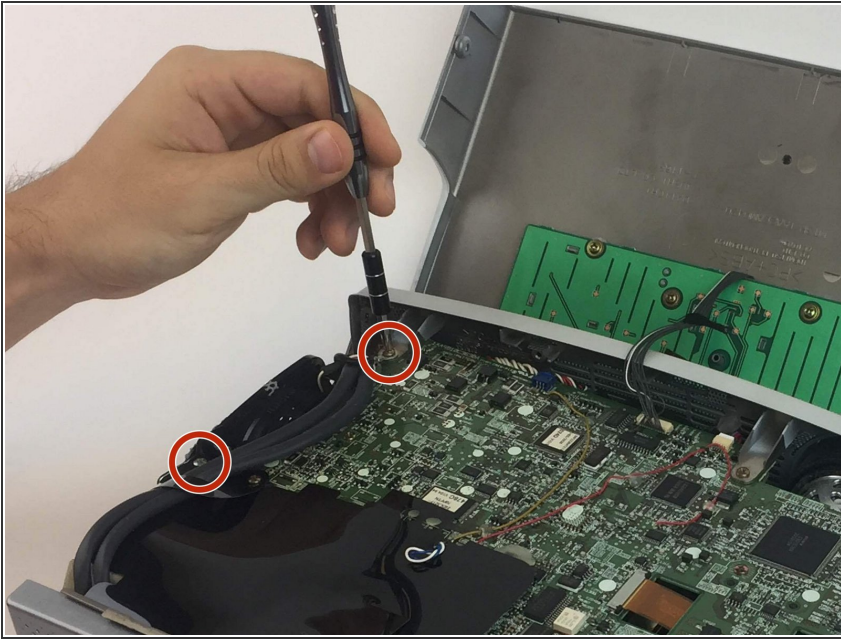
## Step 3 — Fan

- Remove the two 7mm Phillips #0 screws that attach the fan to the motherboard of the projector.

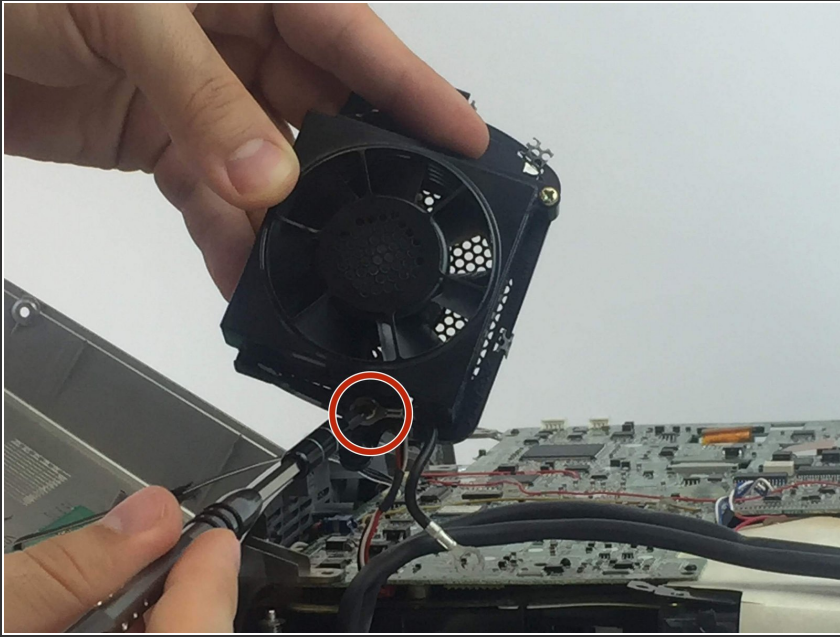
## Step 5

- Remove the 7mm Phillips #0 screw that fastens the black ground wire connected to the fan and the projector.

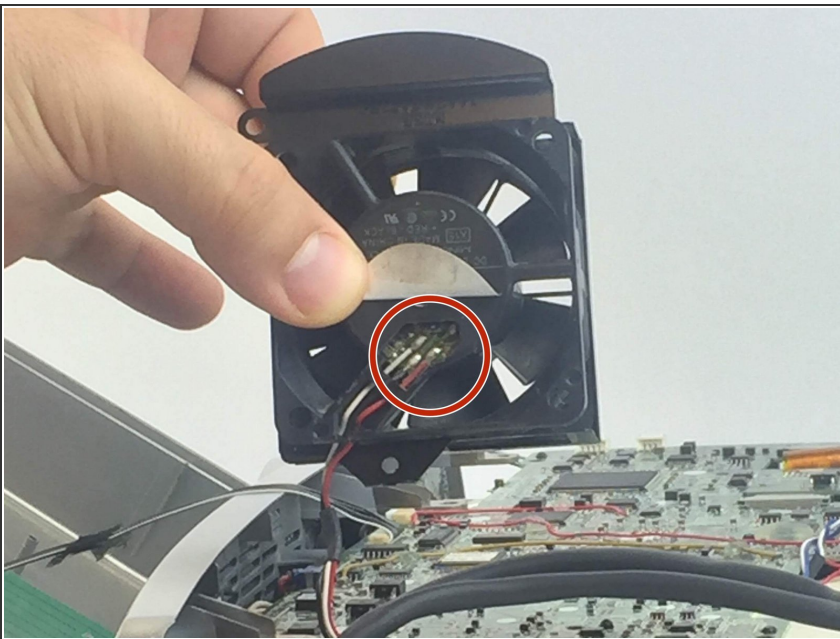
## Step 6

- Peel the sticker up on the back of the fan to expose the port where the red, white, and black wires are attached.
- The wires will need to be cut with small wire cutters in order to completely remove the fan.
