Canon DM-100 microphone rattle noise fix

How to fix the Canon DM-100 video microphone rattle noise. For Canon Vixia / Legria cameras in the HF-series.

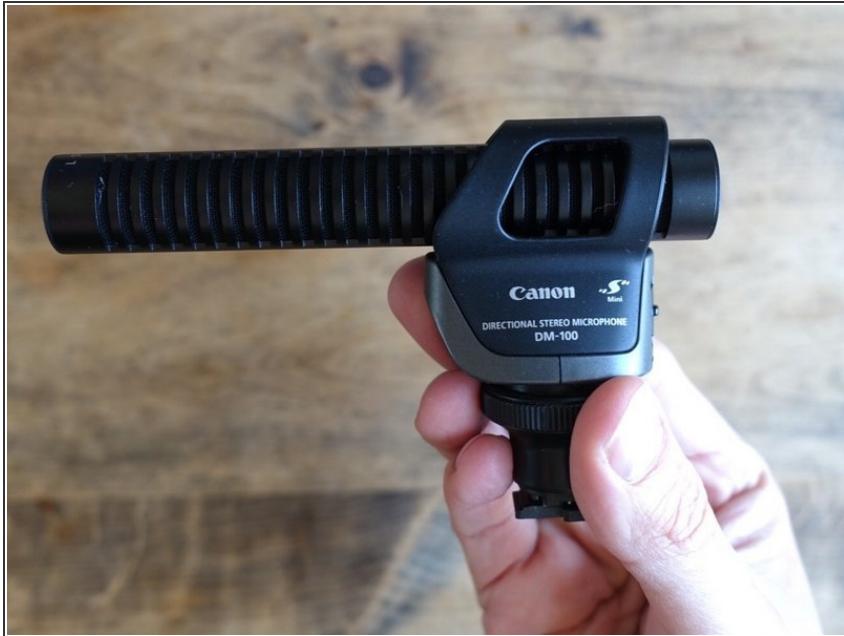
Step 1 — The Mic

- This is the rattly beast.

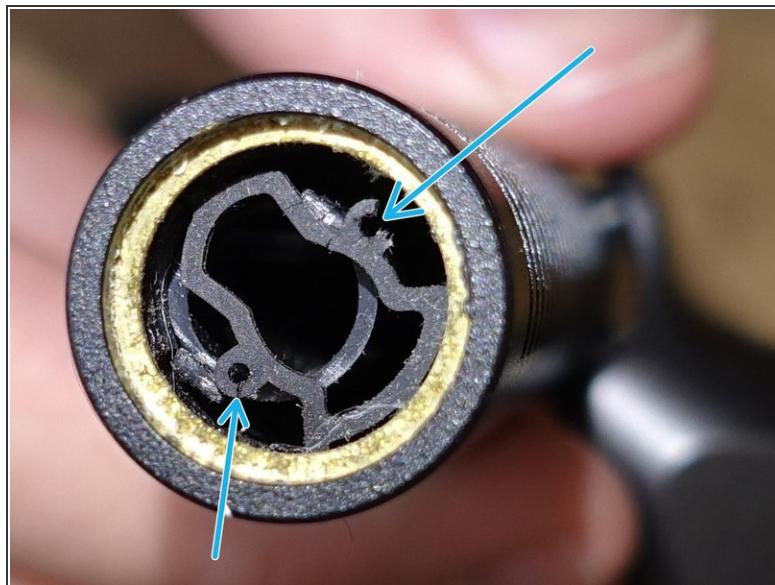
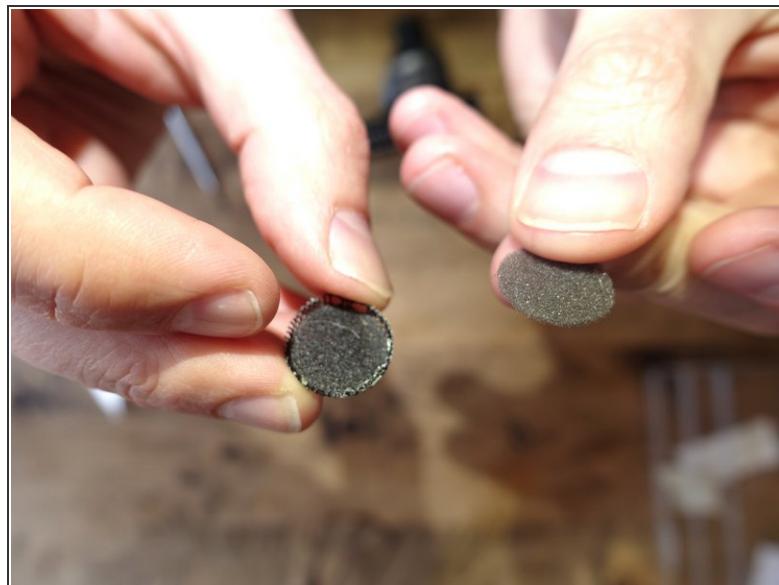
Step 3 — The culprit

- Canon has used an elastic band for vibration reduction of the directional "sound pipe" (seen as a circle behind the elastic band).
- The pipe visible behind the elastic is supposed to be mounted to the inner wall with the two marked circular joints.
- These incredibly weak joints are bound to break as the rubber loses its elasticity.

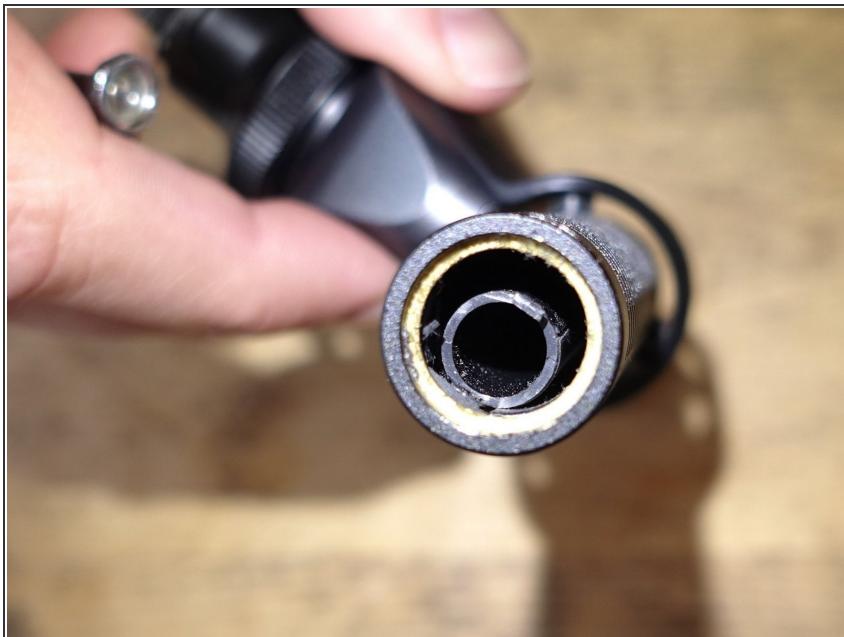
Step 5 — Clean slate

- The culprit of the rattling noise is now apparent. A plastic cylinder stretches through the whole of the

microphone, enabling the microphones forward focused / directional sound.

- When the rubber band breaks because of the bad joints, this thing hits the inner side of the cylinder.

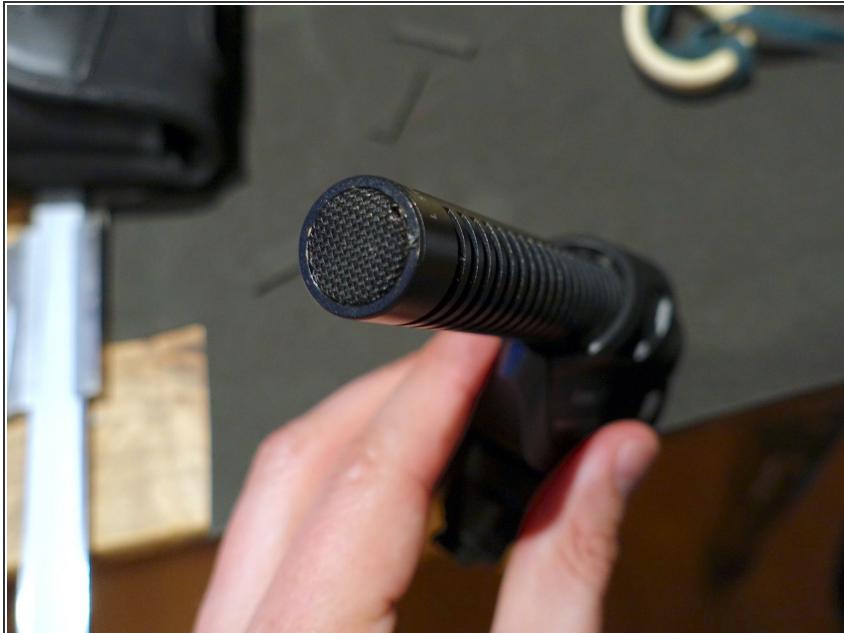
Step 10 — Done

- There! 190\$ microphone fixed for less than a dollar.
- The audio quality isn't affected at all.
