Canon PIXMA MP190 Scan Bed Removal

A dirty scan bed will cause poor scan or copy quality. Cleaning of the scan bed will remedy this issue.

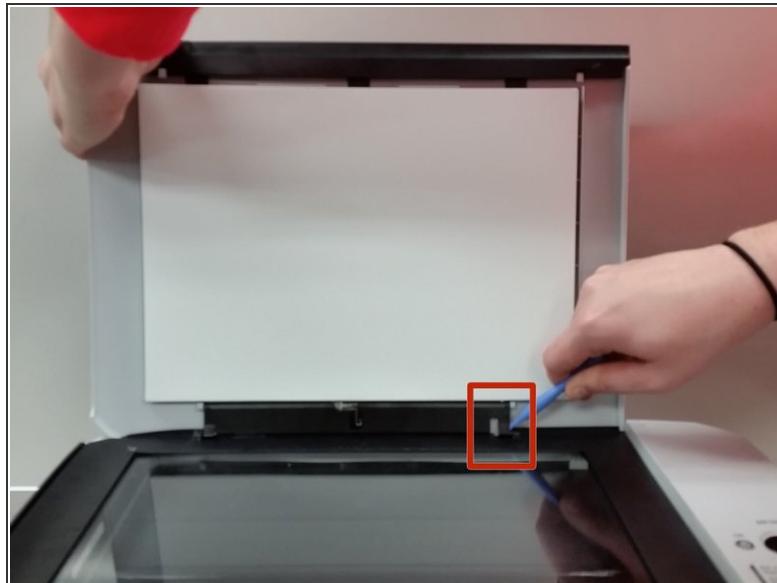
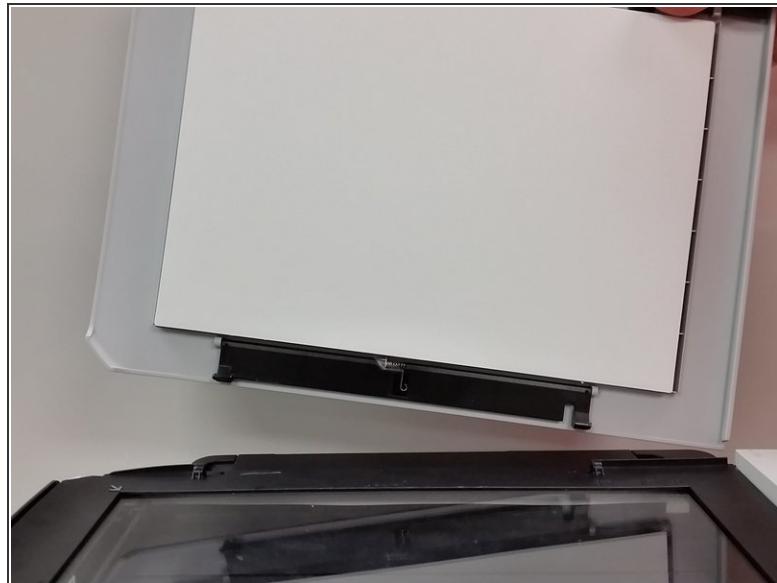
Step 1 — Remove Scanning Bed Cover

- Lift scanning bed cover with one hand, and pry the right hinge inward using a plastic opening tool.
- The cover will lift up and away from the printer.

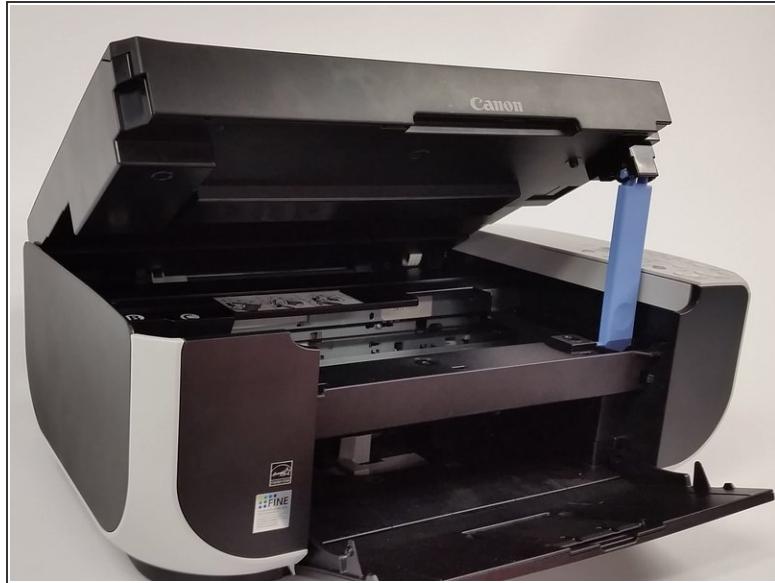
Step 2 — Accessing Scan Bed

- Lift the scan bed into the upright position.
- Ensure the scanning unit support seats into the scanning unit support slot.
- The four arrow markers located on the bottom edge of the scan bed mark the four tabs that must be released.

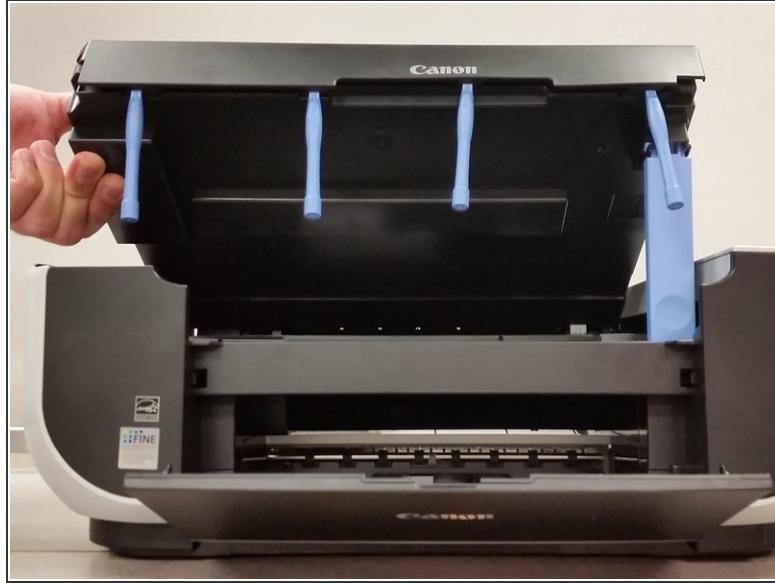
Step 3 — Accessing Scan Bed

- Place a plastic opening tool at each of the four marking arrows.
- The scan bed will detach from the scan bed unit. Lift scan bed glass upward to access the bottom surface of the glass.

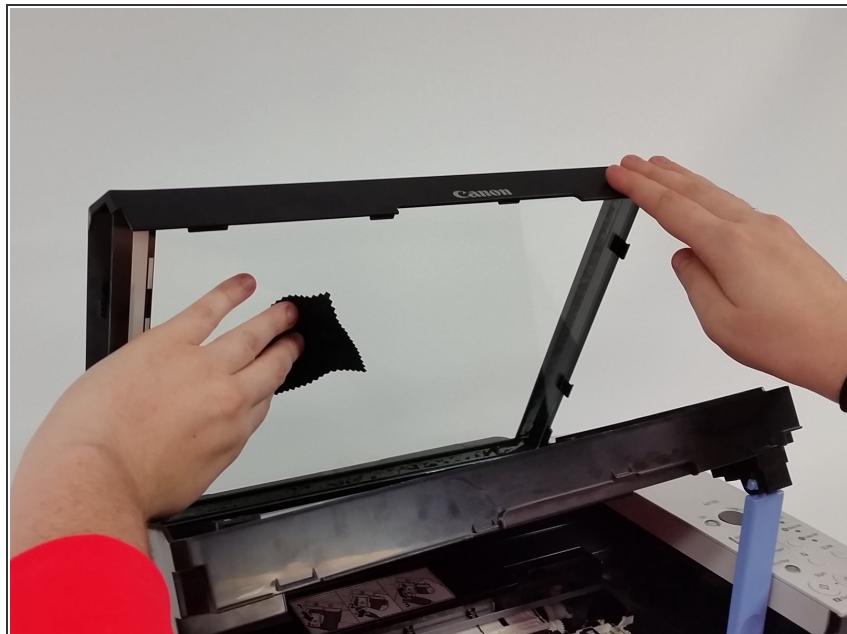
Step 4 — Cleaning the Scan Bed Glass

- Using the screen and device cleaner and cloth remove any dirt or debris from the bottom surface of the scan glass.

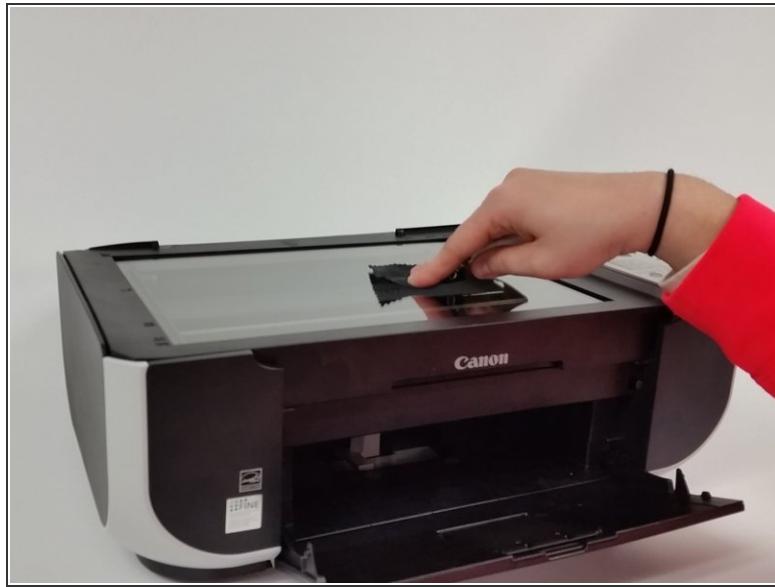
Step 5 — Reassemble Scan Bed Unit

- Lower the scan bed glass down on to the scanning unit until the clips reengage.
- Clean the top surface of the scan bed glass using the screen and device cleaner and cloth.
- Put the scan bed cover back on by placing the left hinge in first.
 - Then snap the right hinge into place.
- The printer is now ready to scan or copy.
