Canon Vixia HF R62 Navigation Buttons Replacement

In this guide the Canon Vixia HF R62 Navigation Buttons will be replaced. The signs of button failure are a delay between or complete failure of reaction.

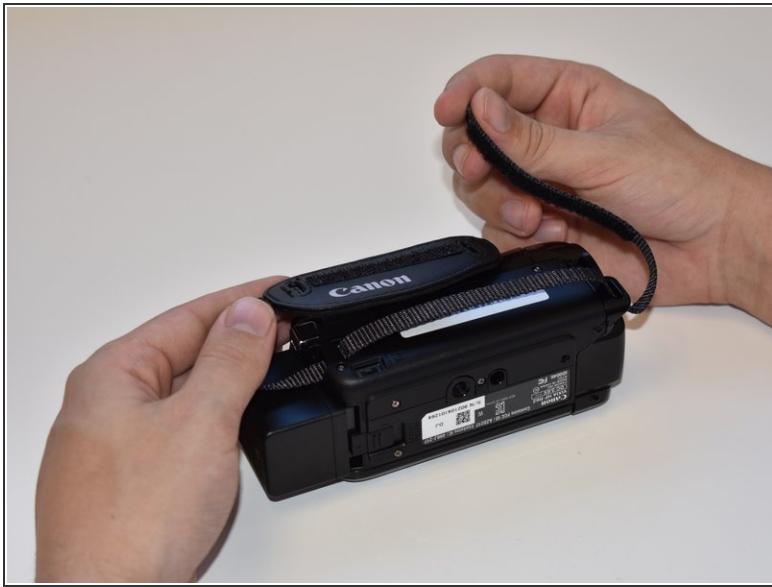
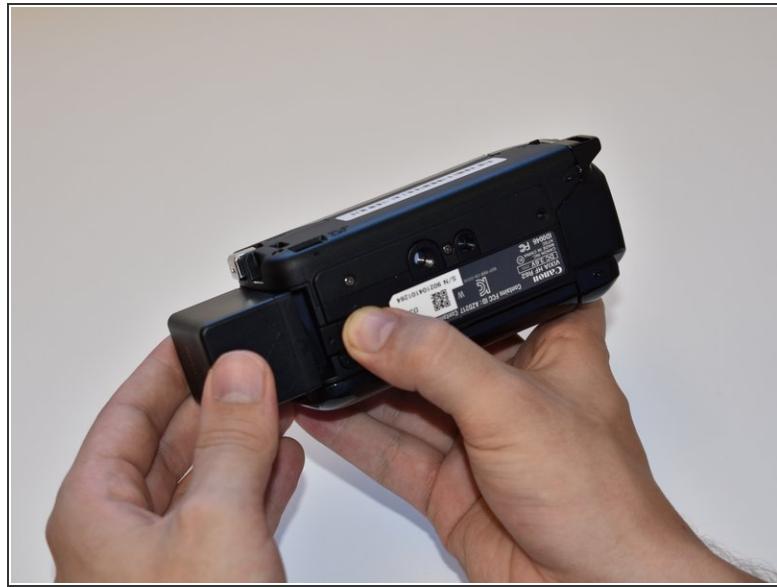
Step 1 — Outer Shell

- Remove the strap by undoing the Velcro and pulling it through the thread points.
- Remove the external battery pack by pressing down on the slide release and sliding it out.

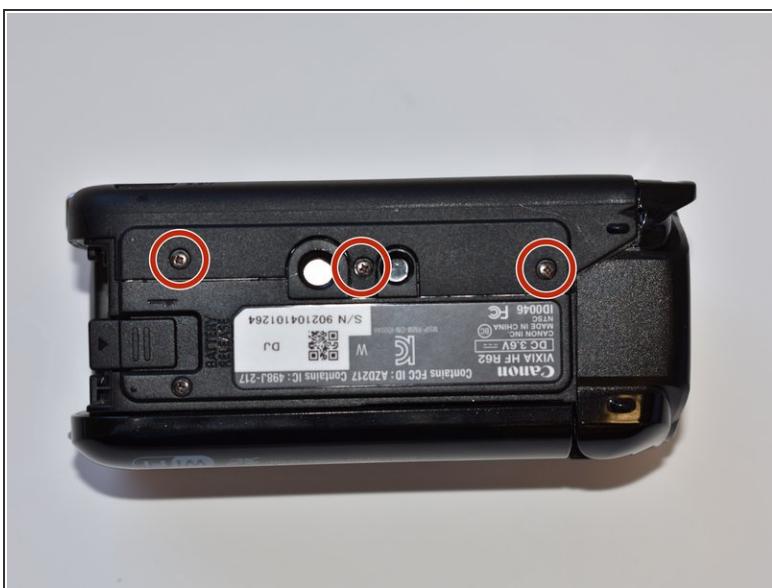
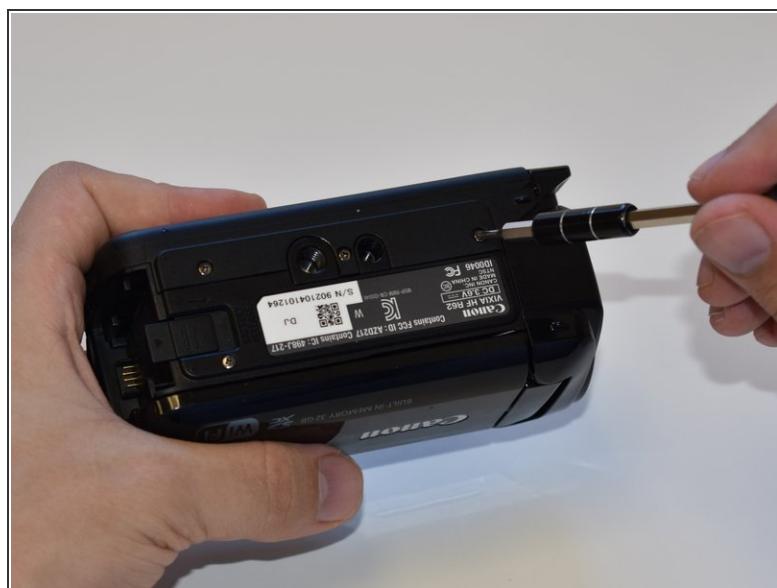
Step 2

- Remove the three 5mm Phillips #000 screws on the bottom of the device.

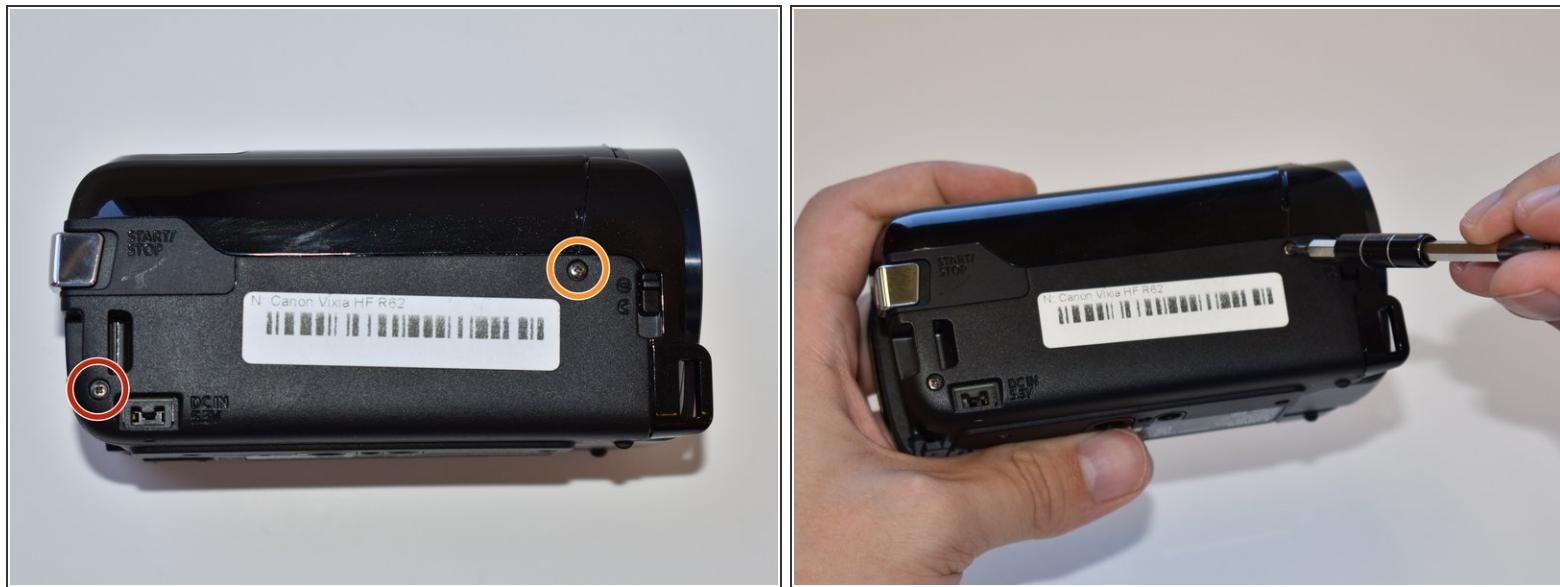
Step 3

- On the side of the device, remove the following Phillips #000 screws:
 - One 3mm screw
 - One 5mm screw

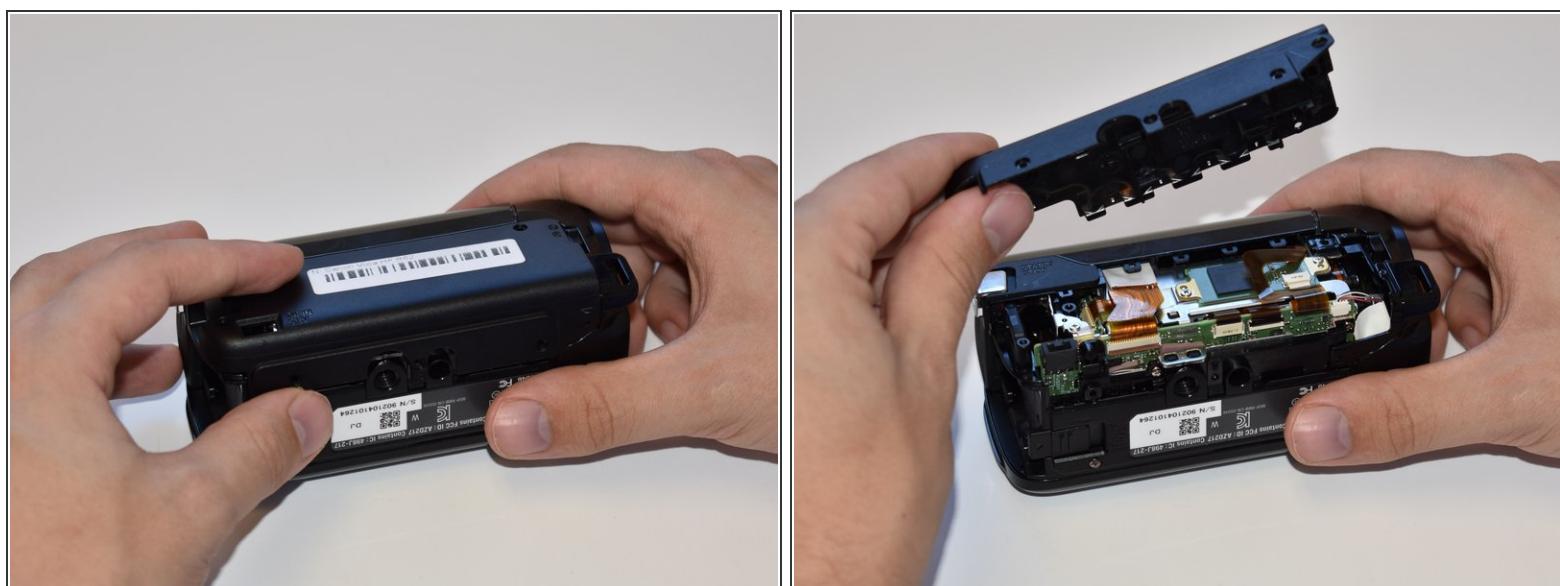
Step 4

- Remove the panel opposite the display by pulling up perpendicular to the side.

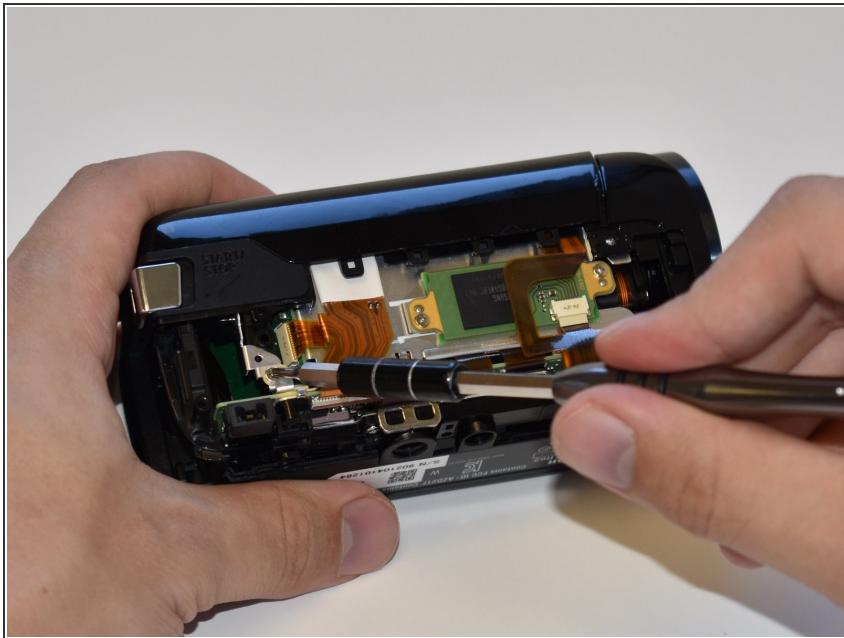
Step 5

- Remove the 4mm Phillips #000 screw that was exposed after taking off the side panel.

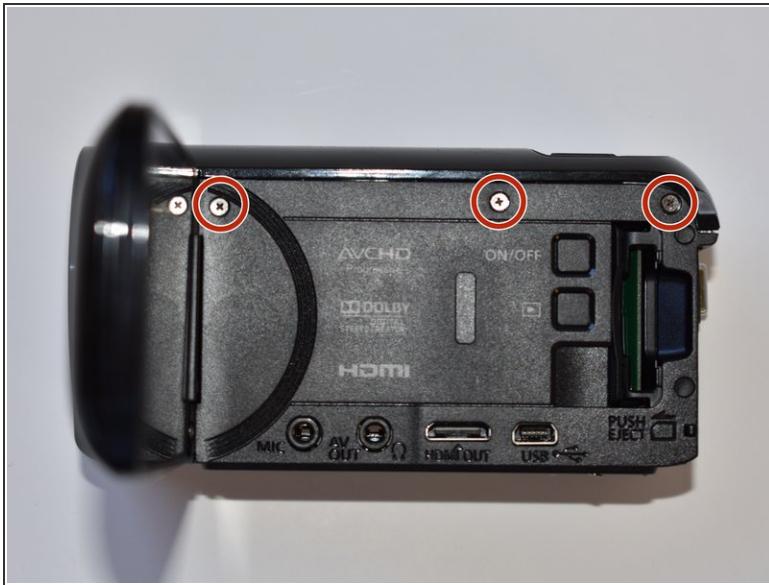
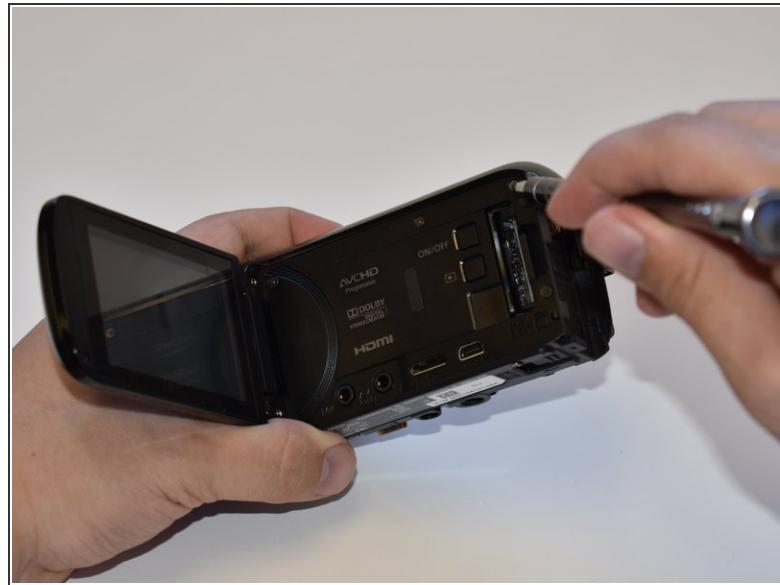
Step 6

- Remove the three 4mm Phillips #000 screws shown.

(i) There will be foam covers protecting some or all of these screws. These will need to be removed before you will be able to unscrew them.

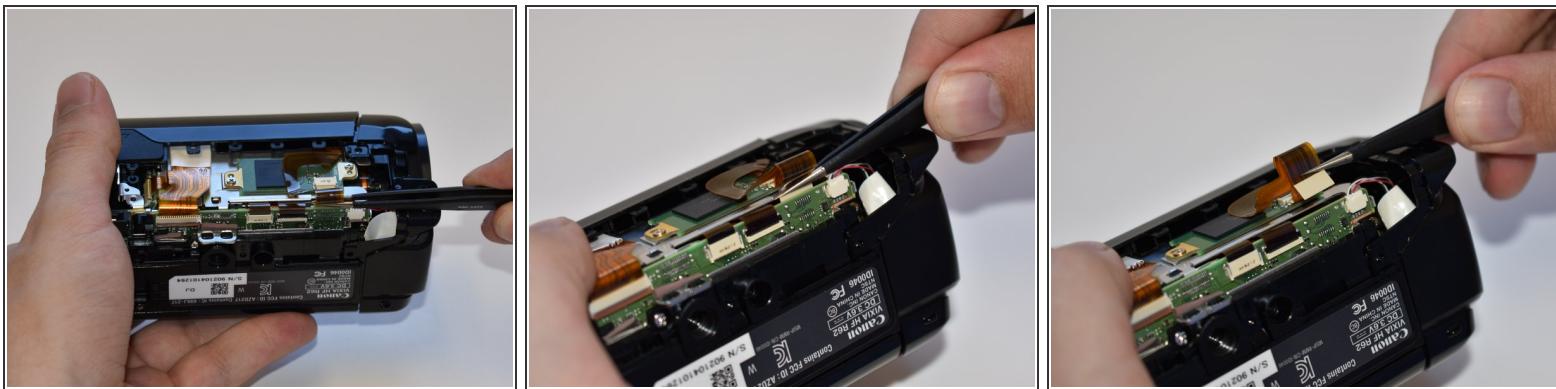
Step 7

- Using tweezers, disconnect this ribbon cable by pulling straight out.

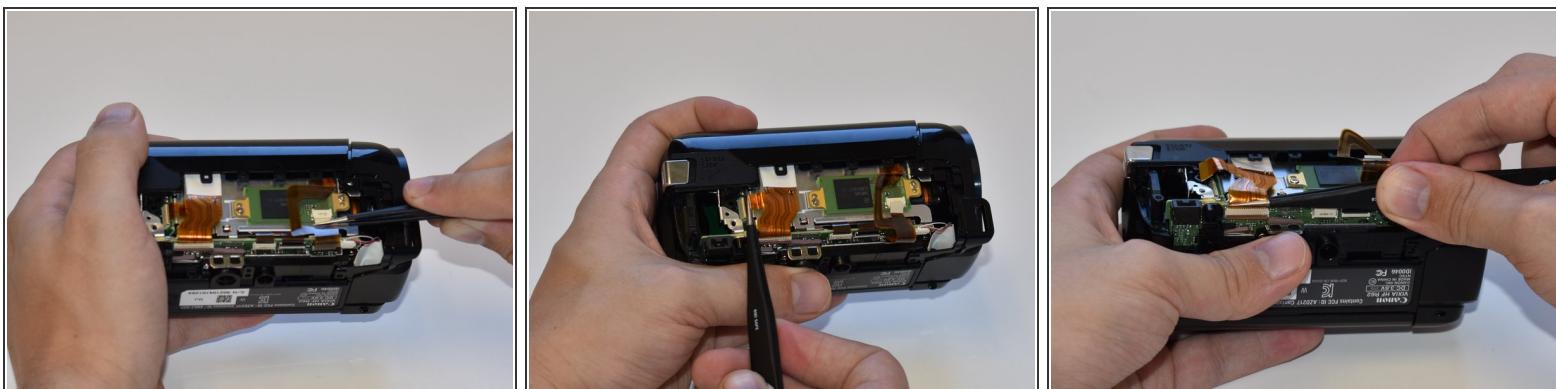
Step 8

- Repeat step seven (7) for the remaining three wires shown.

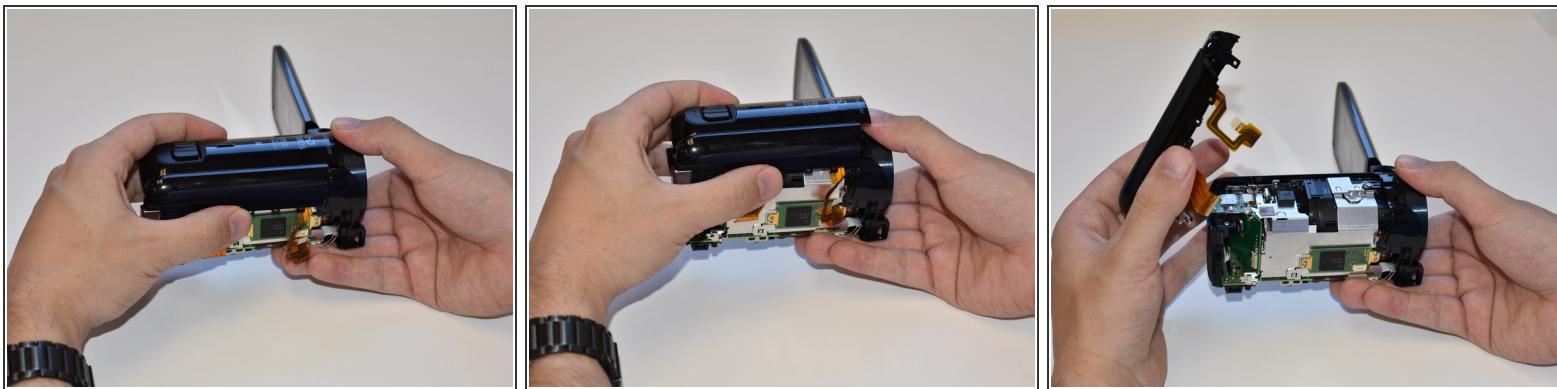
Step 9

- Grasp the top of the camera and pull straight up to remove the top panel.

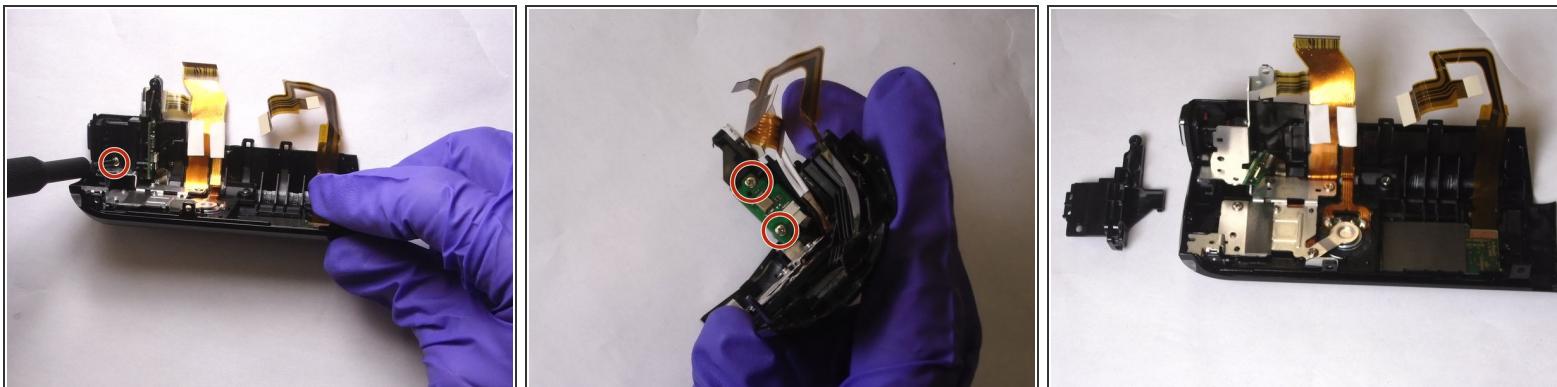
Step 10 — Navigation Buttons

- Use the Phillips #000 screwdriver to remove three 3mm Phillips #000 screws from the outer casing shell around the record button and remove it and the small microchip.

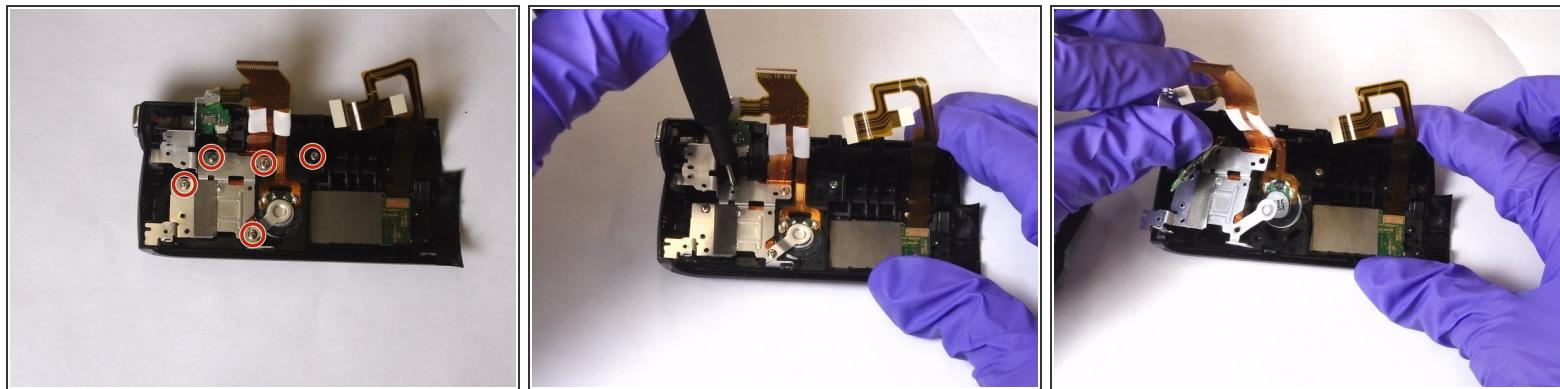
Step 11

- Use the Phillips #000 screwdriver to remove five 3mm Phillips #000 screws from the outer casing shell and remove the metal piece containing the speaker.

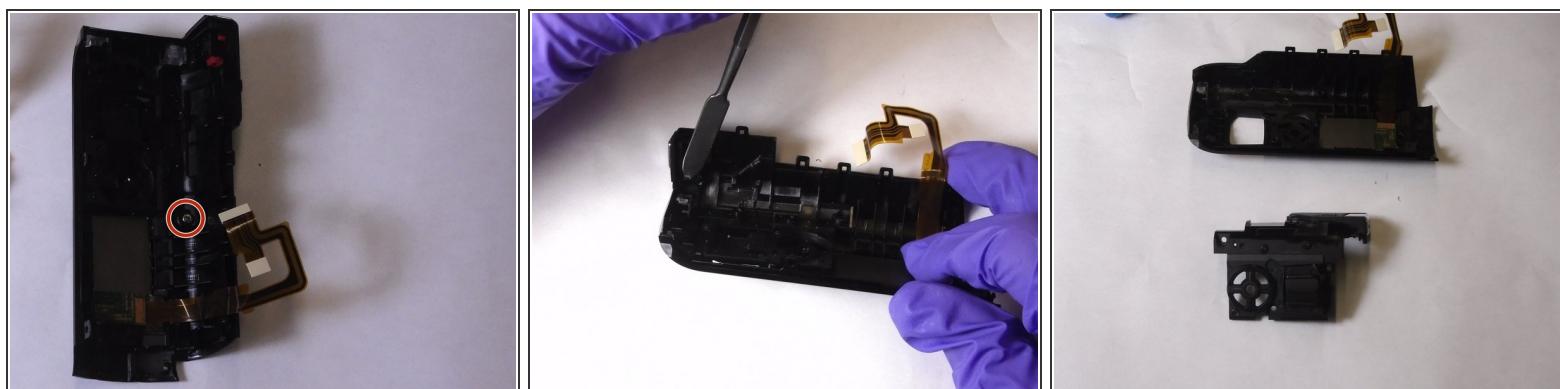
Step 12

- Remove one 3mm Phillips #000 screw holding the navigation button in. Then use the metal spudger to separate the button from the casing.

To reassemble your device, follow these instructions in reverse order.
