Chef's Choice M115 Linkage Pins Replacement

This guide will cover the replacement of the pins that secure the sharpening stones.

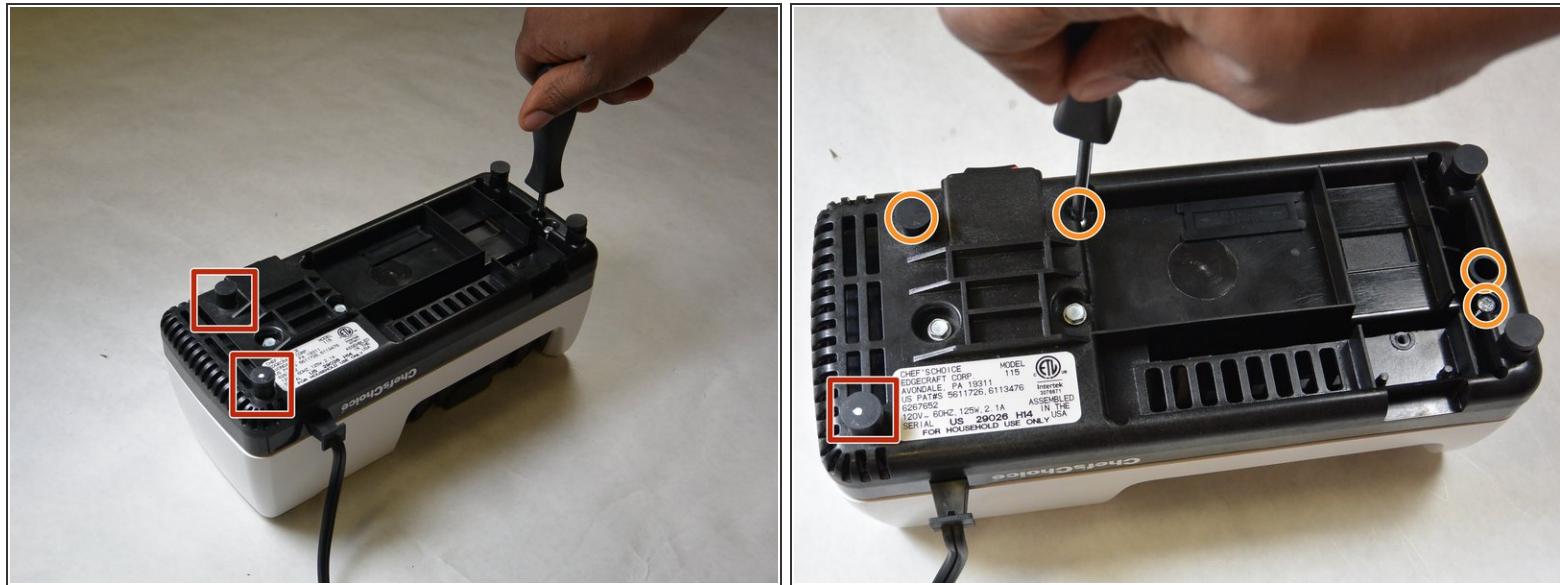
Step 1 — Case

- Remove the two rubber feet on the motor side of the device.
- Remove the five Phillips screws from the bottom of the case.

(i) These screws are recessed deep in the device, so a long, thin screwdriver is required.

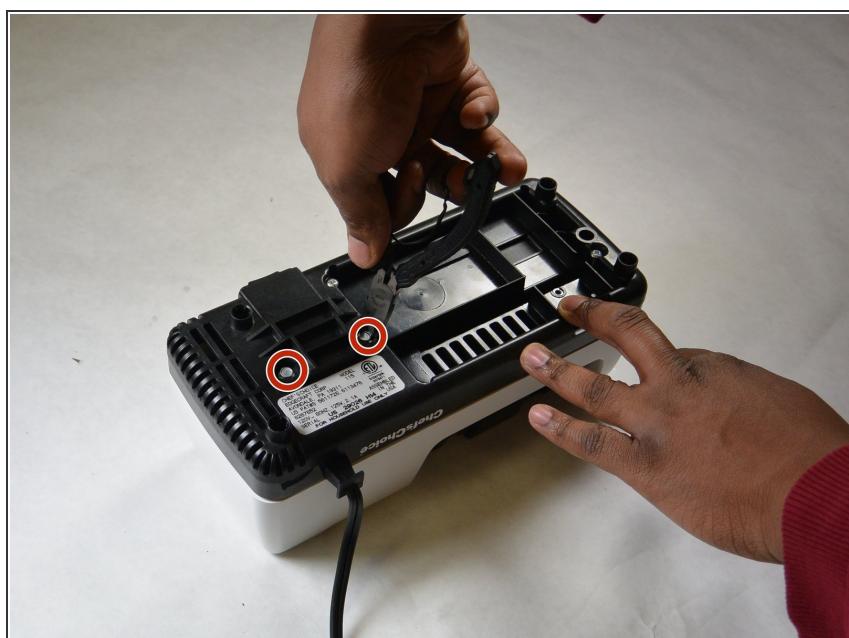
Step 2

- Remove the two hex-cap screws on the bottom using a pair of pliers.

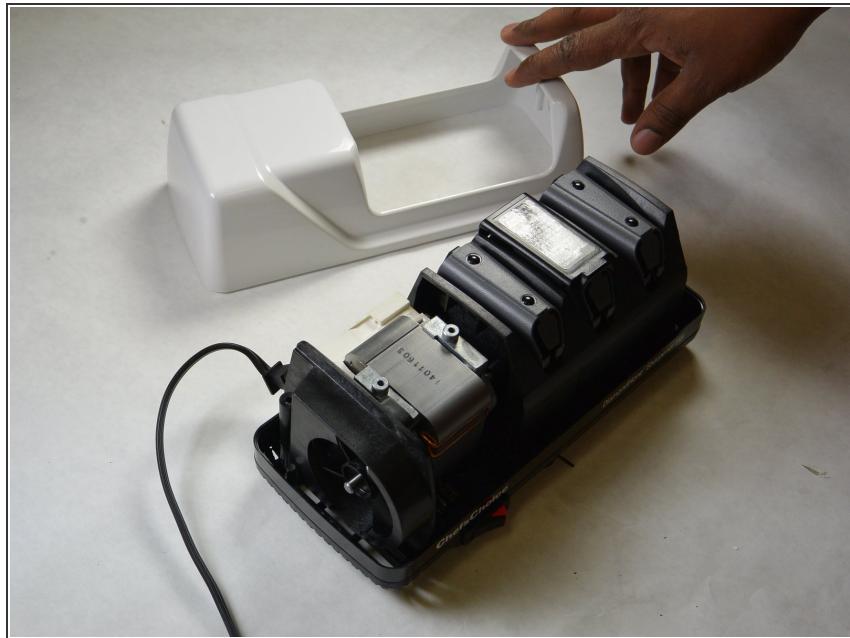
Step 3

- Carefully flip the device right-side-up while grasping the top and bottom pieces.
- *i* The white cover should lift off with no resistance. If it does not, ensure all screws were removed in previous step.

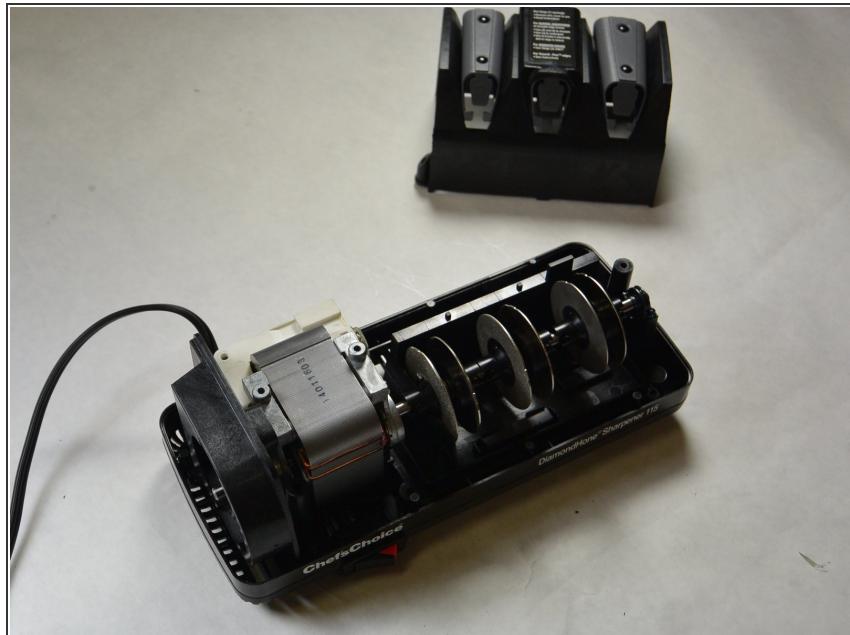
Step 4

- Remove the sharpener guard by gently pulling up on it.
- *i* If the sharpener guard does not come off easily, ensure all screws were removed in step 1.

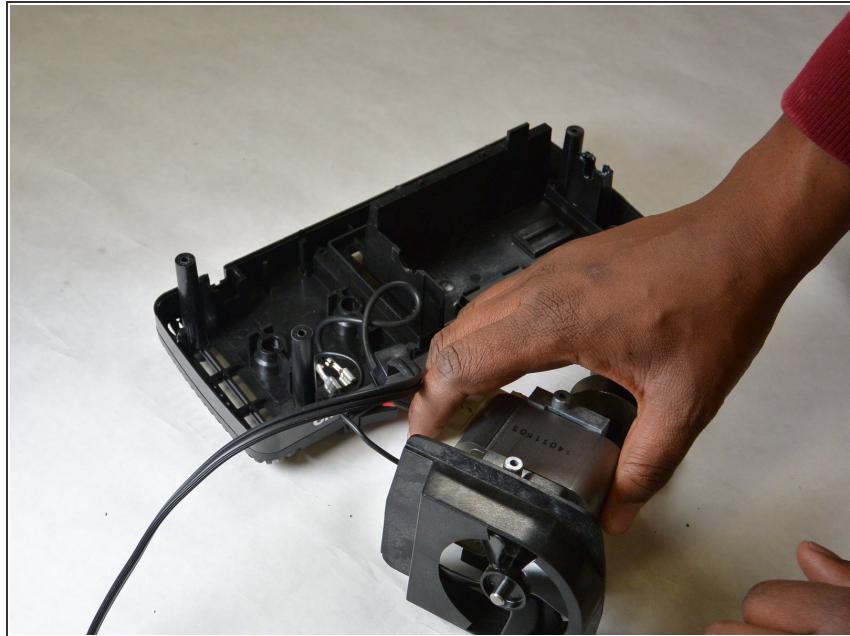
Step 5 — Grinding Disc Linkage Pins

- Remove the motor and shaft assembly from the bottom of the case housing.

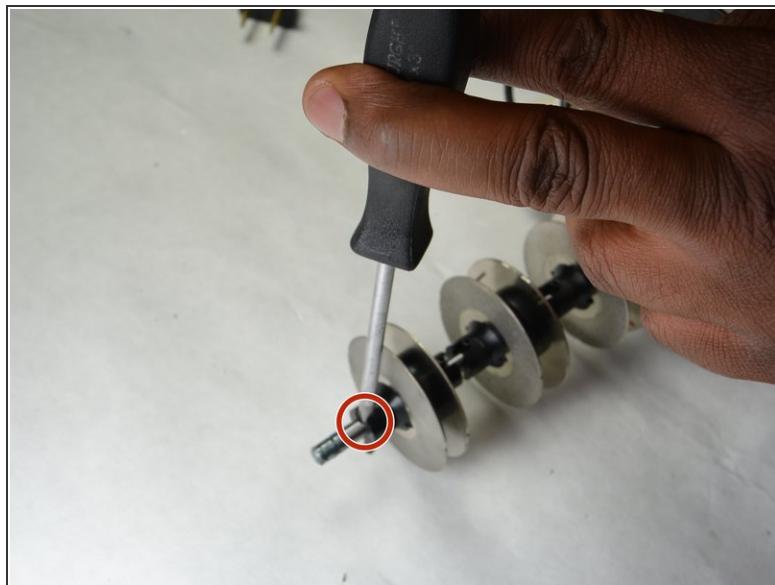
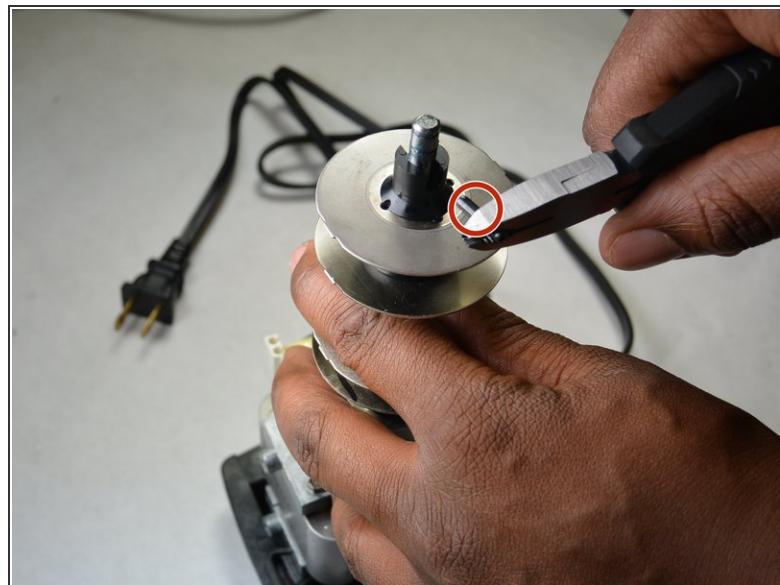
Step 6

- Use a screwdriver to push the pin out of the rod.
- Use pliers to pull the pin the rest of the way out.

To reassemble your device, follow these instructions in reverse order.
