De Dietrich Double Oven Control PCB Replacement

Repair an electric Double Oven. (UK and 240vac mains current) Repair a broken light and no lower oven working. No display or function buttons.

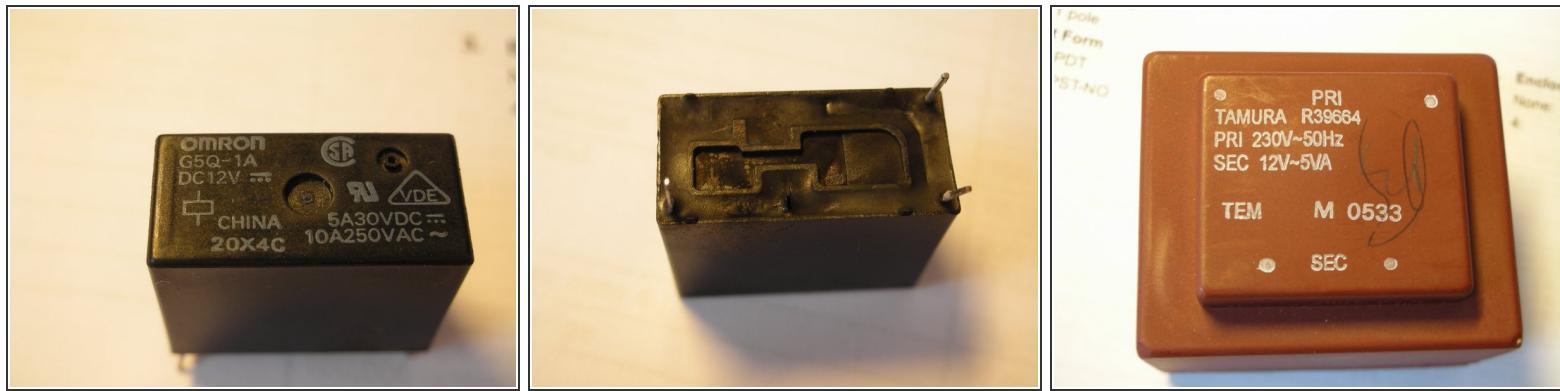
Step 1 — Control PCB

⚠ You will be working on live and exposed wiring components. Disconnect and switch off from wall outlet. No Internal light working and lower oven function or display. Note that this oven has two similar control pcb's. You can compare one board to the other.

- The lamp has been replaced but still not working. The next thing to do is check out the lamp wire end connections, the terminals went high resistance on my unit, replacing the push on connectors was easy. The connectors are the type used on cars and I had some handy. Re-testing still no light.

- Tracing the lead wires back to the control pcb I noticed the small relay looked bad and this only applied a neutral return.
- Pulling the relay showed more blackened marks. So the relay was replaced. Success now the light was on again.

- Moving on to the lower oven with no display or function buttons working. Checking the output from the small 12v 5VA transformer was zero. 240V AC input was there. A slight bulge on the top of the transformer confirmed a problem, it was also coming out. Resistance on the primary showed o/c windings.

(i) The new transformer was made by Myrra (not Tamura as in the photo) and that a Myrra unit was working on the other controller pcb. Guess the factory used both.

- A new replacement from Farnell was fitted. Part number 1689081, (Manufacturer part number 44231)
- Testing and the controls were restored to normal.
