Dell VRP100 Auxiliary Cord Replacement

How to replace the auxiliary cord to fix the audio in a Dell VRP100.

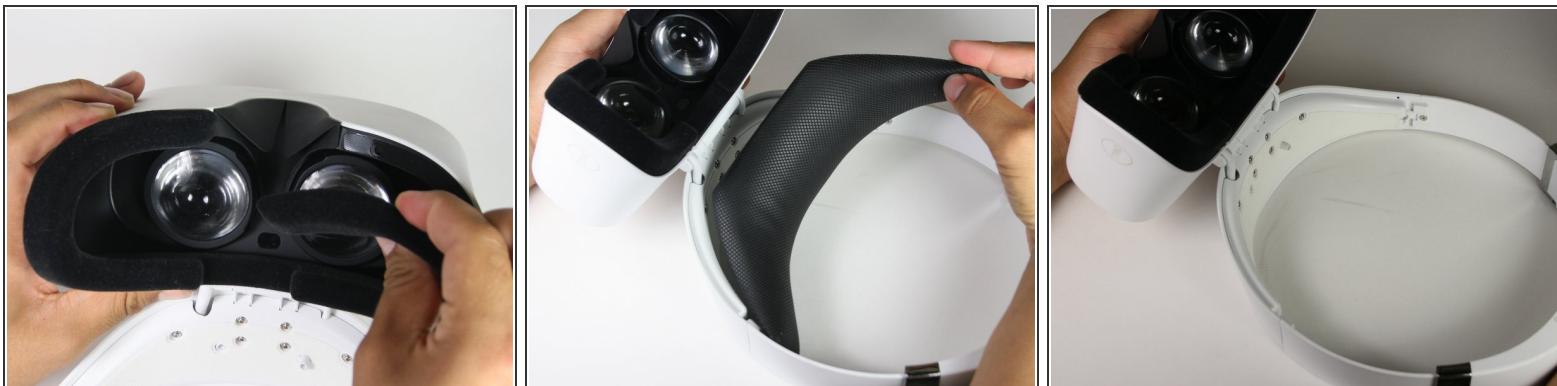
Step 1 — Cover Panel

- Remove the black foam padding by peeling away slowly.
- Remove the front and back padding from the headset by peeling away slowly.

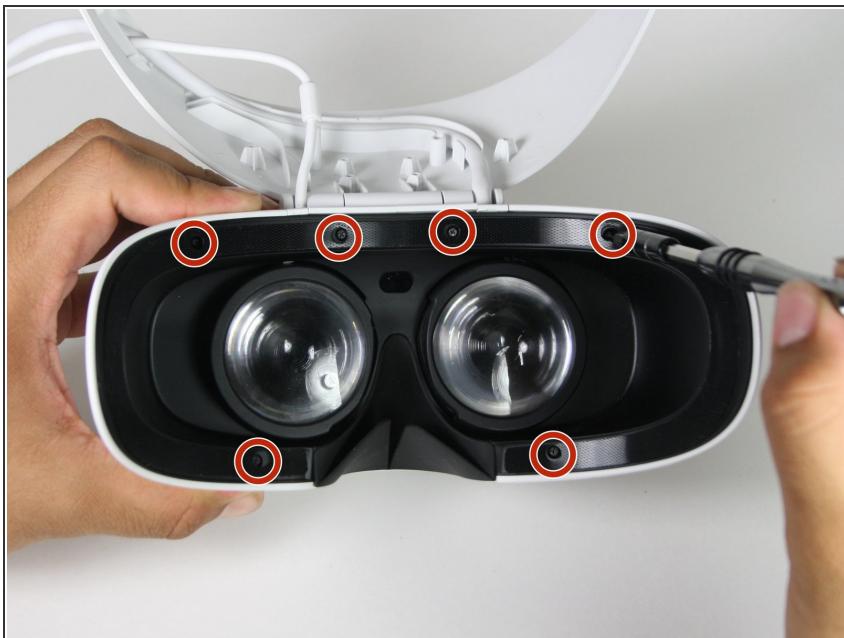
Step 2

- Remove the six 5.5mm PH000 screws from the cover by rotating counter-clockwise.
- ➡ Cover panel may need to be pushed in before inserting screws.

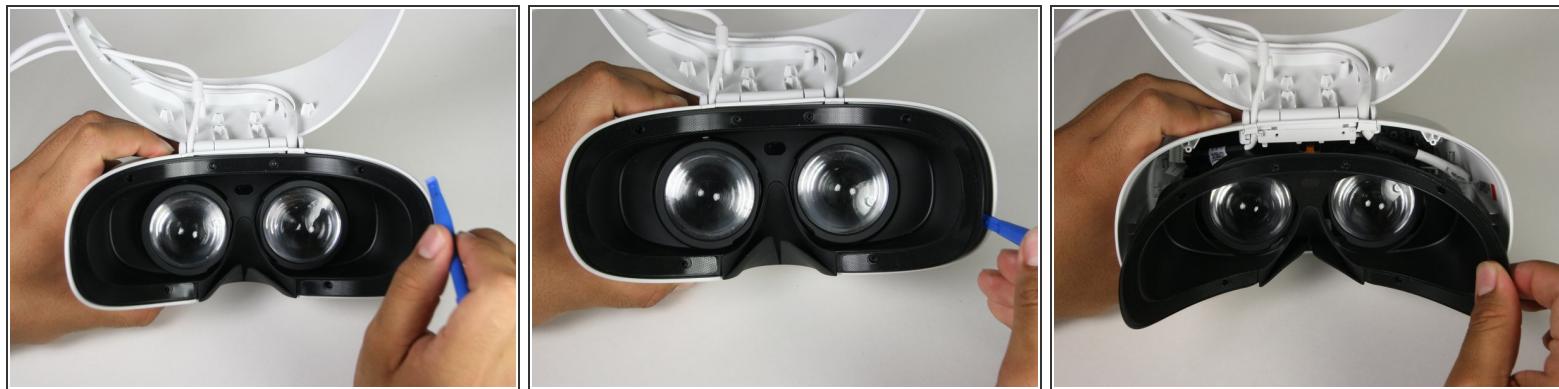
Step 3

- Remove the cover using one of the plastic opening tools, and then carefully pull it from the casing.

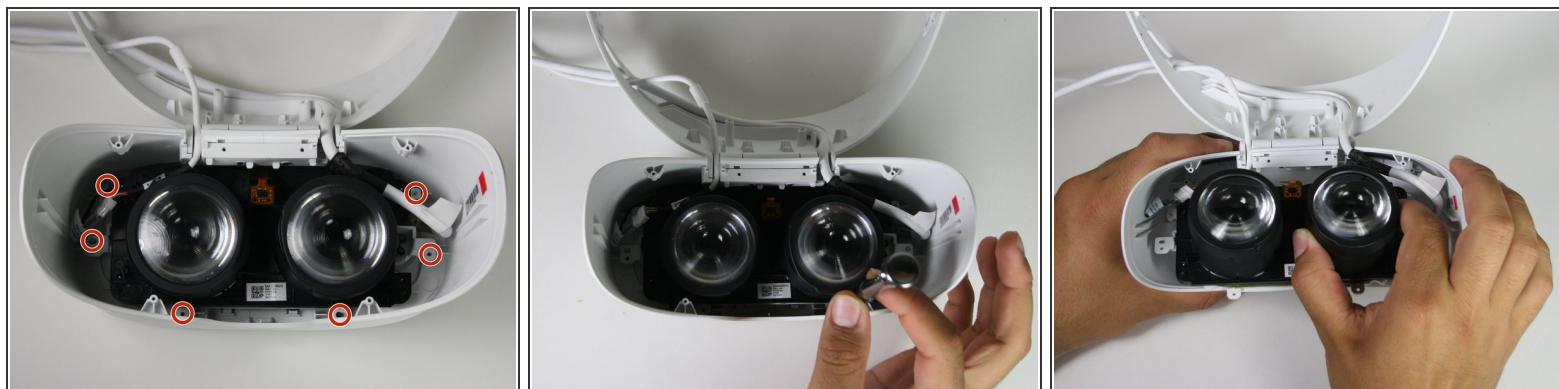
Step 4

- Remove the six 5.5mm PH000 screws from the cover by rotating counter-clockwise.
- Carefully remove the lens and motherboard assembly from the white casing.

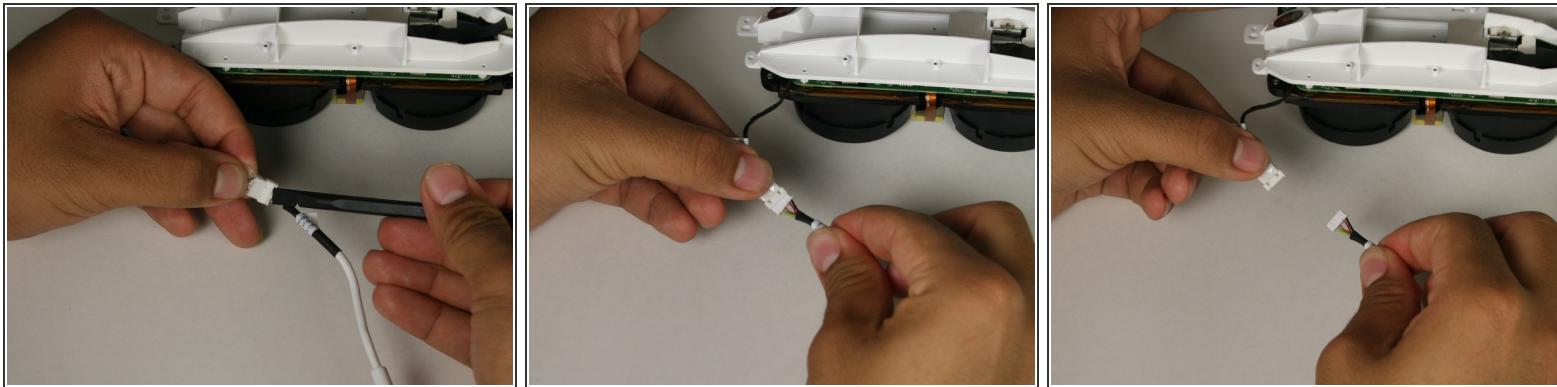
Step 5 — Auxiliary Cord

- Separate the external connector of the auxiliary cord.
- *(i)* A spudger may be needed to separate the connector.

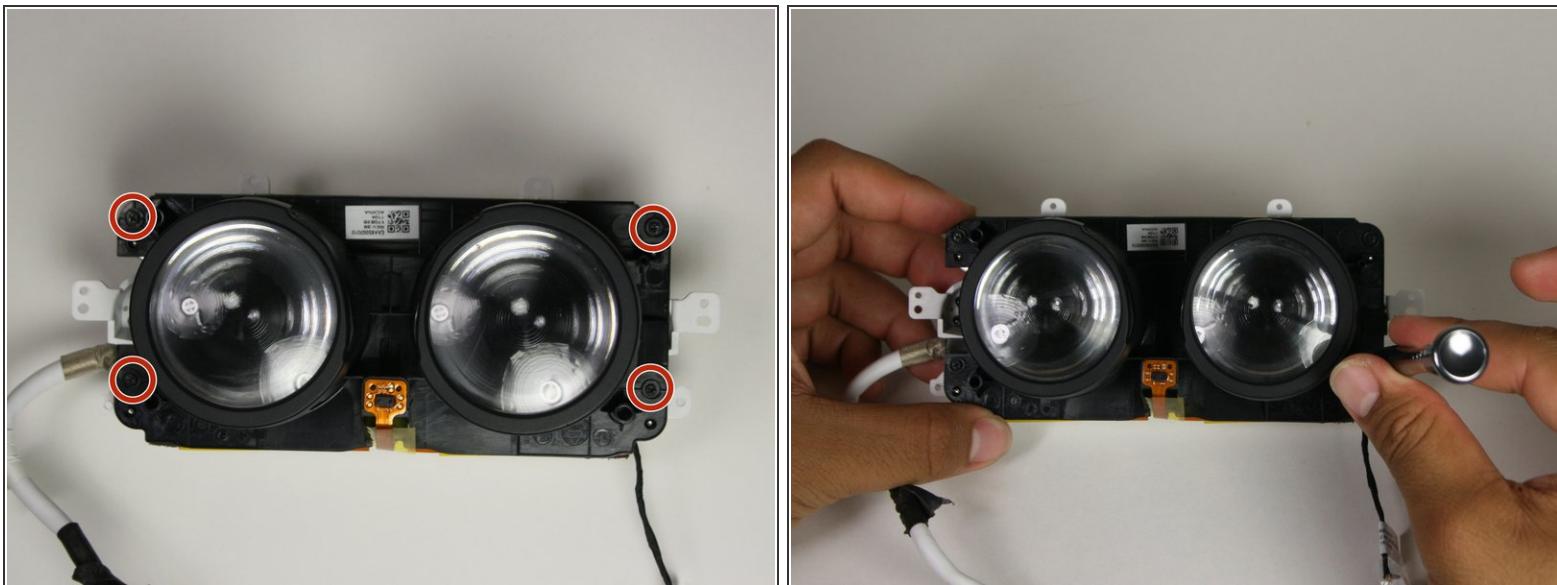
Step 6

- Remove the four 2.5mm PH000 screws by rotating counter-clockwise.
- Separate the lens housing from the motherboard panel.
