Dell Vostro 3550 Disk Drive Tray Latch Replacement

This guide will instruct you on how to replace the disk drive tray latch on the Dell Vostro 3550.

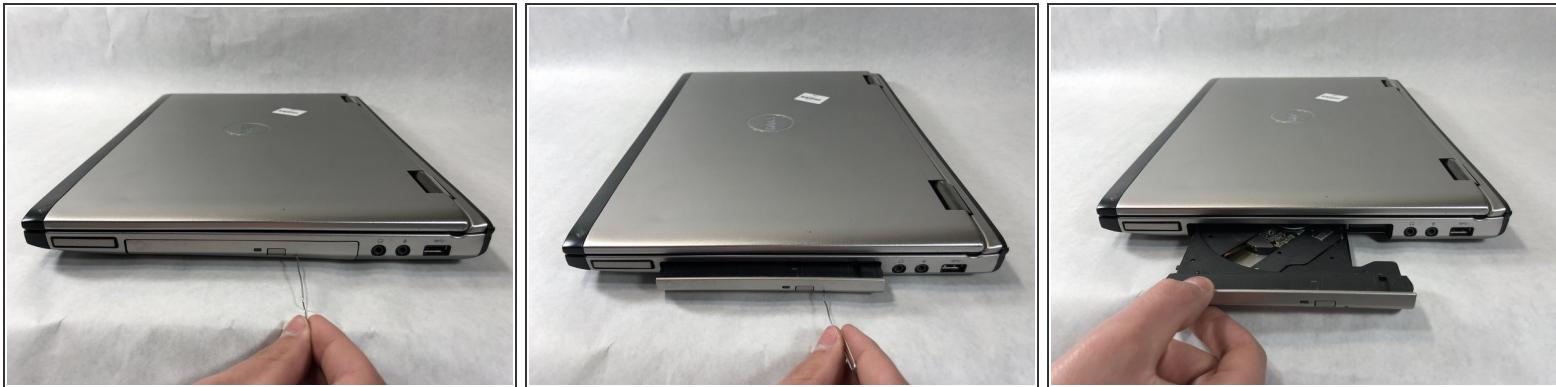
Step 1 — Disk Drive Tray Latch Mechanism

- Push a paperclip that is bent straight into the small pin hole on the right of the release button.
- When 3/4" of the paperclip is inserted the tray will pop open.
- Pull the disk tray out as far as it will extend.

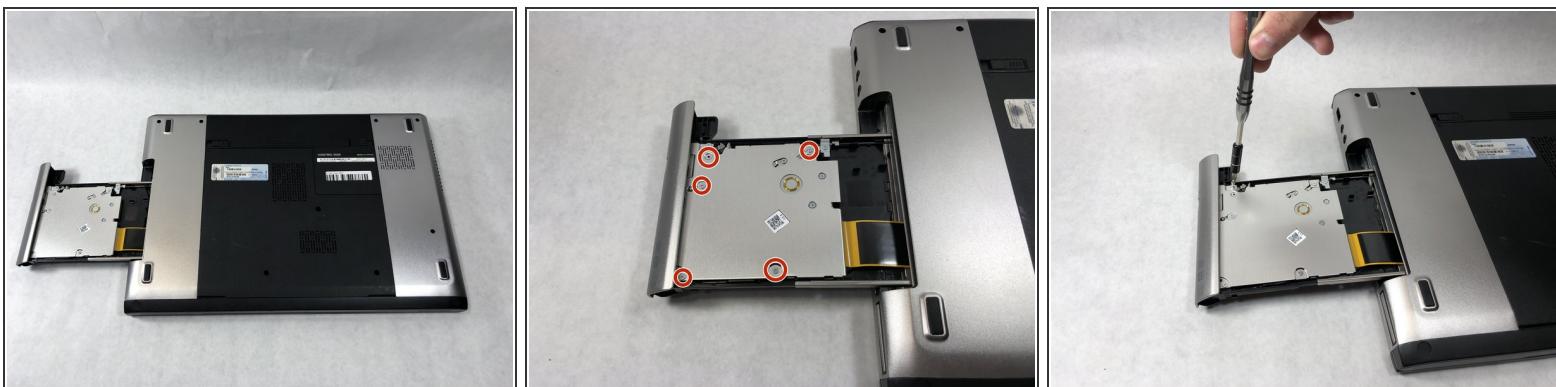
Step 2

- Flip the laptop over and position it so the disk drive is in front of you.
- Remove the five 5mm Phillips #0 screws fastening the top plate to the disk tray.

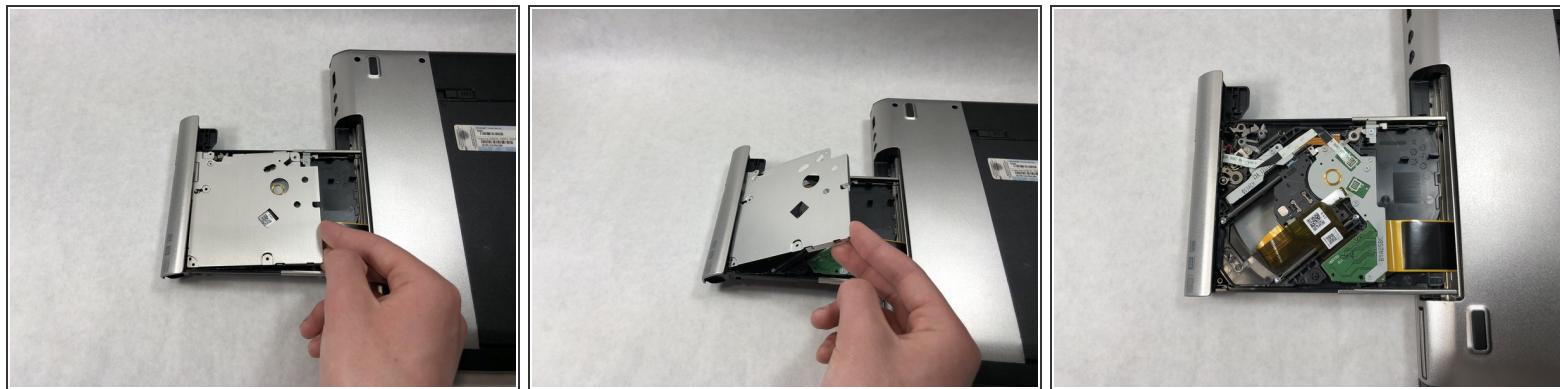
Step 3

- Remove the top plate of the disk tray and place it off to the side.

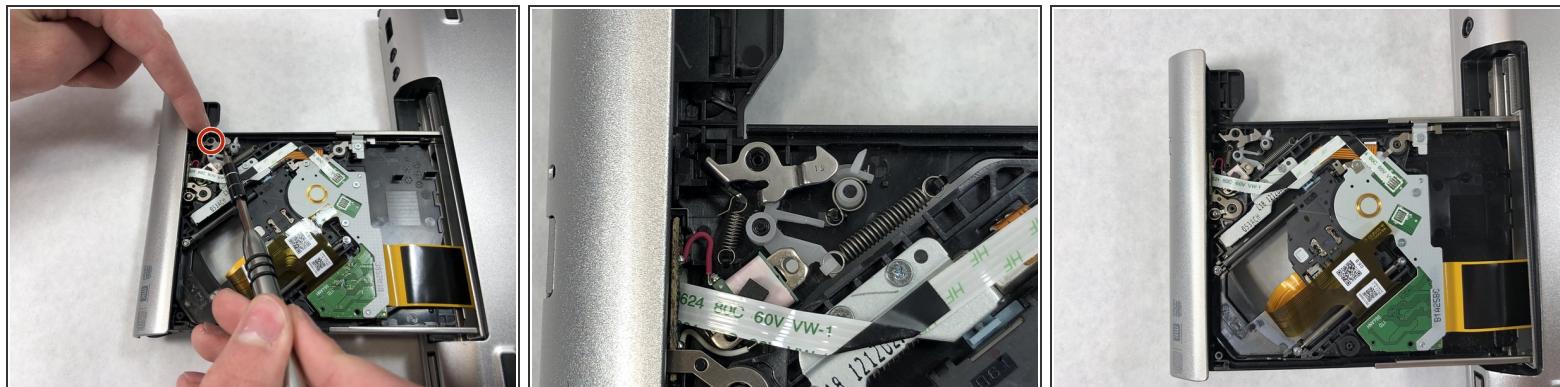
Step 4

- Remove the single 5mm Phillips #0 screw securing the latch mechanism to the disk drive.
- Pull the damaged latch away from the disk drive and replace with the new latch.

To reassemble your device, follow these instructions in reverse order.
