EBK340 Powerhead Replacement

This will guide will replace a worn neck joint, which can cause failure to latch closed for carrying.

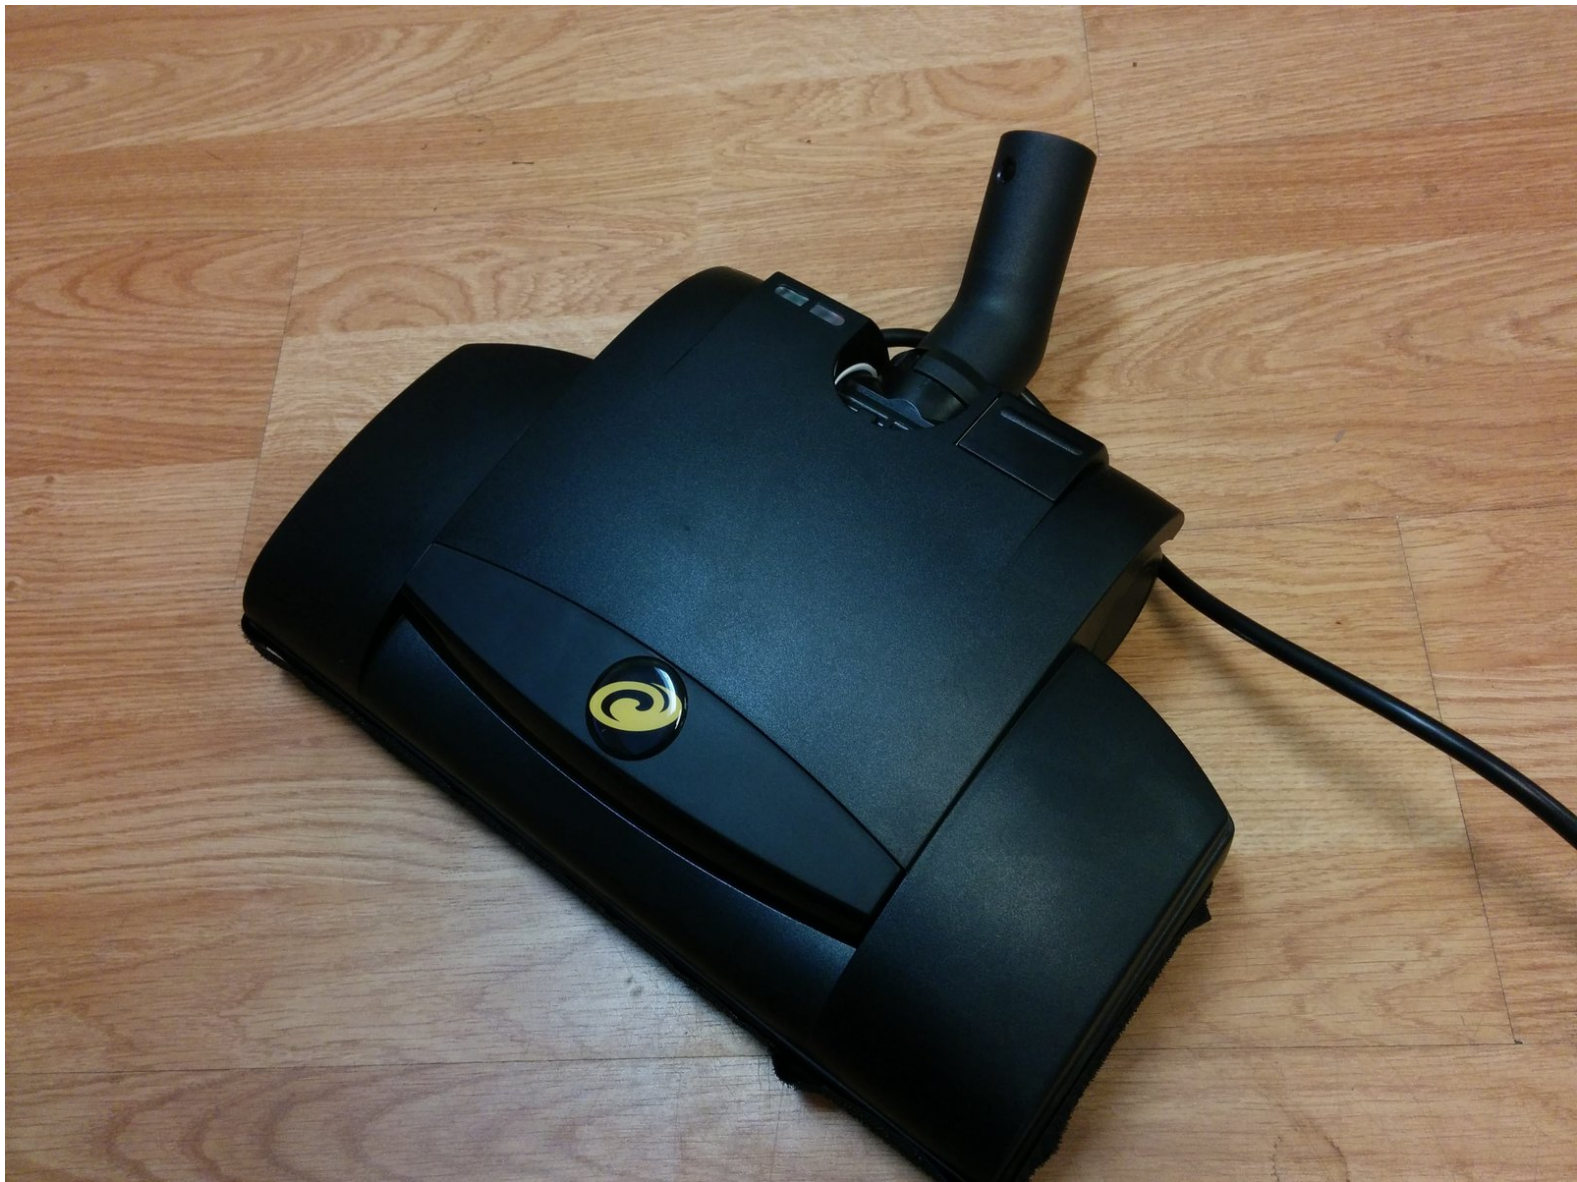
It is very annoying to carry around the powerhead when it does not click together. Usually this results from wear on the plastic neck joint, which can be replaced.

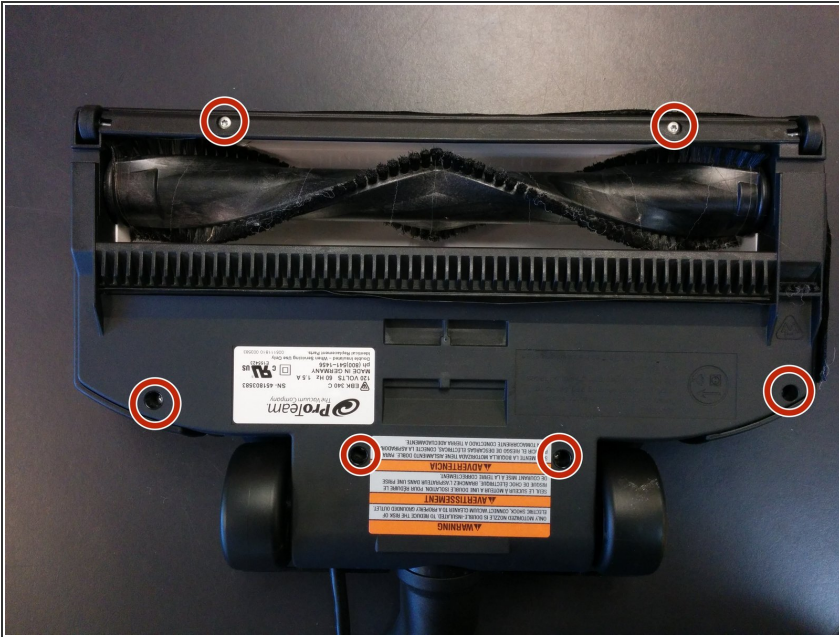
Step 1 — Remove Outer Cover

- Position the device so brushes are upwards and visible
- Unscrew the 6 outer screws. 2 on the edge of the brush crevice, and 4 nearer to the wheels.
- Turn over the device.
- Pull the cover off gently.
