EliteBook x360 1030 G3 Repairability Assessment

Repairability Assessment for the EliteBook x360 1030 G3.

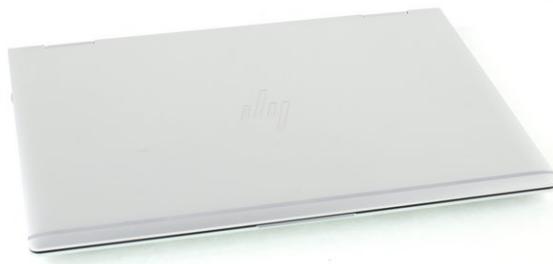
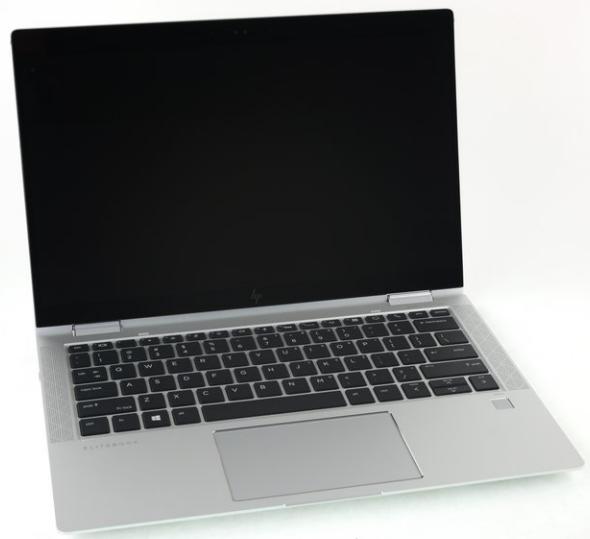
Step 1 — EliteBook x360 1030 G3 Repairability Assessment

- Exterior reference photos.
- The laptop isn't ingress-proofed, so many gaps in the keyboard and lower case, including ports, vents, speaker grilles etc. may allow water damage or particle buildup.

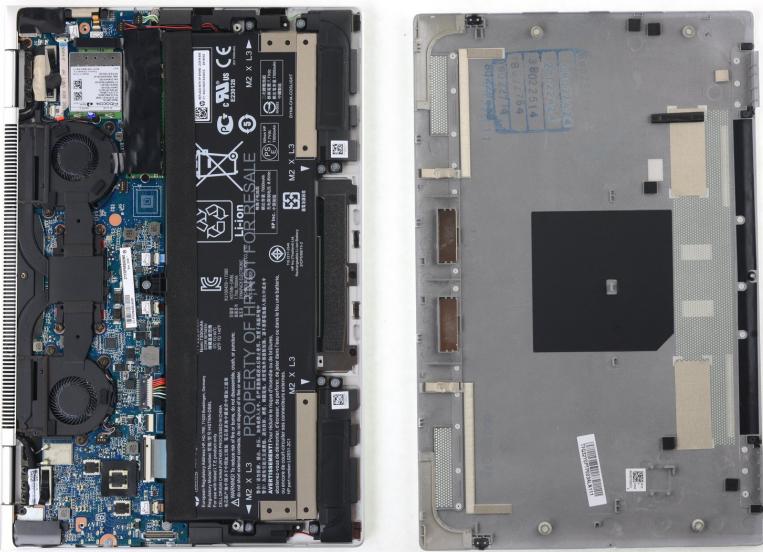
Step 2

- The lower case is secured by a few Torx screws, most of which are removable.
- The upper Torx screw is captive, as long as you don't unscrew it too far.
- The case can then easily be pried off the laptop.
- The case contains no major components, making for easy replacement, and the laptop itself has a flat construction that allows access to most components at this stage.

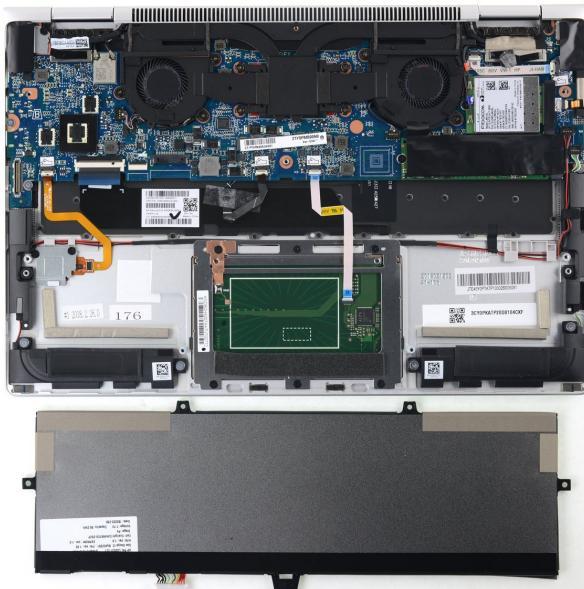
Step 3

- The battery is immediately accessible and can be removed after a couple standard screws. No adhesive holds it down.
- A laptop battery is consumable—even if it's kept in mint condition, the battery will wear down and need replacing. An easily accessible battery is very important for the life of the device, as well as its end-of-life recycling.

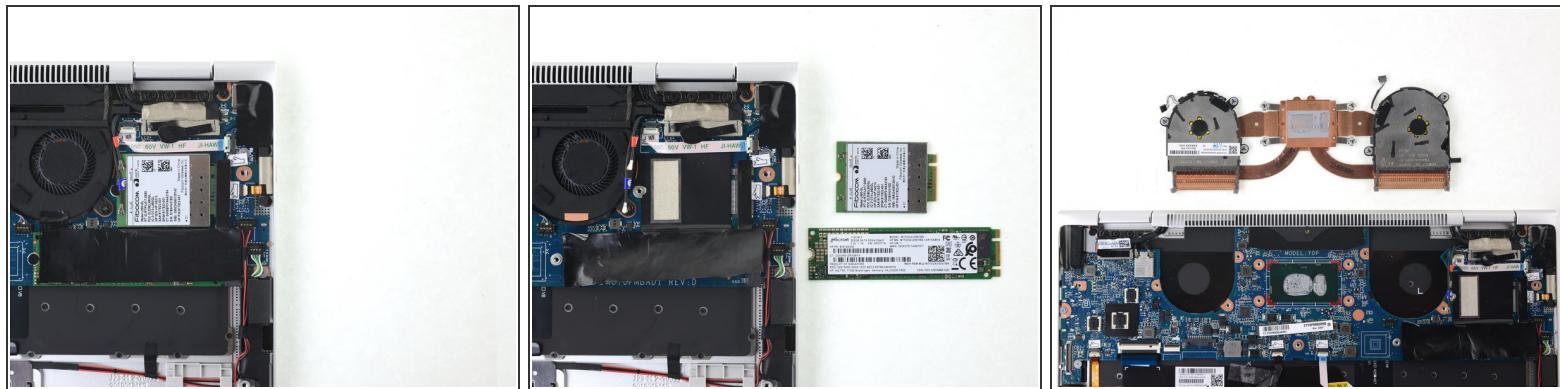
Step 4

- The antenna interconnect cables are nicely labeled for easy wireless card replacement.
- The SSD however is covered in some kind of shielding tape that needs to be peeled off of the fan, the SSD itself, and folded back over the wireless card slot and speaker wires before you can get the stick out.
- The heatsink is also immediately accessible. Its screws are captive making for easier reassembly, but the unit is a large assembly.
- The heat management system includes heat pipes, thermal paste area, and two fans. Replacing a loud or broken fan will require replacing the whole unit.

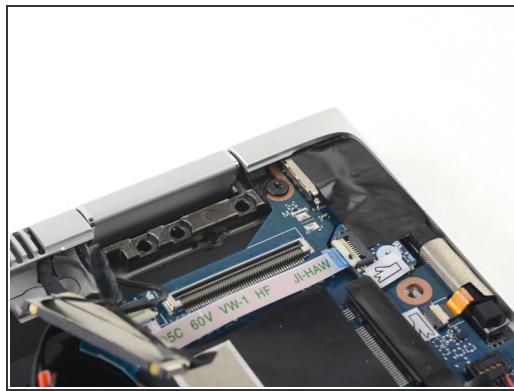
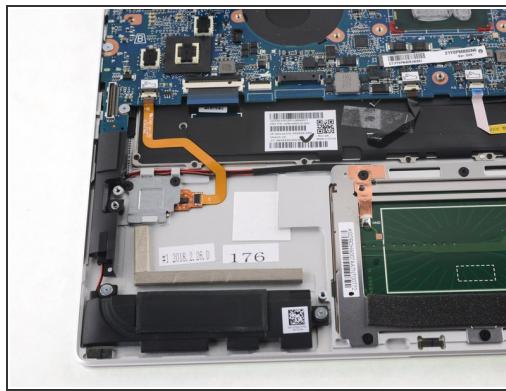
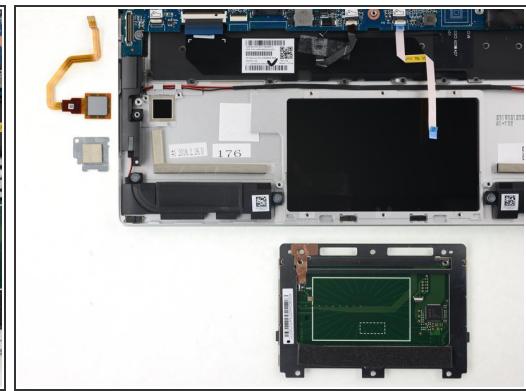
Step 5

- In attempting to remove the display, we removed the display cables (with pull tabs that didn't work very well) and the antenna interconnect cables (covered with an adhered plastic plate complicating repair).
- The display assembly looks removable, but the final screw in the hinge is trapped under the motherboard.
- While a laptop is less likely to need a screen replacement compared to smaller mobile devices, it's still an important part to access. This layering makes screen replacement unnecessarily tough.
- The speakers look removable but their wires are trapped under the trackpad for no discernible reason.
- Removable after the battery: the trackpad assembly and fingerprint reader, after its bracket is removed.

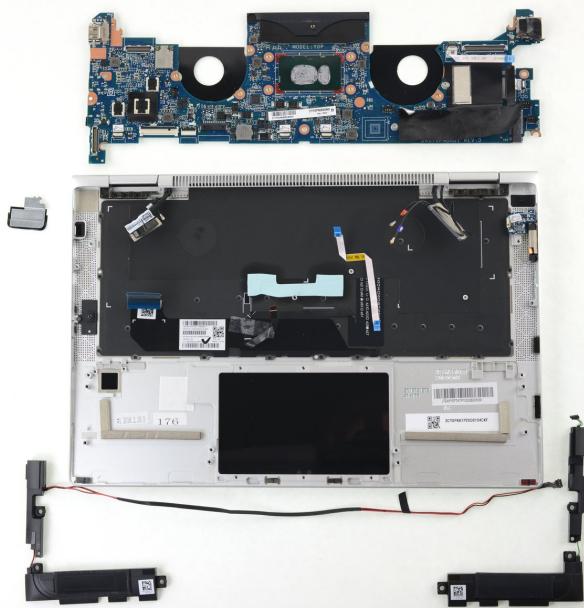
Step 6

- The speakers are finally accessible. The wires seem unnecessarily routed and are taped in several places, but at least they're modular.
- The motherboard is removable after the heat sink assembly and a small bracket are removed, and after some cables (mostly labeled) connectors are disconnected.
- The motherboard contains the CPU, memory, volume buttons, and ports. High-wear components like ports and buttons make for very expensive replacement when they're soldered to the motherboard.

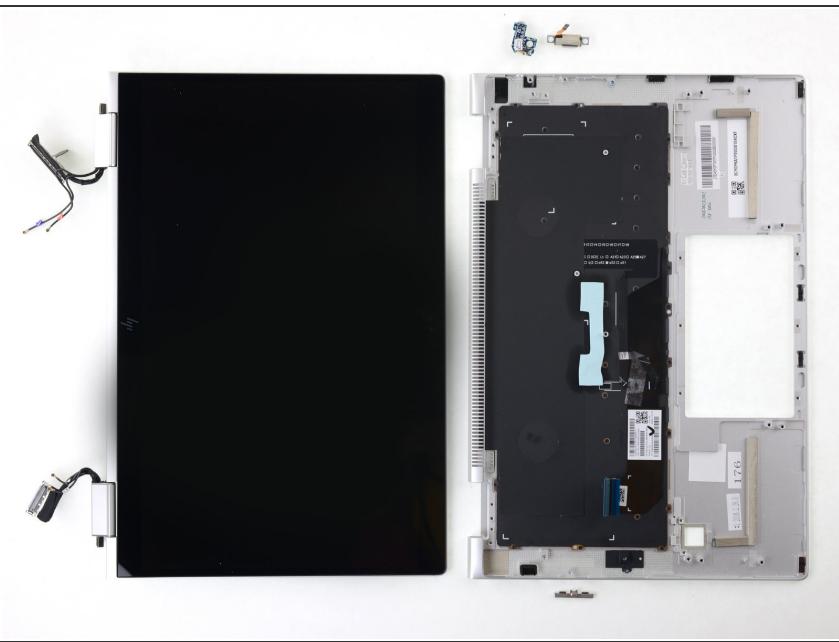
Step 7

- The display assembly is finally removable. While not all components will need to be stripped out as shown, the device layering could be altered to improve serviceability of high wear components such as the hinges.
- The display can actually be pried out without removing the assembly from the laptop, however access to prying areas is more limited when it's attached.
- The final components in the rear case can be removed without display removal, including the power button, volume rocker cover, and headphone jack.

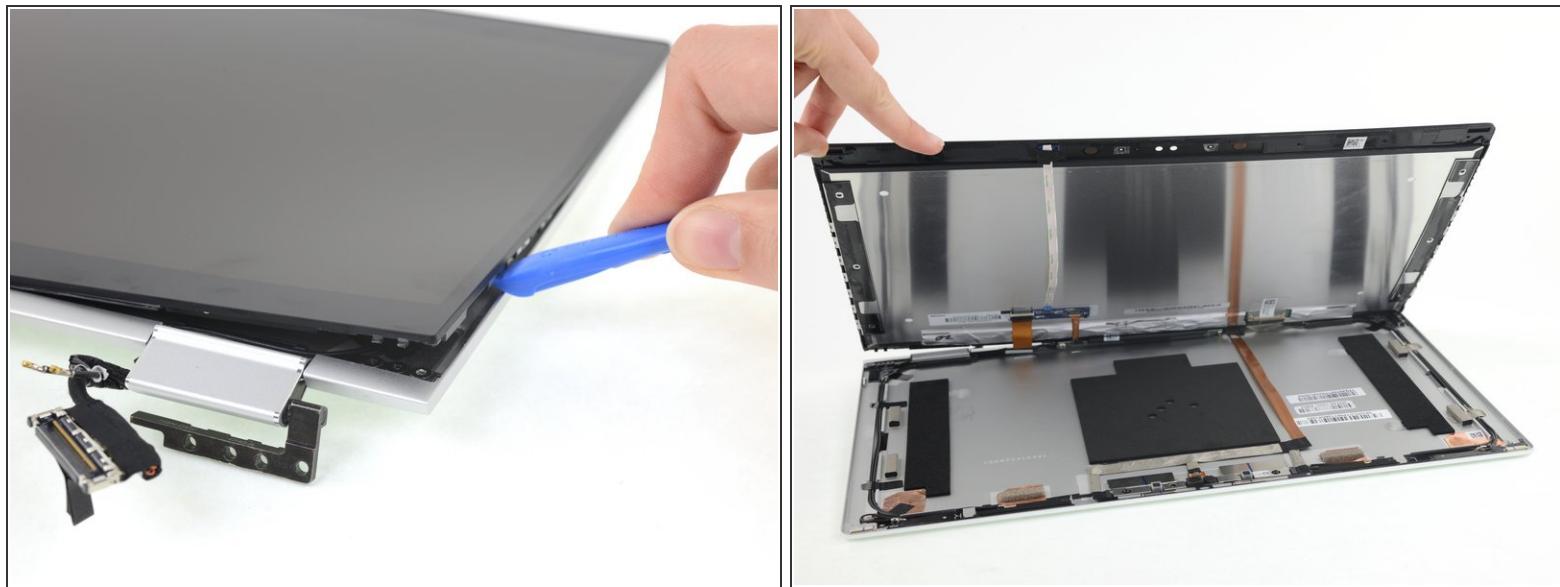
Step 8

- The display assembly can be pried out of the rear case with some difficulty. There are lots of small fragile clips and stubborn adhesive around the edges.
- It's quite difficult to reach all the way under the display, so you risk separating the various frames from the screen.
- The initial point of entry seems to be the hinges at the bottom, but the outside edges and top must be freed before the lower central portion, which isn't immediately evident.
- After cutting through all the adhesive and nearly bending the sensor assembly board in half, the display can be lifted up, but not removed.
- The thin sensor board is adhered to the display and to the rear case, so display removal pulls it between the two. On the other hand, slicing that adhesive runs the chance of damaging the cameras.

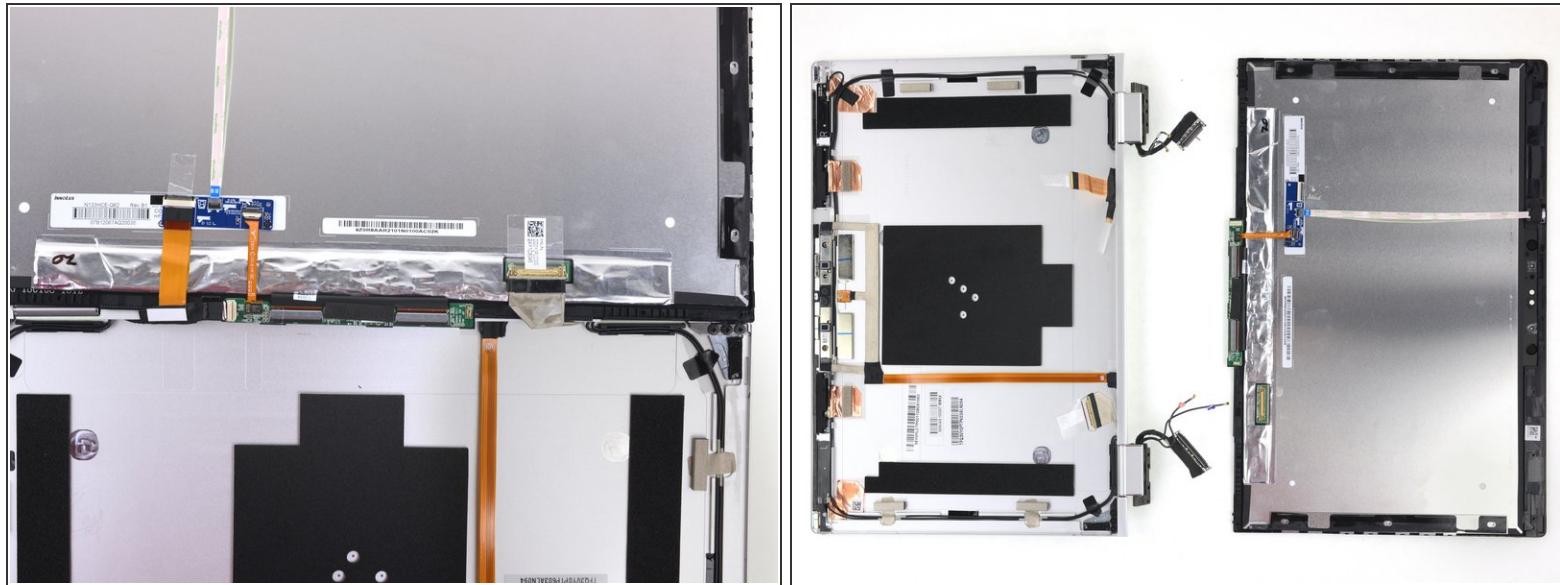
Step 9

- The display is attached to its case with several small cables that are easy to disconnect—but they're also taped down with obnoxious sticky tape.
- The display is finally freed. Both the display and the rear case have several extra components mounted on them.

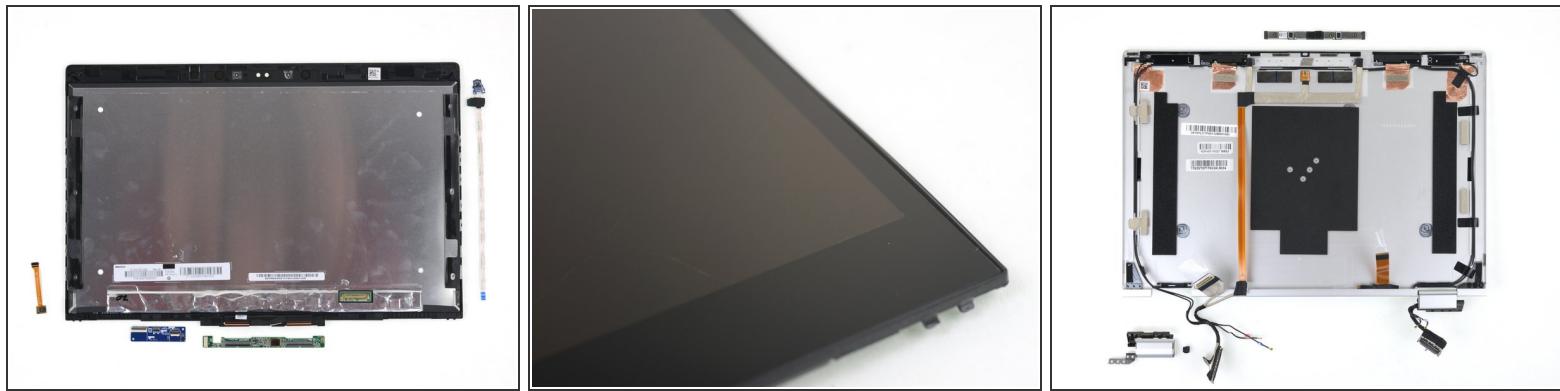
Step 10

- The display carries a status LED, some interconnect boards and chips that are fairly easily pried off of their adhesive.
- The screen itself appears to be a single fused unit, so glass and display will need replacing together, making for a more expensive part.
- You will also have to be extra careful not to separate the layers when trying to access any of the components in the display assembly. Pictured is a cracked display, and damage from separating the layers.
- The components on the rear case include: upper sensor board (on a very fragile board), several antennas secured by a lot of tape (copper and otherwise), and hinges (with rubber plugs to hold cables).
- Ideally the antennas won't fail, but their cables run through the hinges, which means some stress over time. The copper tape will complicate replacement.

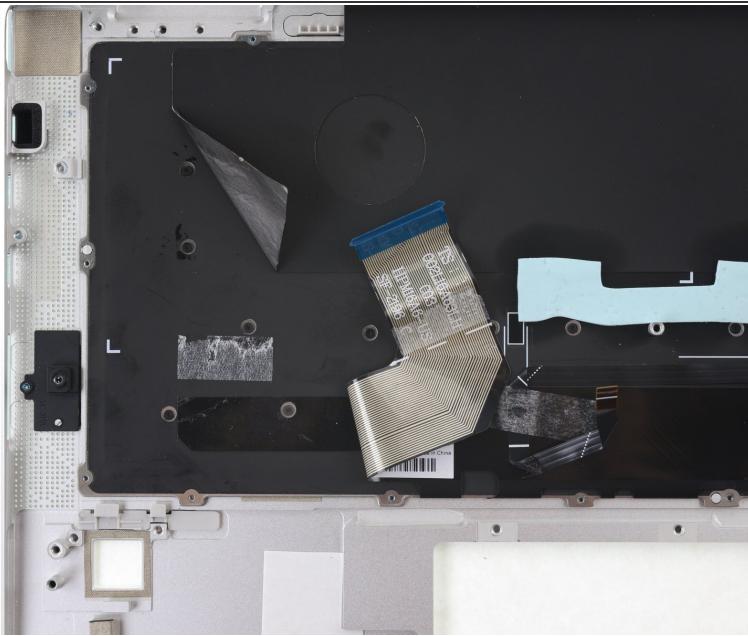
Step 11

- While the keyboard is probably technically removable, it has far too many screws hiding under several layers of adhesive, so we deem this a single assembly. A component this complex will cost more, either in time or money.

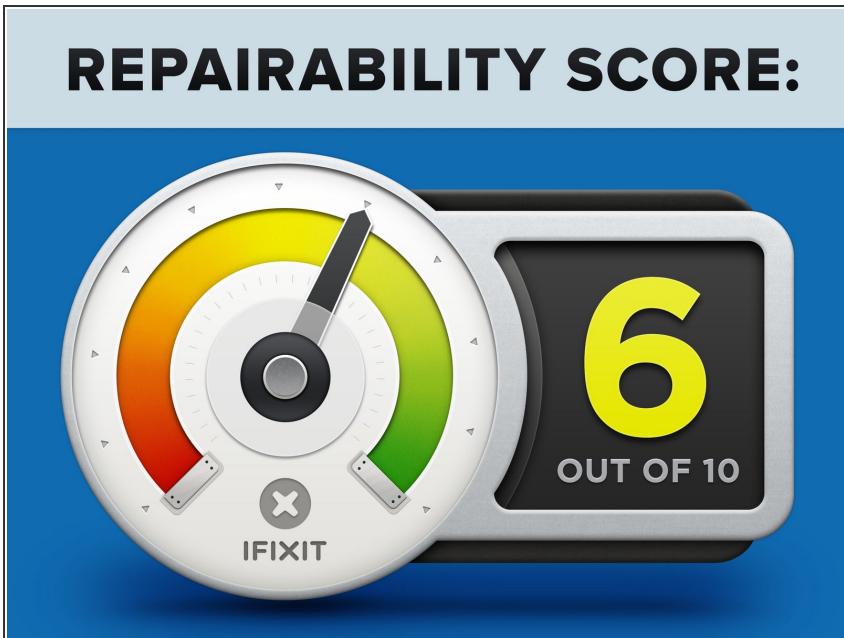
Step 13 — Final Thoughts

- The HP EliteBook x360 1030 earns a **6 out of 10** on our repairability scale (10 is the easiest to repair):
 - SSD, wireless card, and battery are easily accessible and removable.
 - Manufacturer provides free user-accessible repair documentation.
 - All screws are standard Phillips and Torx, but some are so securely glued, and made of such soft metal that stripping them is hard to avoid.
 - Overall mostly modular, but the keyboard, heatsink, display, and motherboard are all large assemblies, which will make repairs more expensive.
 - The device relies heavily on tapes, adhesives and fragile clips to secure components, complicating repairs.
 - The processor and RAM are soldered to the motherboard, eliminating the opportunity for upgrade.
