Fasteners for repairing a chest freezer lid

Some chest freezer lids can form condensation that causes issues, and use odd one-time-use fasteners. This document gives a part number for the hard-to-find replacement fasteners.

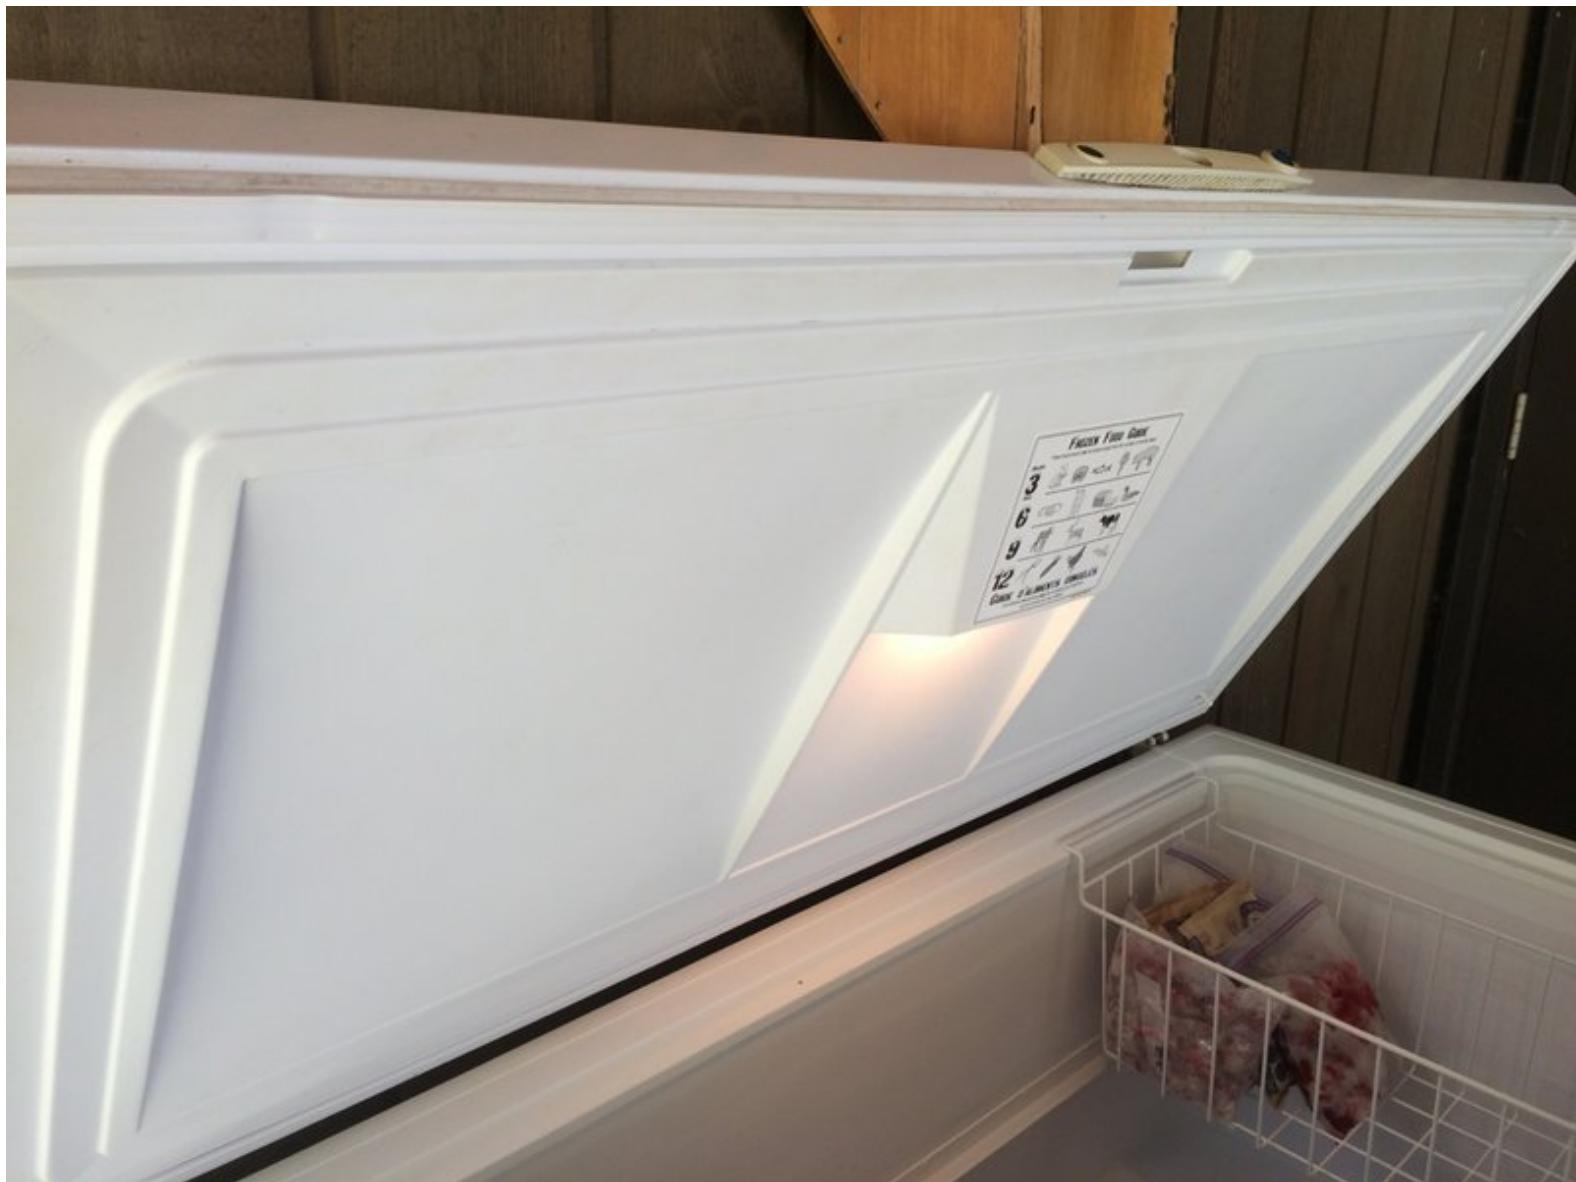
Our chest freezer is located outside and forms condensation inside the lid which freezes. The lid contains wiring for lights and switches and the ice surrounding the wiring harnesses causes trickle-currents which trips GFI breakers.

To repair it requires removing the inside plastic panel from the lid and thawing and removing the soaked fiberglass insulation batting (which just acts as a sponge for condensation).

The plastic panel is held on by push-in retainers which are destroyed by their removal. It is hard to find replacement retainers. AuVeCo makes a wide range of auto retainers and I think I've found the most suitable: AuVeCo #19149 which you can order from Fastenal with their SKU 11120582.

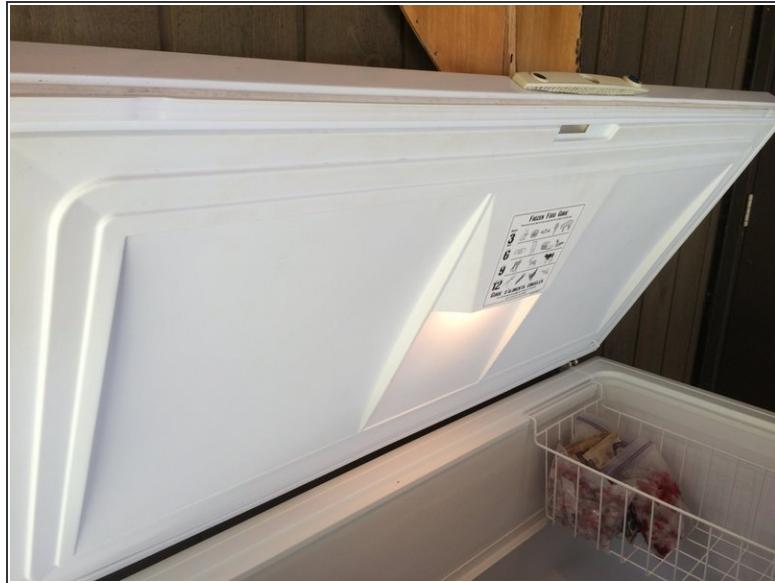
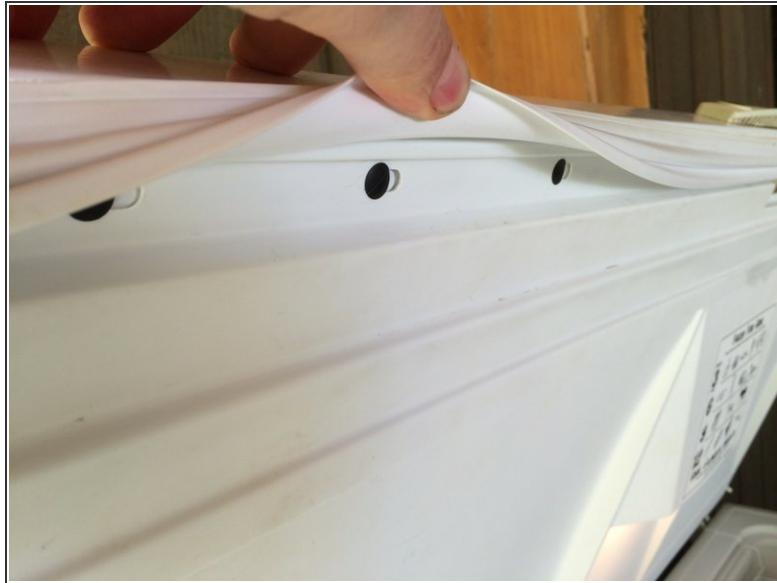
Step 1 — The lid

- The lid is a steel frame around a solid foam panel. The inside of the lid is a thin plastic molded cover held on with plastic push-in retainers (under the gasket). The plastic cover is too thin to be able to use metal screws as a replacement.

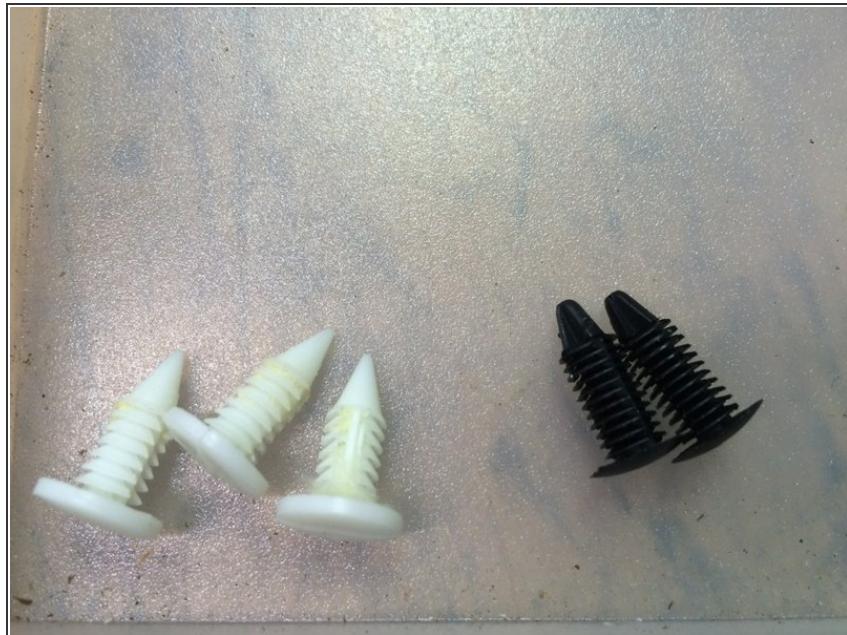
Step 2 — The retainers

- The original retainers (white) and the replacements I found (black). The replacements are AuVeCo #19149: 3/8" head, 7/32" stem width, 5/8" length. Fastenal carries them with SKU 11120582 for a box of 50 (I needed 42).
