# Fitbit Surge Touchscreen Sensor Replacement

This guide provides instructions on how to replace the touchscreen sensor in the Fitbit Surge.

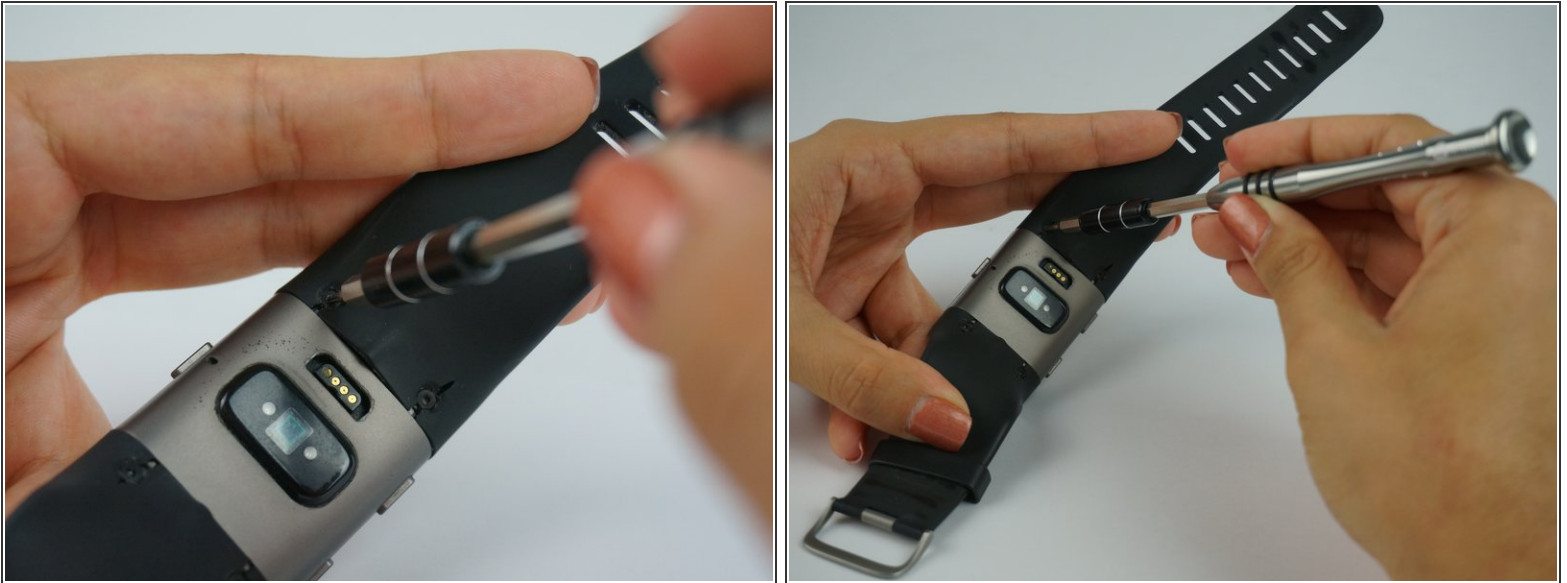
## Step 1 — Touchscreen Sensor

- Unscrew all four black 3 mm screws on the underside of the watch using a T5 screwdriver.

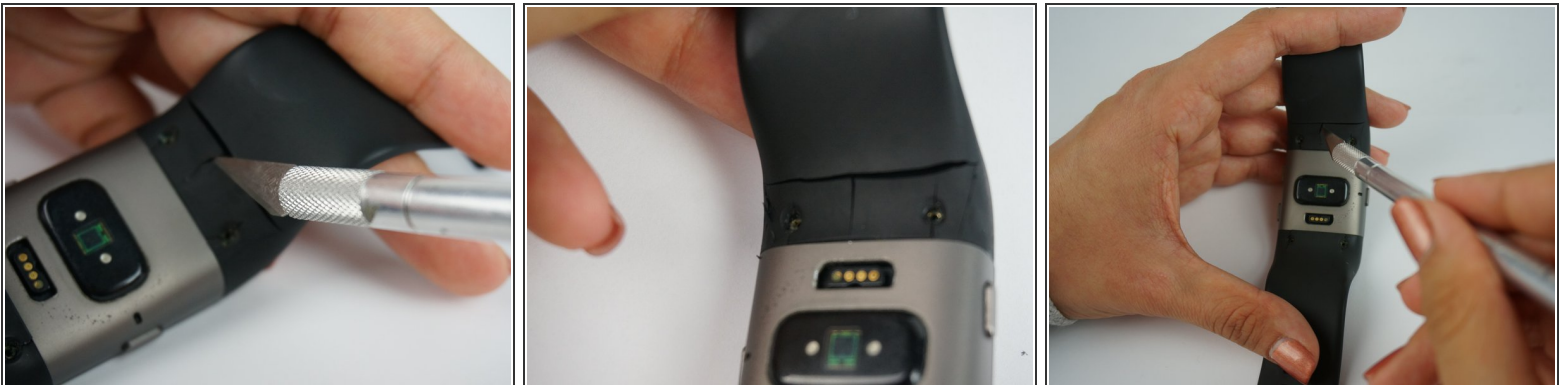
## Step 2

- Use an X-Acto knife to cut the band above, on either side, and in between the 2 screws.
- **Note:** Part of the band is hard plastic.
- **Caution:** Once the band is cut it cannot be reattached.

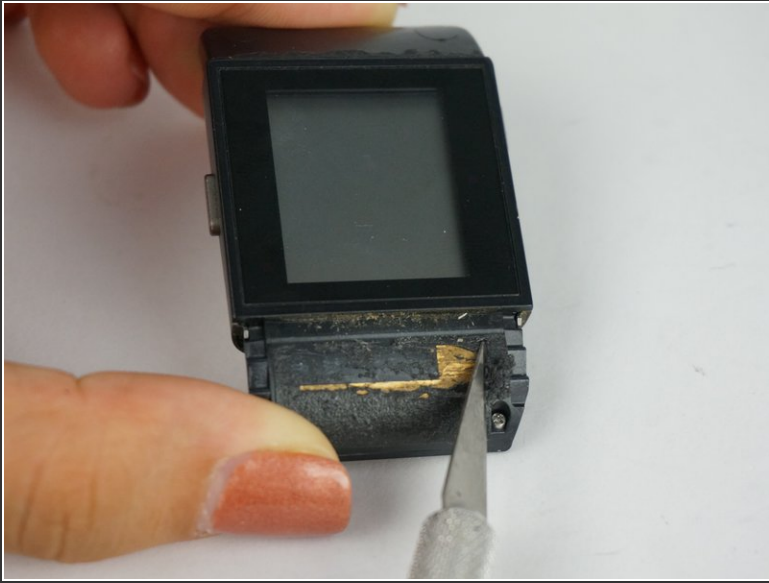
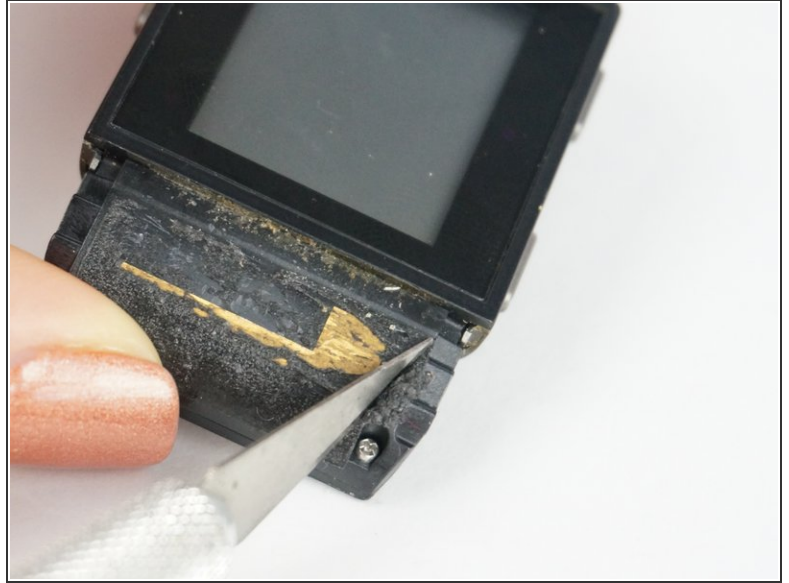
### Step 3

- Scrape away the glue beneath the hard shell portion of the band to reveal the GPS.

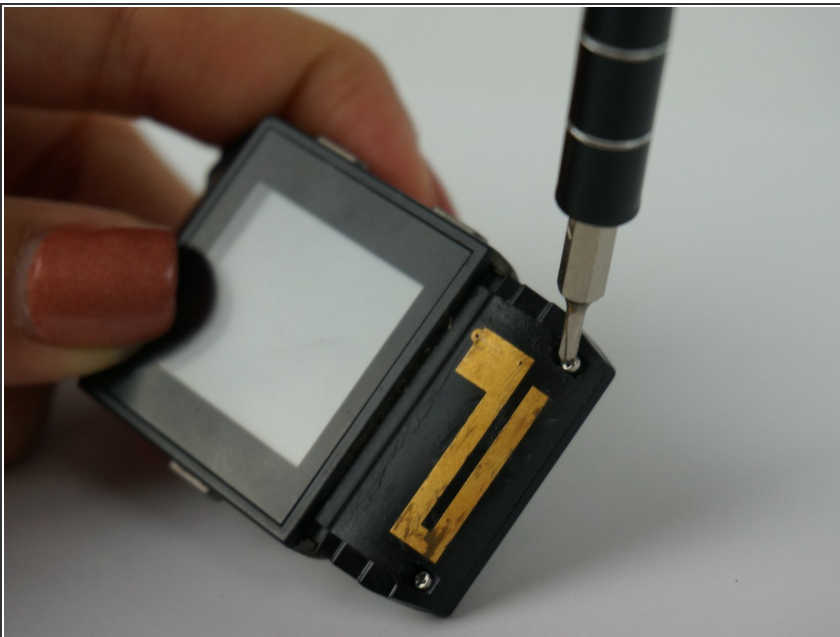
### Step 4

- Use a PH000 screw head to undo the newly revealed silver 4 mm Phillips screws that were hidden beneath the glue.

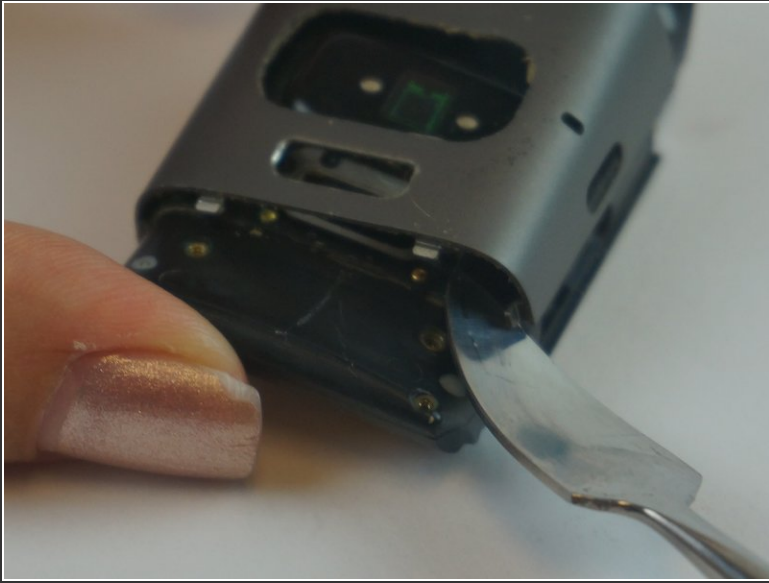
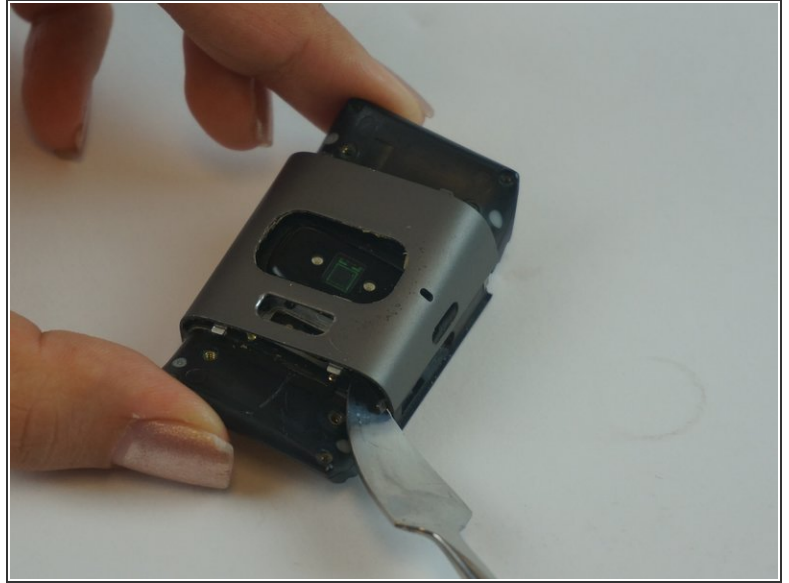
## Step 5

- Using a metal spudger, push down on the plastic gray square clamps on the underside of the device to dislodge the whole silver backing.
- **Note:** the buttons will also come off.

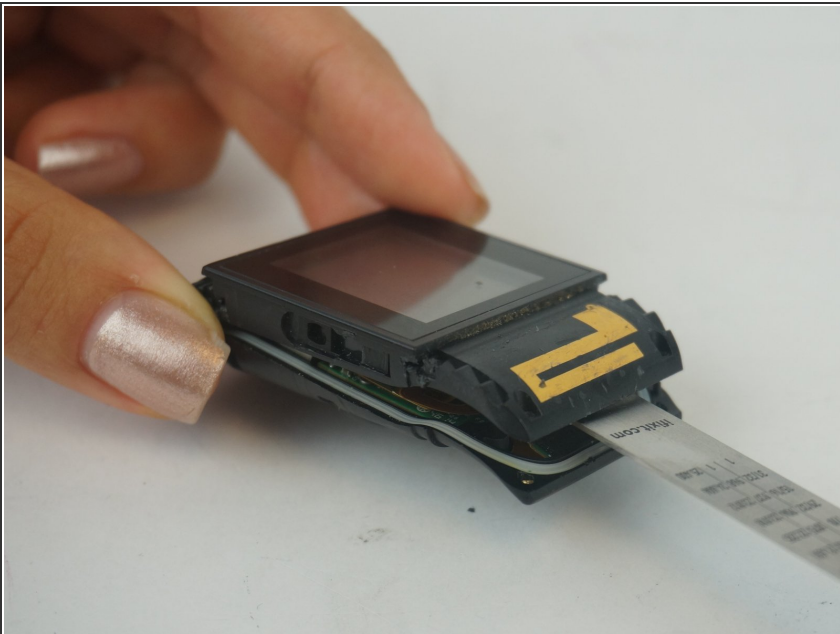
## Step 6

- Use a thin tool to pry the the device apart by lodging it between the clock face and back side of the device.
- **Note:** A spudger may not be thin enough to fit in the seam of the device. We used the 6 inch metal ruler from the Pro Tech Toolkit.

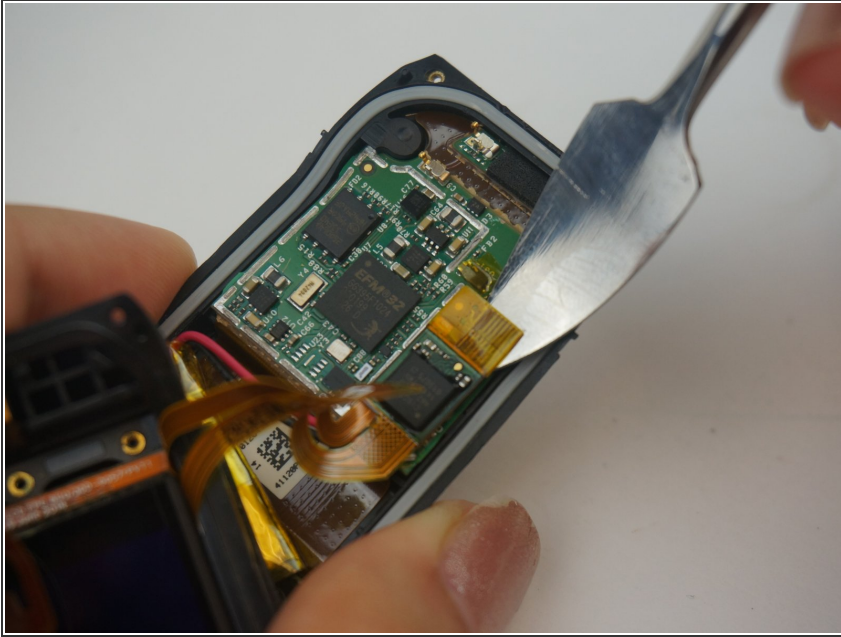
## Step 7

- Remove the touchscreen sensor using a spudger or your fingers.
- **Note:** In this photo we removed the metal cover on the main PCB, but you do not need to remove it for this guide.

To reassemble your device, follow these instructions in reverse order. Keep in mind that the wristband will need to be cut for this repair and it cannot be reattached.
