# Garmin Forerunner 735XT Teardown

Teardown of the glued forerunner series

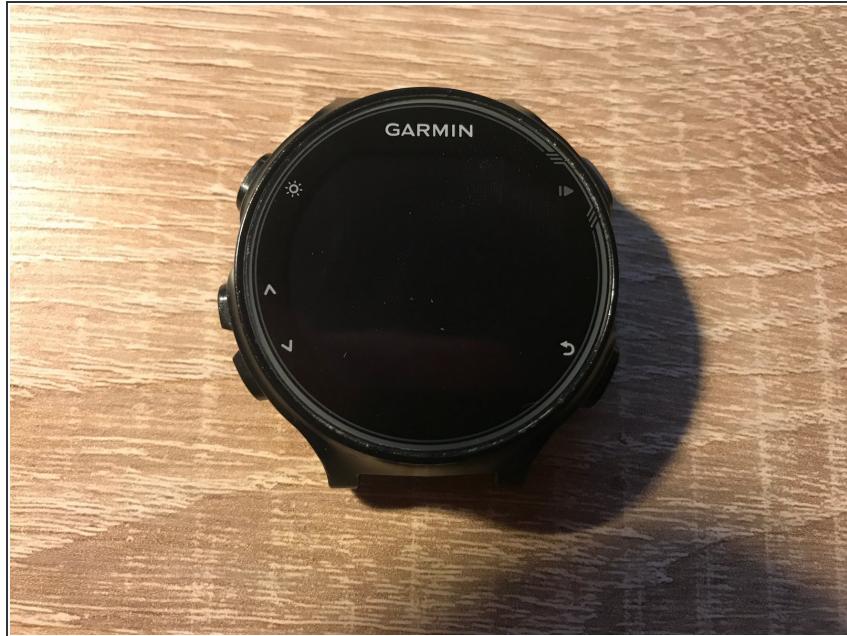
## Step 1 — Garmin Forerunner 735XT Teardown

- The strapless 735xt, the straps are secured by two T6 screws on each side.

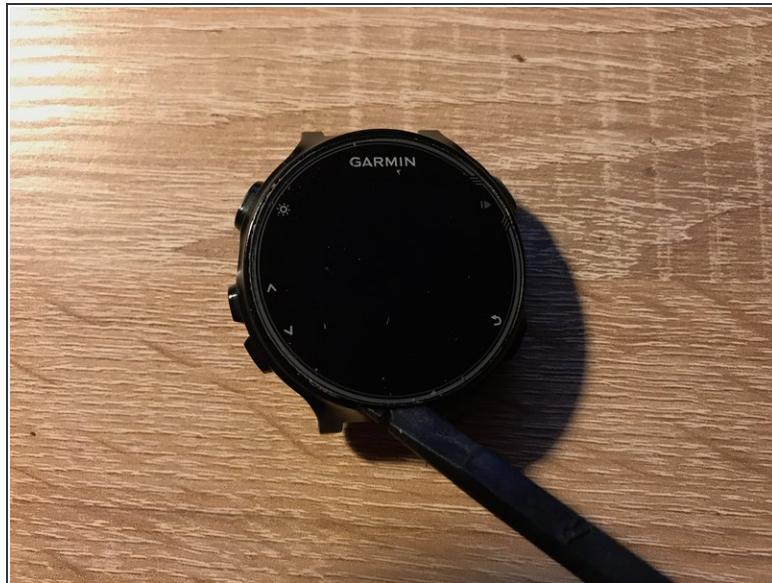
## Step 2 — Prise off the front

- The front is glued
- Use an iFixit Spudger to prise around the glue. It's not necessary to use a heat gun here.

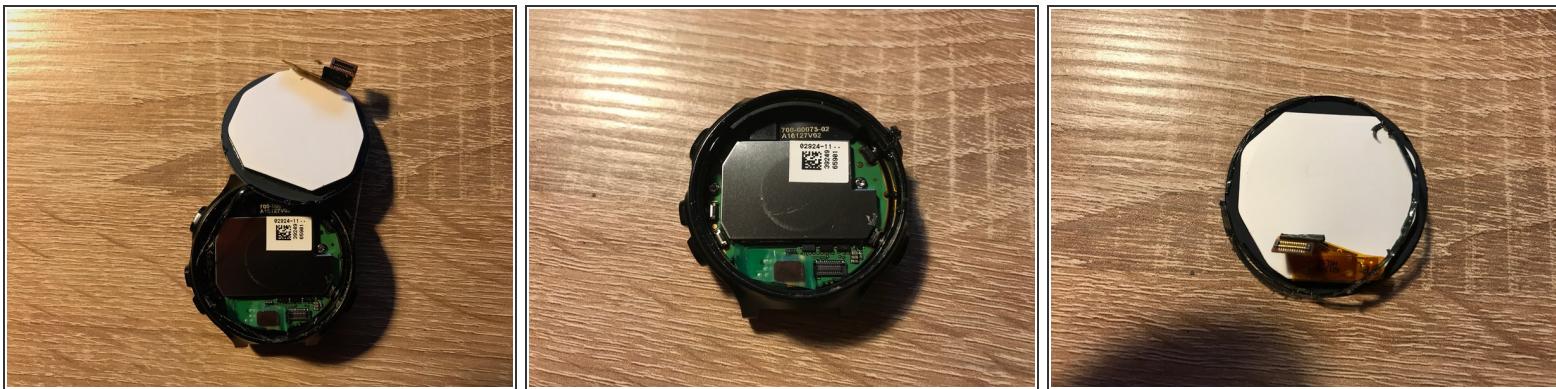
## Step 3 — Carefully remove the screen

- Once the screen moves, carefully remove the ribbon connector and the screen.

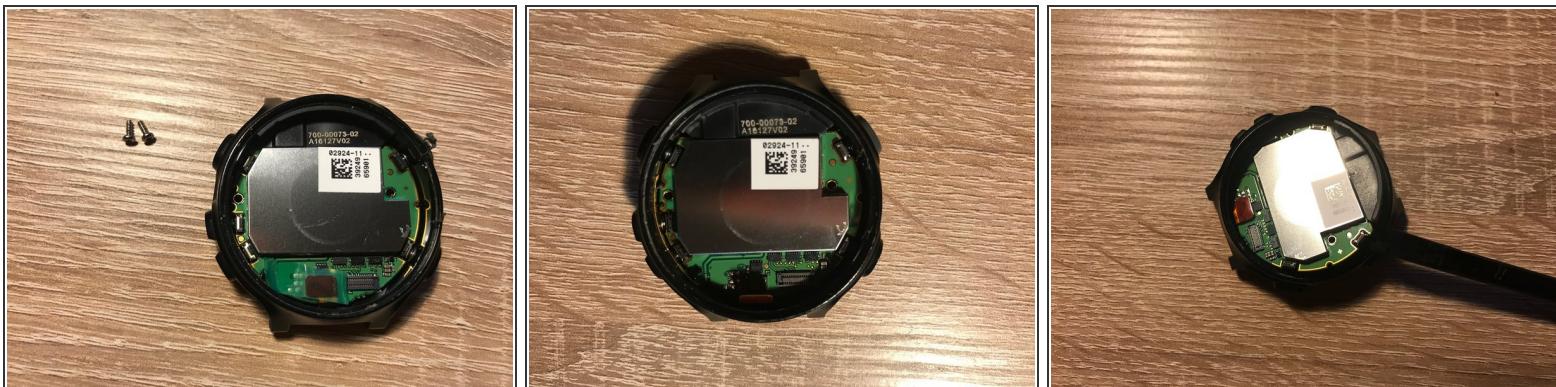
## Step 4 — Remove the main board

- Two T6 screws hold the mainboard to the body.
- The main board will move from where the Spuder is inserted.
- Remove the green protective tape and disconnect the second ribbon cable before proceeding.

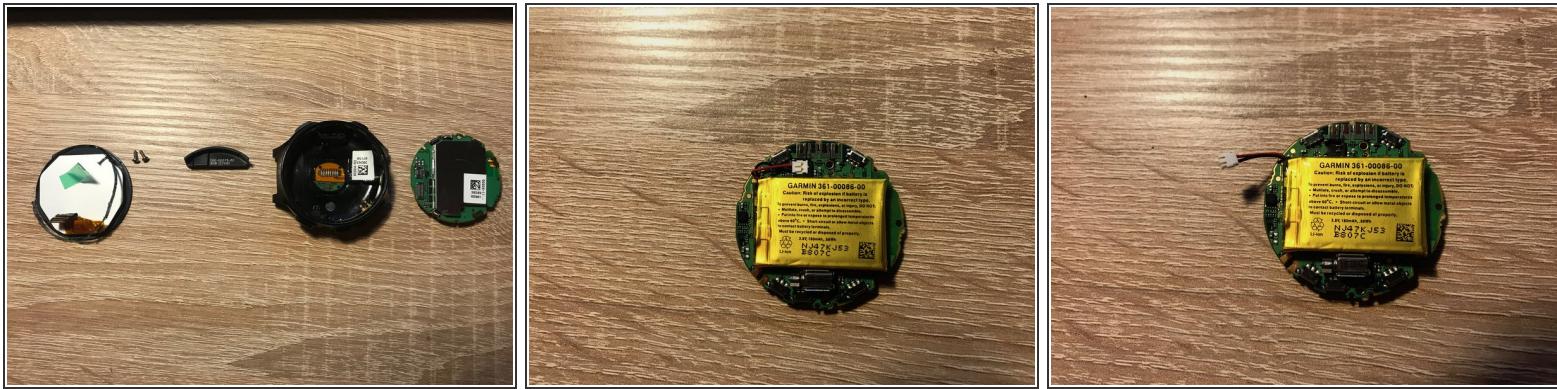
## Step 5 — Disassembled

- The unit will now be disassembled
- Unplug the battery by lifting up the connector from the bottom.
- Further disassembly and analysis to follow...

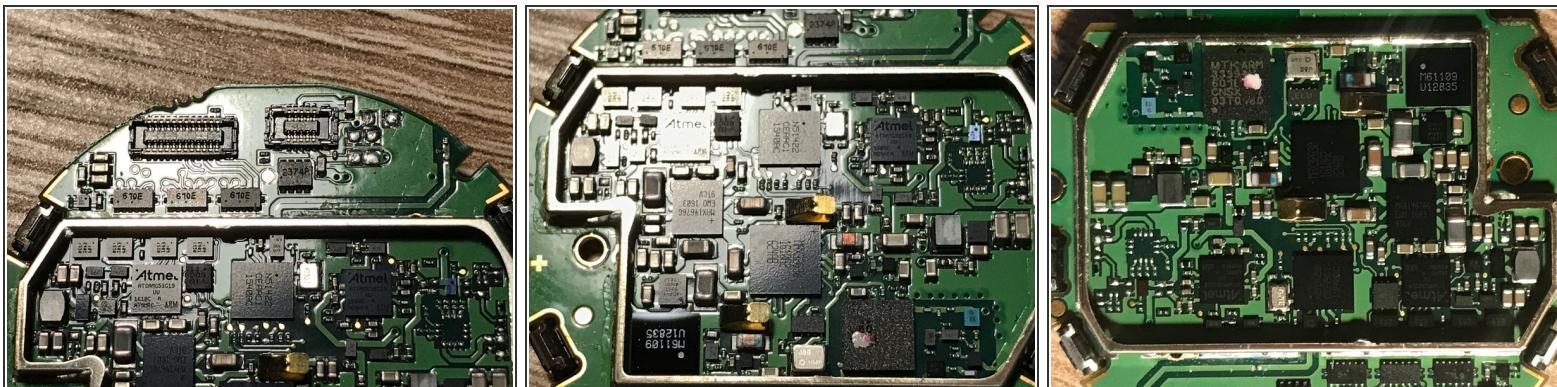
## Step 6 — Closeup

- GNSS receiver looks like MediaTek MT3333 with external amplifier+filter+chip antenna. And ARM7 CPU.
- The watch has at least 3 Cortex-M4 microcontrollers, not counting Ant+ or GNSS chips! Microchip ATSAMG51, ATSAMG53 and MAX32360
- nRF51422 contains ANT+ and Bluetooth LE functionality. And Cortex-M0 CPU to run these.
