INTRODUCTION

In this guide the repairer replaces the microphone by disassembling the device to access the motherboard.

Step 1 — Microphone

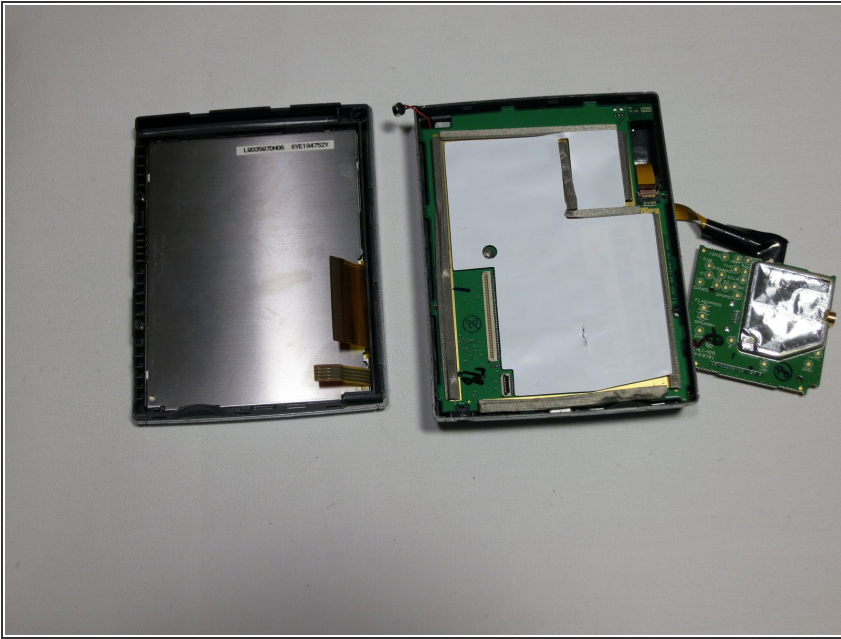
- After following the instructions in the [main dis-assembly guide](#), you should have the screen detached from the motherboard.

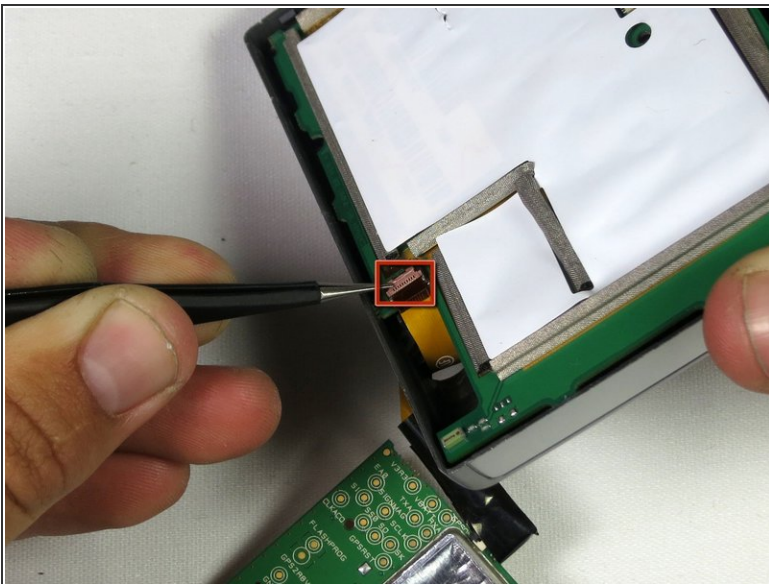
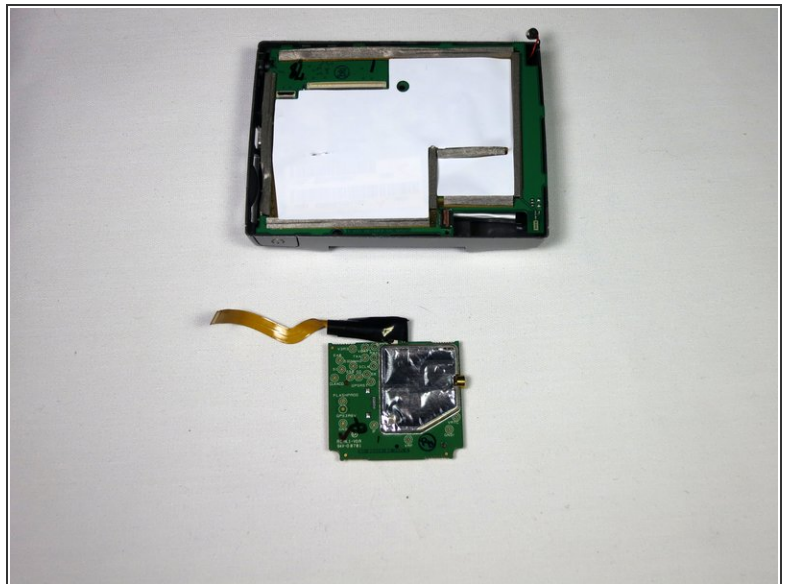
Step 2

- Use the tweezers or the spudger to lift the tan latch off the ribbon cable (ZIF connector) and gently pull out the ZIF connector and cable from underneath the opened latch.

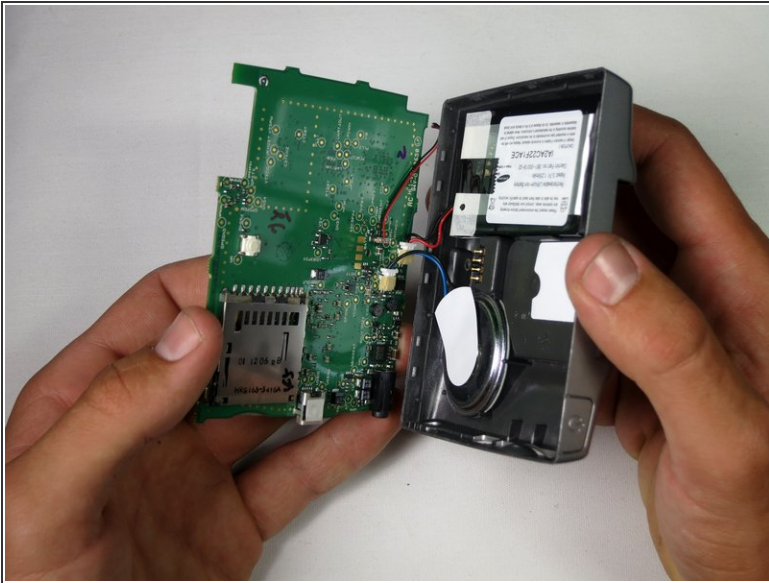
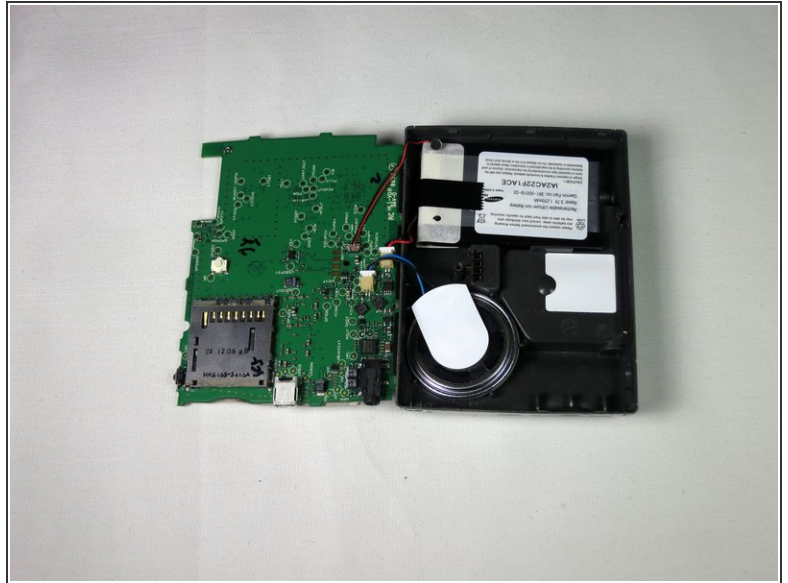
Step 3

- The motherboard will now freely separate from the back casing; lay it flat next to the housing.

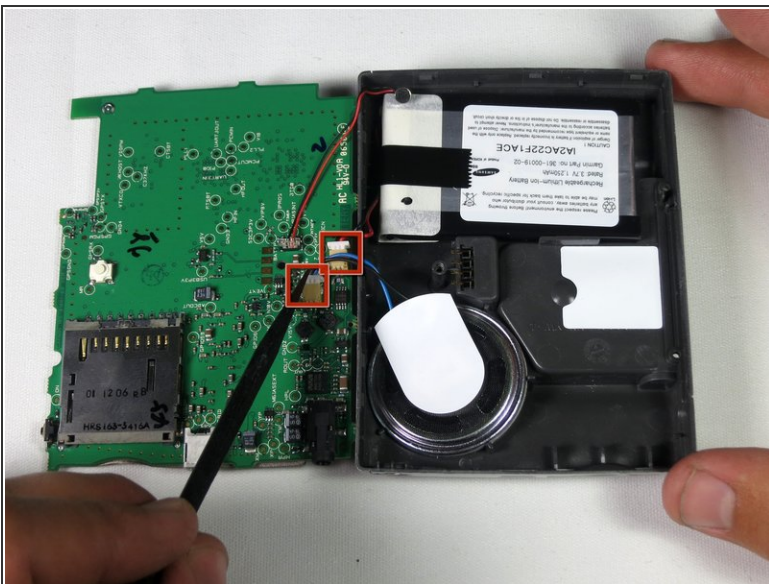
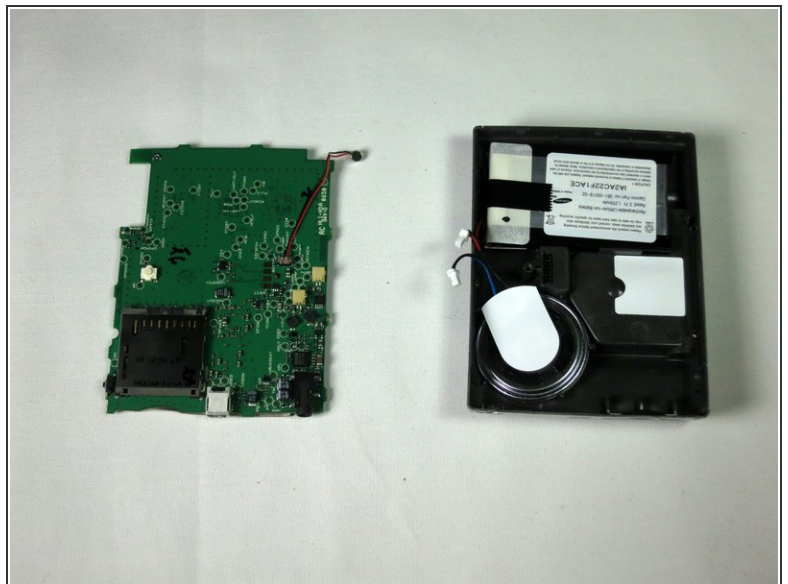
Step 4

- Disconnect the speaker and battery from their terminals on the motherboard. This should disconnect the motherboard completely from the back panel.
- ⓘ This step is optional but is recommended as it will create more room to work.
- ✦ It is recommended that you use tweezers or the spudger for precision.

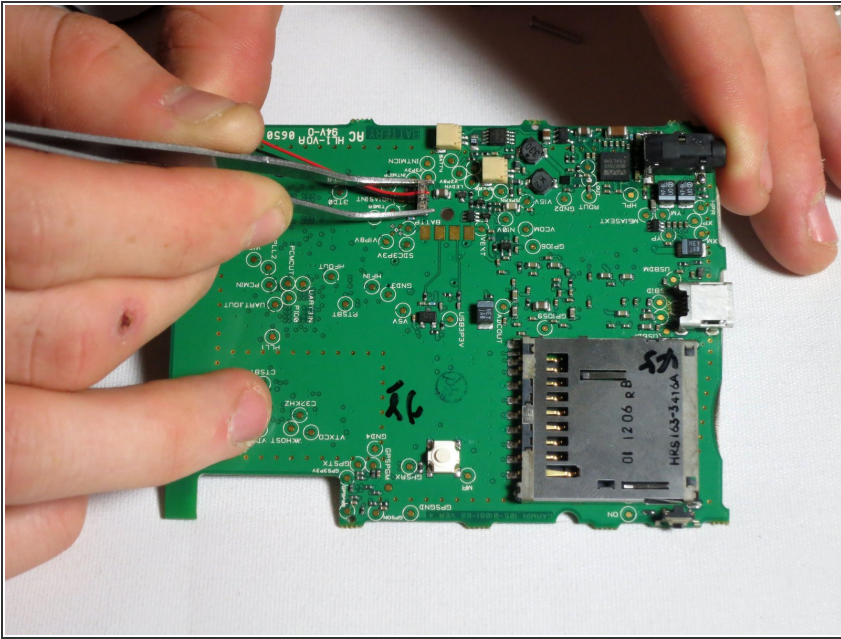
Step 5

- Gently pull out the microphone wire from the terminal. Tweezers are recommended for precision.
