HP Elite x2 1012 G2 Repairability Assessment

Repairability assessment of the HP Elite x2 1012 G2 hybrid tablet, performed on July 26, 2017.

Written By: Evan Noronha

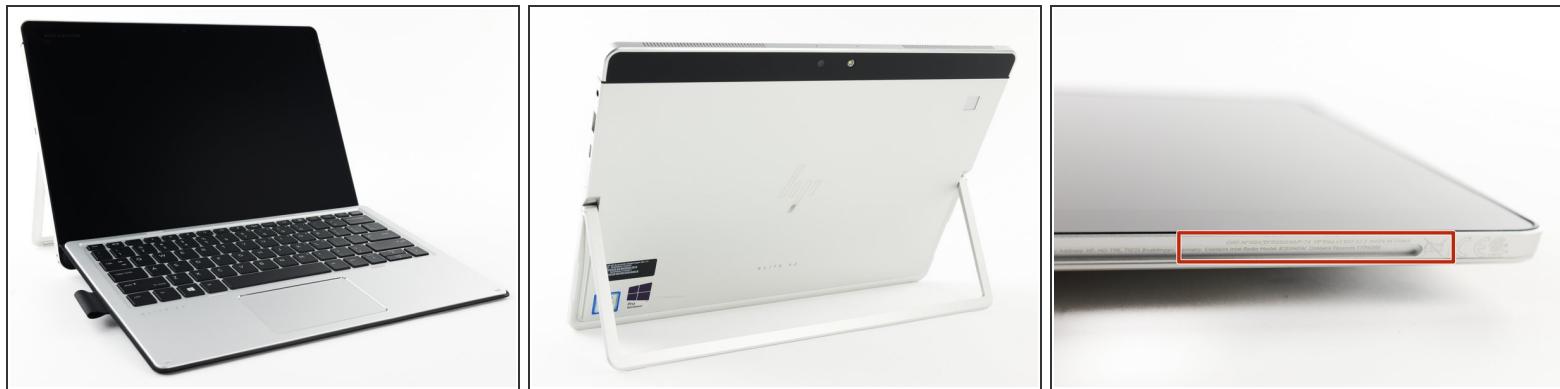
Step 1 — HP Elite x2 1012 G2 Repairability Assessment

- Reference shots with and without the included keyboard.
- Full model number is HP Elite x2 1012 G2 3.

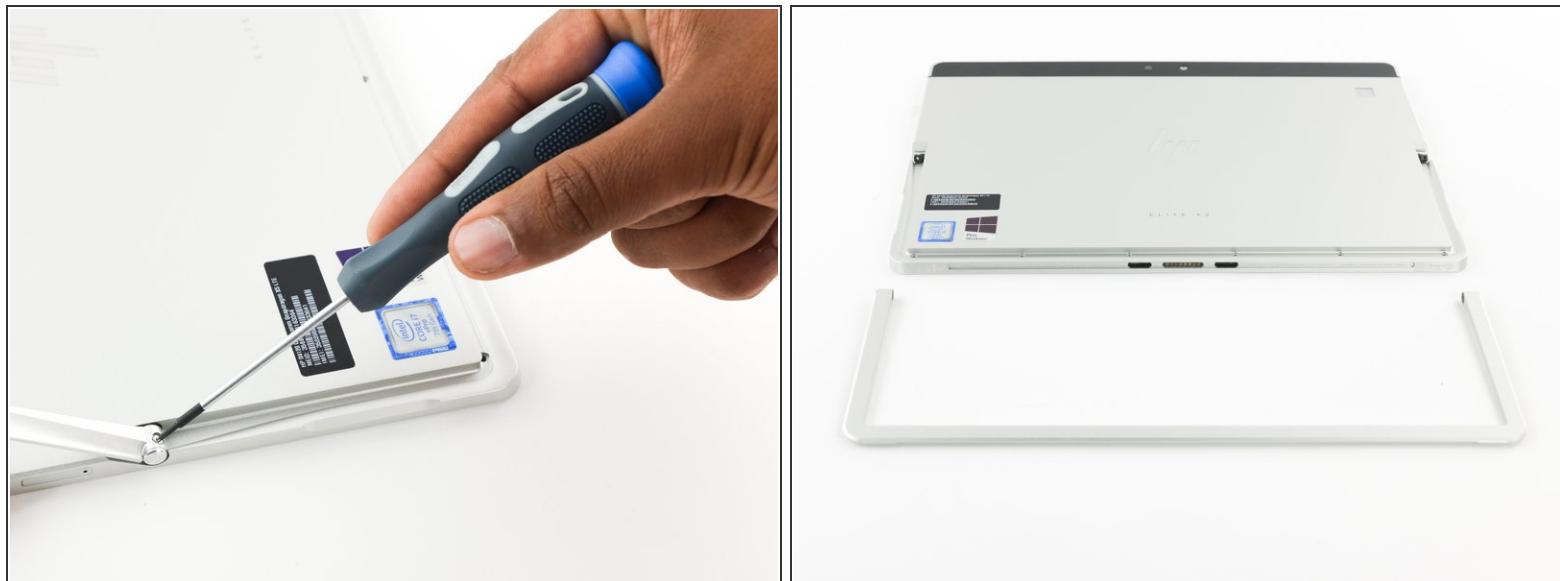
Step 2

- Before starting on the internals we check that the hinge is easily replaceable—it's a moving part and arguably the most likely to break.
- It is! Just remove the T5 Torx screw on either side and the hinge easily slides off.

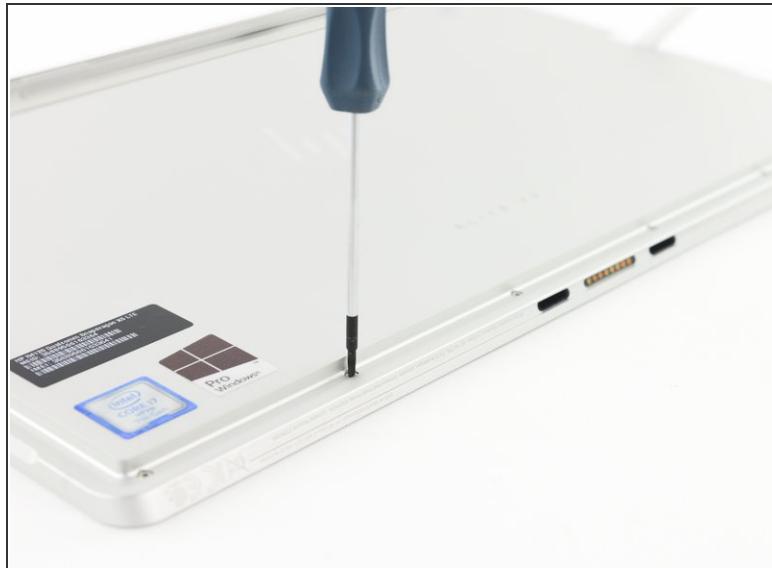
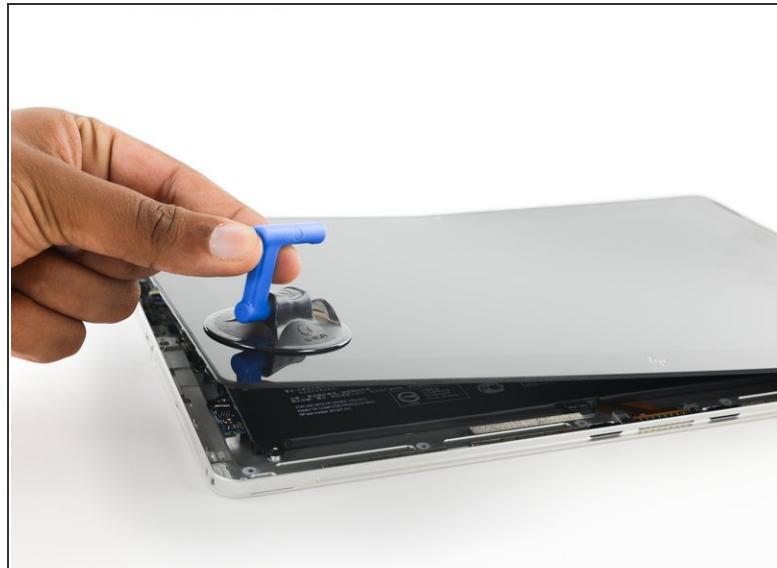
Step 3

- The display assembly is secured with six T5 Torx screws hiding underneath the hinge.
- After removing the screws, the screen is easily detached from the housing with a suction cup.

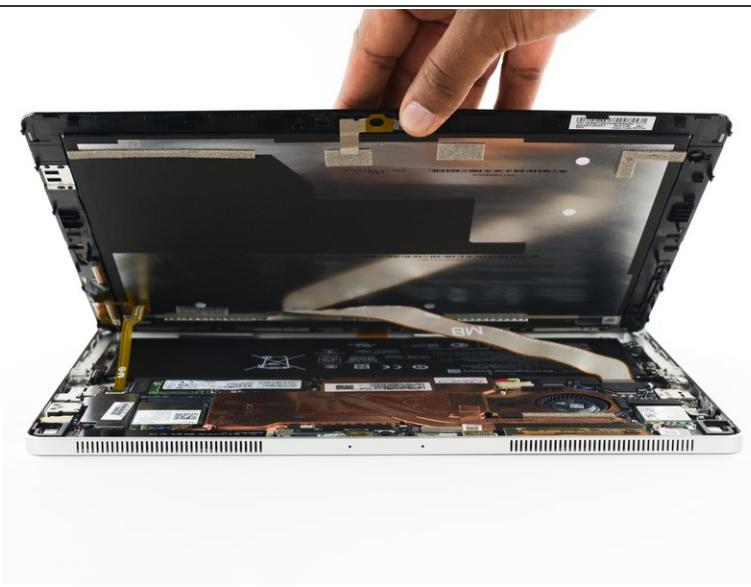
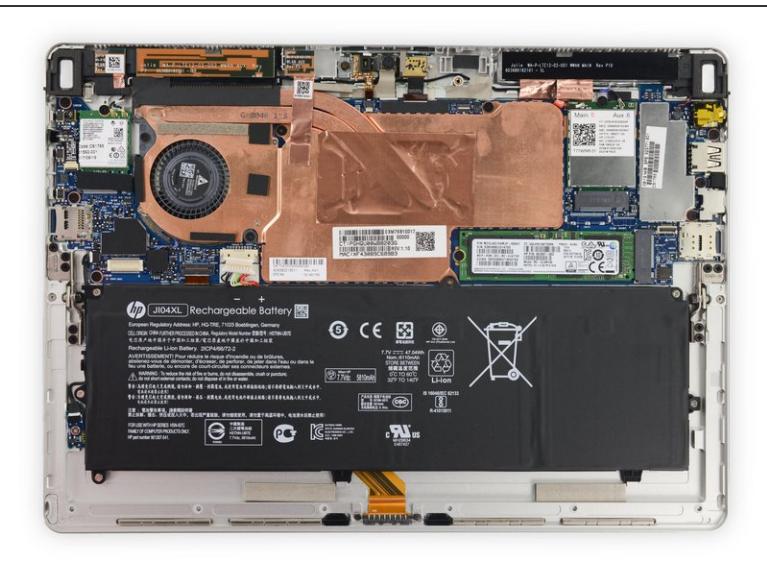
Step 4

- Lifting up the display is fairly easy—the display cables are long and there's no adhesive to fight against.
- The layout is similar to last year's model. This unit features a single system board rather than a mother- and I/O board combination. This step away from modularity is going to be inconvenient when a power jack or USB port breaks.
- We also immediately note that the battery and SSD are both secured with screws.

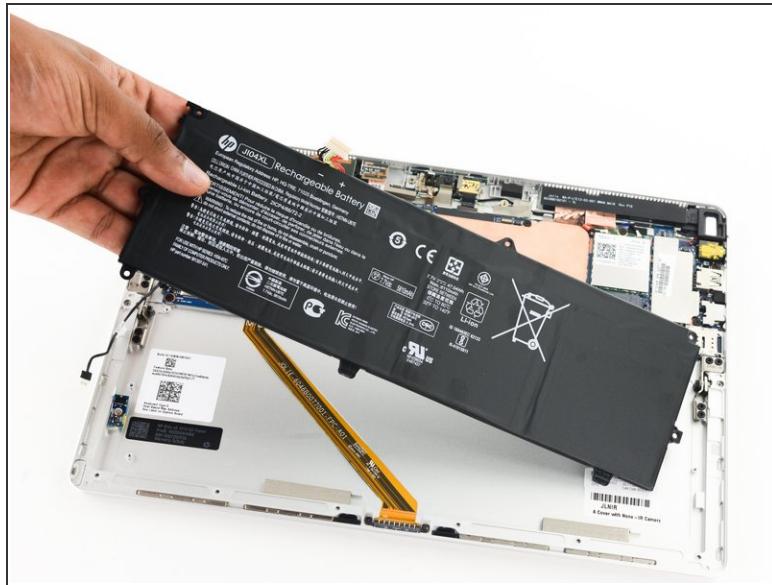
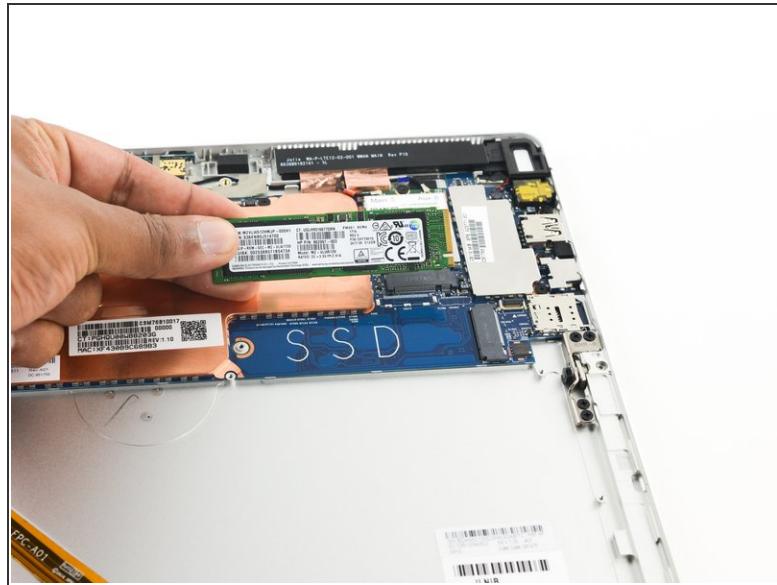
Step 5

- Like always, the battery is first out. It has a simple connector you can remove from its socket with tweezers.
- Once we remove the six Phillips screws holding it in place, the battery can be lifted straight out.
- Likewise, the (NVMe!) SSD is secured with a single screw and is easy to remove and upgrade!
- The same is true for the WLAN and WWAN cards (not pictured).

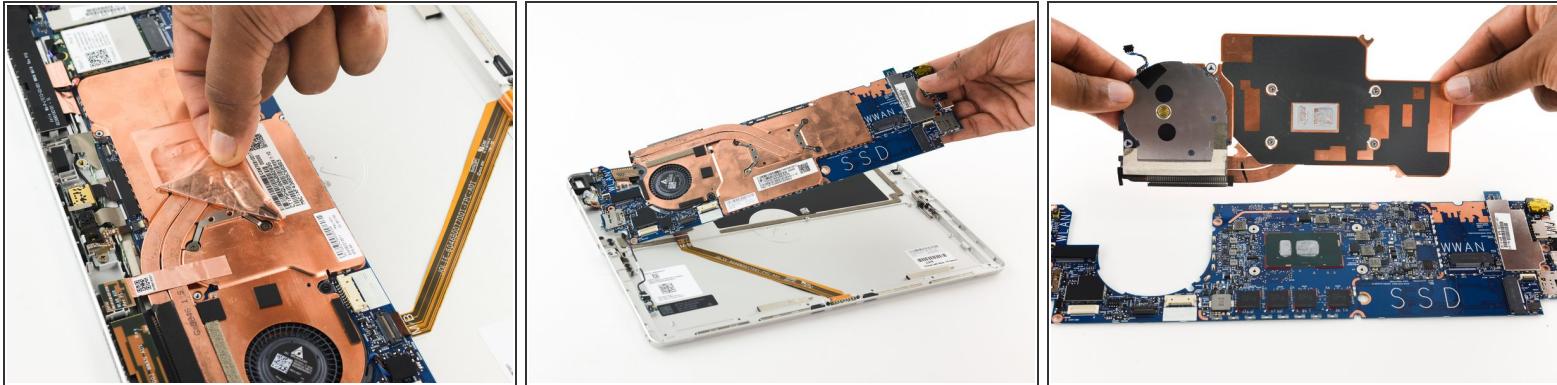
Step 6

- Moving to the motherboard we start to remove all the screws we can find, but the board will not budge.
- We spy some copper tape over the CPU. Removing the tape reveals a handful of screws, but removing them doesn't allow us to remove the main board.
- So we consult the repair manual, remove the specified screws, and successfully finesse the motherboard out of its slot in the rear case.
- The clipped-in thermal assembly comes next without too much trouble.

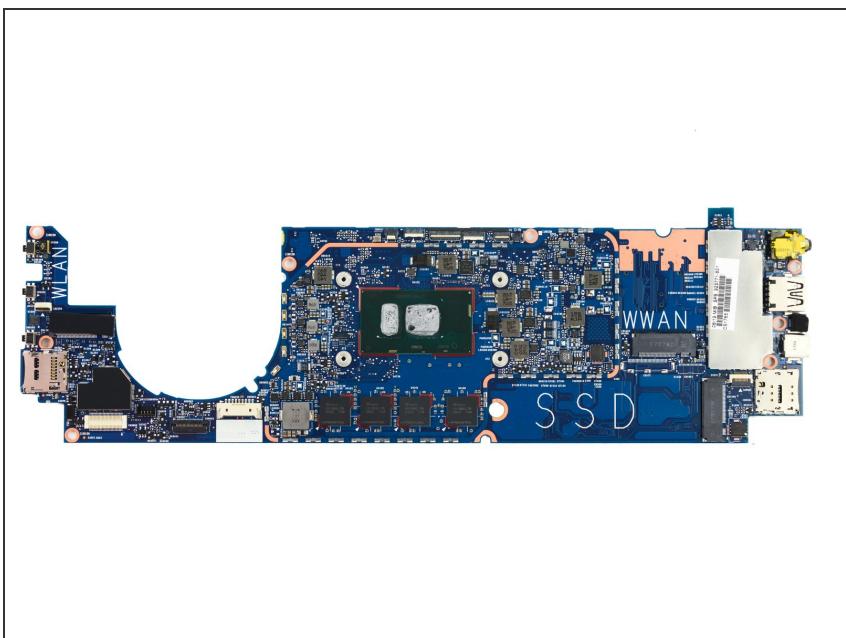
Step 7

- Motherboard reference shot.

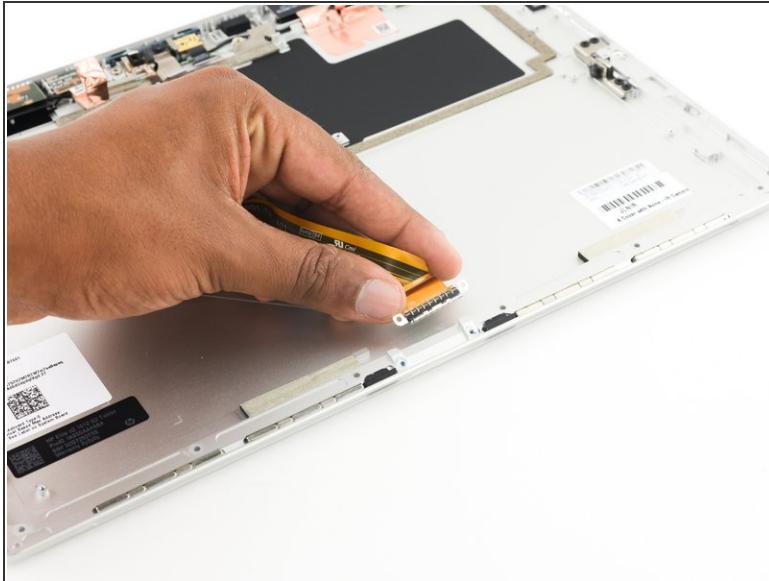
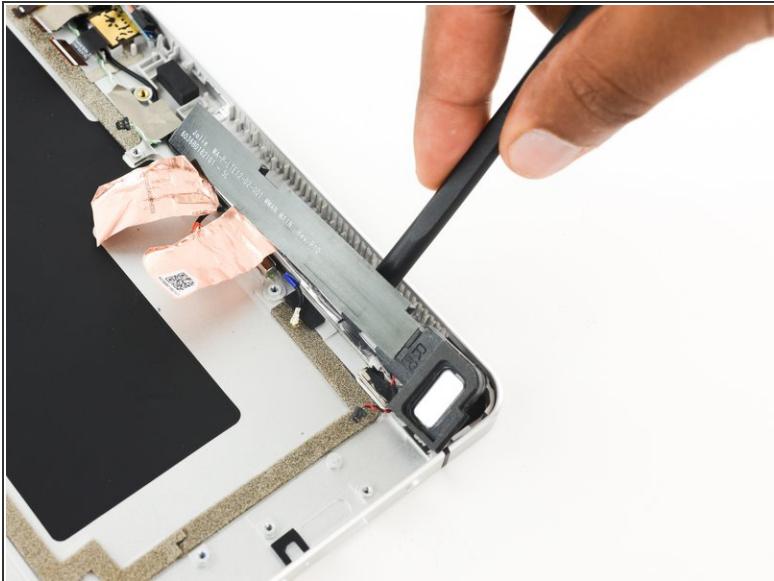
Step 8

- Finally we turn to the peripherals on the periphery of the device.
 - The keyboard connector is still a piece of cake to remove. It's held in with two Phillips screws, and the ribbon cable is held in with a little double-sided adhesive.
 - The upper components are a different story. The antennas are each connected to the chassis by a pair of copper tape strips.
- (i)* This conductive adhesive is malleable, easy to tear, and difficult to replace unless you have some on hand. We're not happy to see this inclusion as it makes reassembly more difficult and costly.

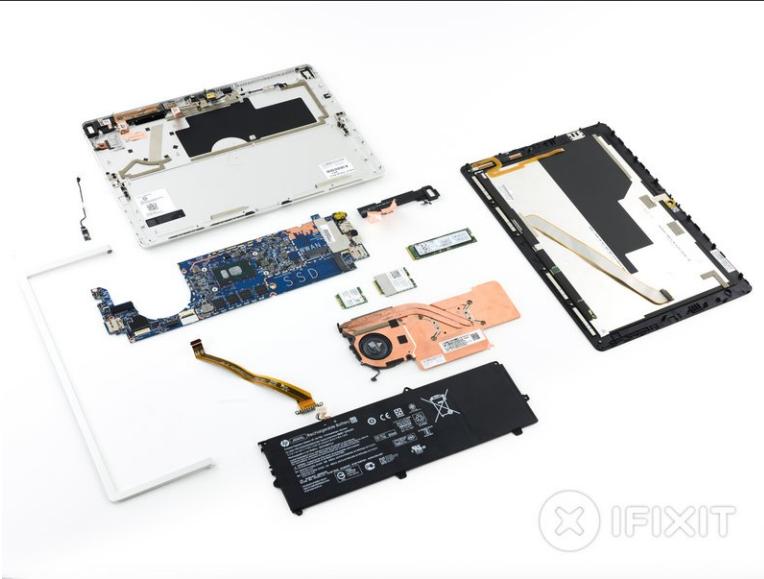
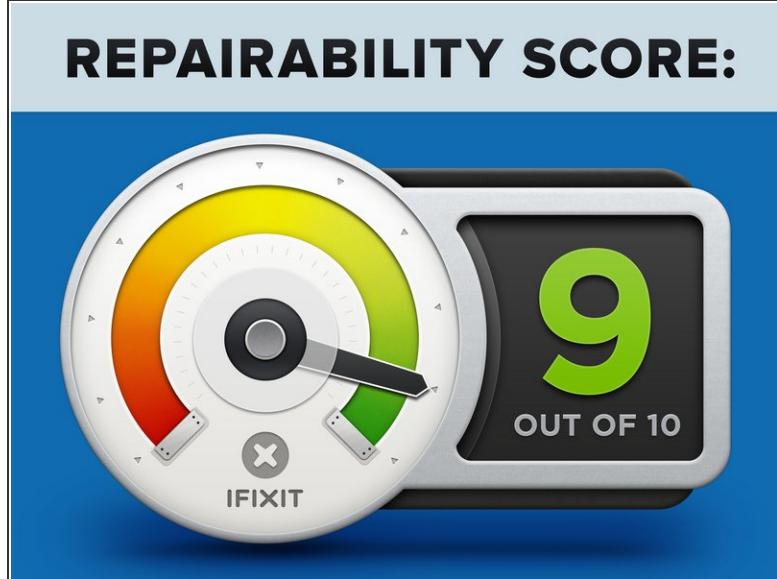
Step 9

- And that's a wrap! The HP Elite x2 1012 G2 is no slouch, but has some pain points that didn't exist in last-year's model. It earns a **9 out of 10** on our repairability scale. Here's why:
 - All screws are standard T5 Torx, Phillips #1, or Phillips #0.
 - Manufacturer provided [repair documentation](#) takes the guesswork out of repair.
 - Removing the battery, display, and system board is relatively straightforward and does not require fighting against adhesive
 - The flash storage is a standard M.2 card and can be easily upgraded or replaced. The RAM is soldered to the motherboard, but this is common for mobile devices.
 - The device is fairly modular, but consolidation of the I/O board into the system board is a notable step in the wrong direction.
 - The display and digitizer are fused, simplifying repair but increasing the cost of an LCD or front glass replacement.
