HP EliteBook 830 x360 G6 Repairability Assessment

Repairability assessment of the HP EliteBook 830 x360 G6.

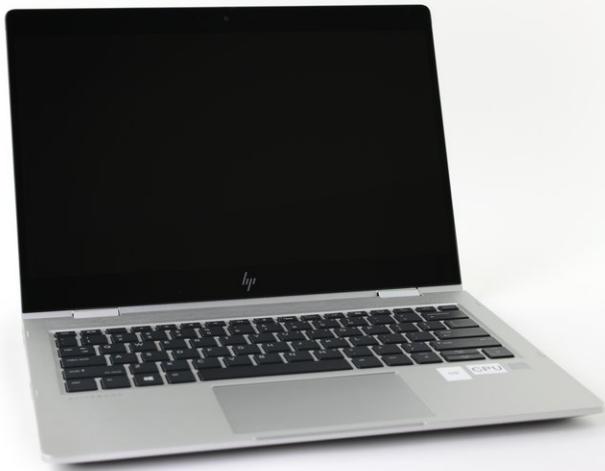
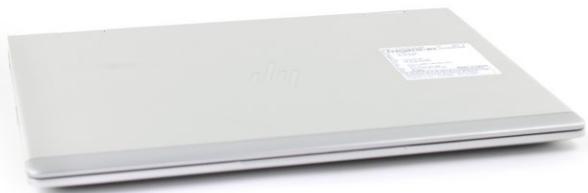
Step 1 — HP EliteBook 830 x360 G6 Repairability Assessment

- Exterior reference photos.
- The laptop isn't ingress-proofed, so many gaps in the keyboard and lower case—including ports, vents, speaker grilles, etc.—may allow water damage or particle buildup.

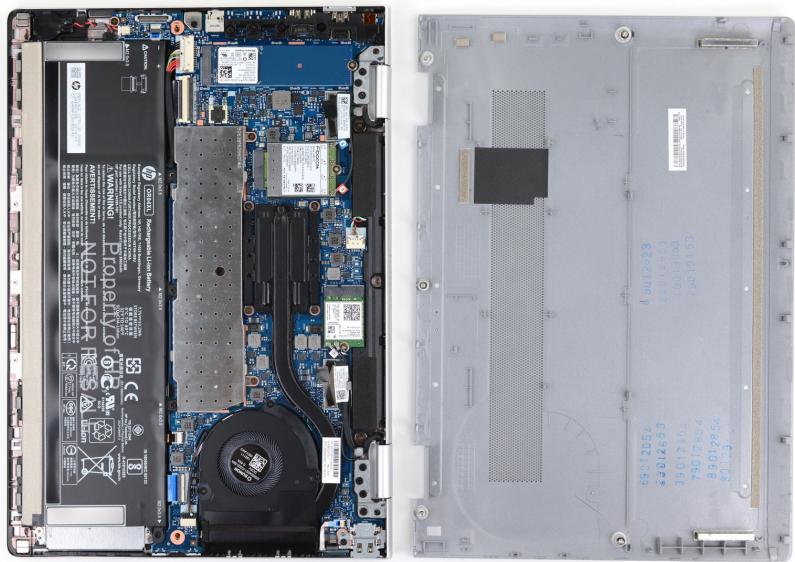
Step 2

- The lower case is secured by a few captive Torx screws. Torx isn't as common as Phillips, but should better withstand repeated removal. Captive screws will also be hard to lose.
- The case is fairly well secured and requires a thin plastic prying tool to gain access; fingernails won't be strong enough and metal tools will likely scratch the laptop surface.
- The bottom case contains no major components, making for easy replacement, and the laptop itself has a flat construction that allows access to most components at this stage.

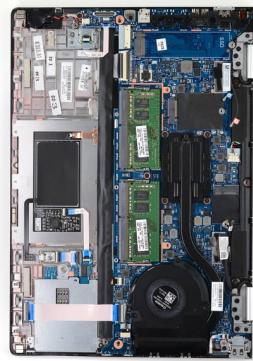
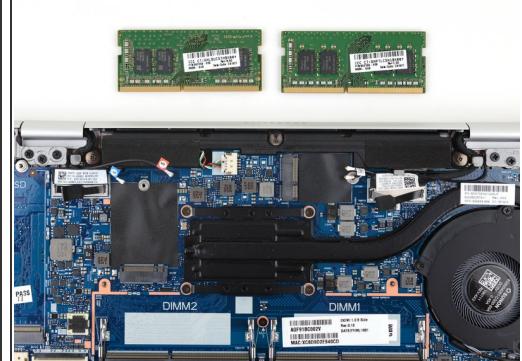
Step 3

- The battery is immediately accessible after removing a few standard screws. No adhesive holds it down.
 - A laptop battery is consumable—even if it's kept in mint condition, the battery will wear down and need replacing. An easily accessible battery is very important for the life of the device, as well as its end-of-life recycling.
- The wireless cards and SSD are immediately removable, secured only by Phillips screws.
- The modularity of these items is a great point in favor of repairability and device longevity, as well as user privacy with regards to the SSD.
- The RAM is still covered by an unlabeled EMI shield, but only a few screws and clips secure it, making it trivial to remove.

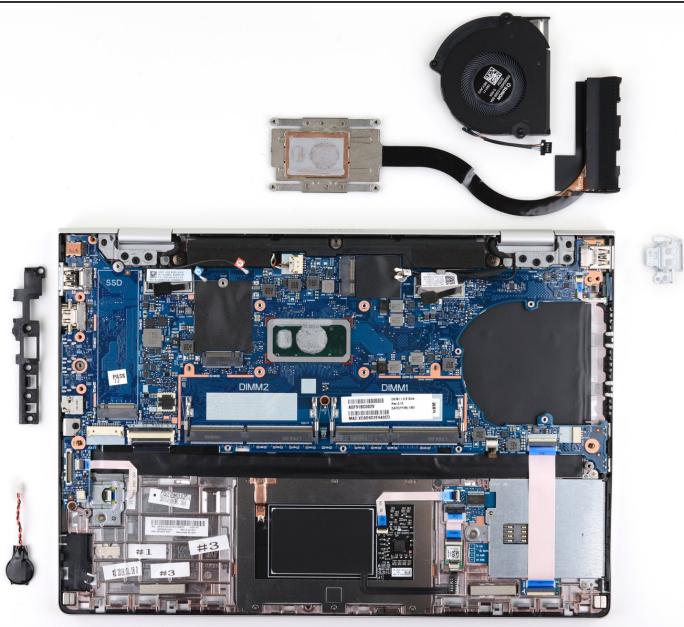
Step 4

- The heat sink and fan are modular. They're immediately and easily removed by loosening captive Phillips screws. Access to these components is desirable for maintenance and cleaning.
- The BIOS/CMOS battery is also immediately accessible. While these batteries are very low power and often last a long time, they will eventually need replacing, so easy access is appreciated.
- Also immediately accessible are a couple non-essential port cover/stabilizers.
- The ports are unfortunately soldered to the mainboard, meaning that failure will be costly to repair. Brackets to support the ports are a welcome reinforcement—hopefully postponing an expensive repair, if not preventing it entirely.

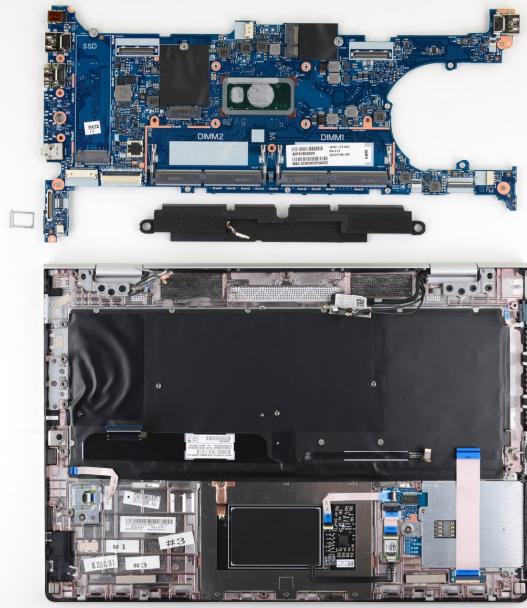
Step 5

- The motherboard is removable after the heat sink assembly, and after some (mostly labeled) connectors are disconnected. The motherboard contains the CPU, volume buttons, and ports.
- High-wear components like ports and buttons make for a very expensive replacement when they're soldered to the motherboard.
- The placeholder SIM tray comes out without a fuss in this version. Prior editions required complicated motherboard removal, so this is a nice change.
- The speaker can be removed at the same time as the motherboard, but it's slightly easier with the motherboard removed. Its modularity and simple cable layout is appreciated.

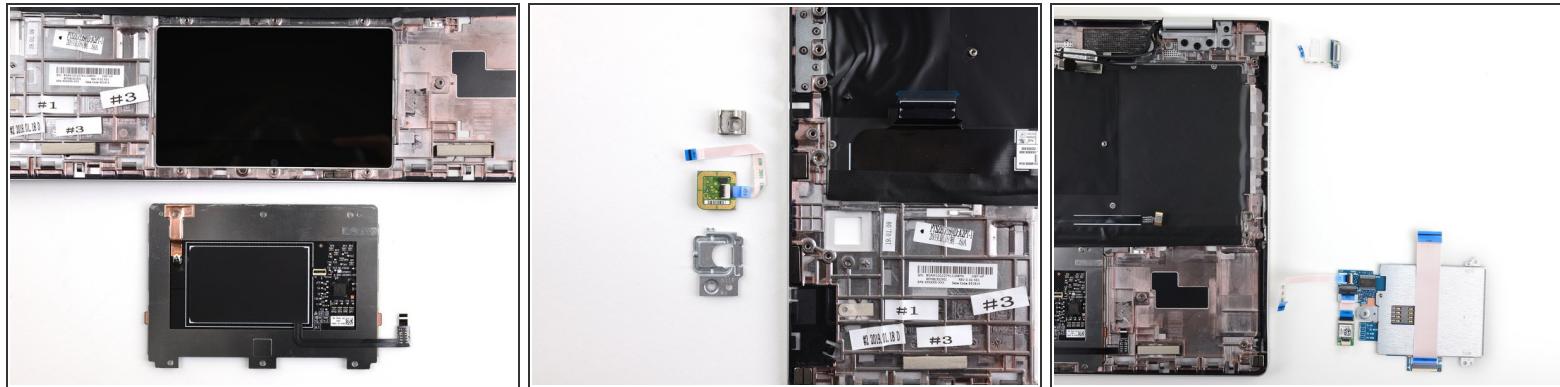
Step 6

- With the battery removed, the following components are accessible:
 - The trackpad assembly, which is secured with standard screws and no glue.
 - The fingerprint sensor and its interconnect cable.
 - The lock bracket can be removed after the motherboard.
 - The peripheral port with an interconnect cable adhered to it.
- The power button is not easy to pry out of its recess even with the motherboard removed, and could likely be removed earlier. The modularity of this button is appreciated considering the number of components soldered on the main board.

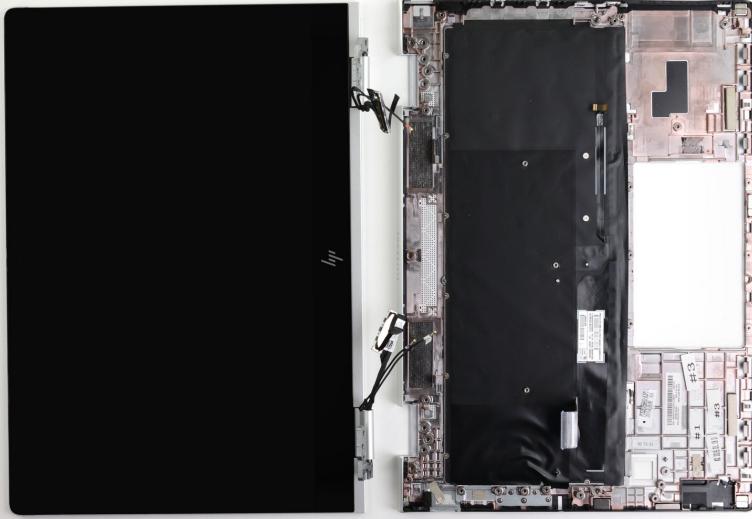
Step 7

- The display is actually removable upon opening the bottom case, which is great for repairability.
- That said, the cables are tough to wrangle, making hinge removal a little tricky.
- The keyboard assembly can be removed intact after some large stickers and a few dozen screws are removed.
 - This procedure is not ideal, but not terrible—lengthy, but not especially challenging. Presumably the stickers provide EMI shielding and should be reinstalled, but doing so without damage will be a challenge. Removing and replacing the many small screws will also be a marathon.

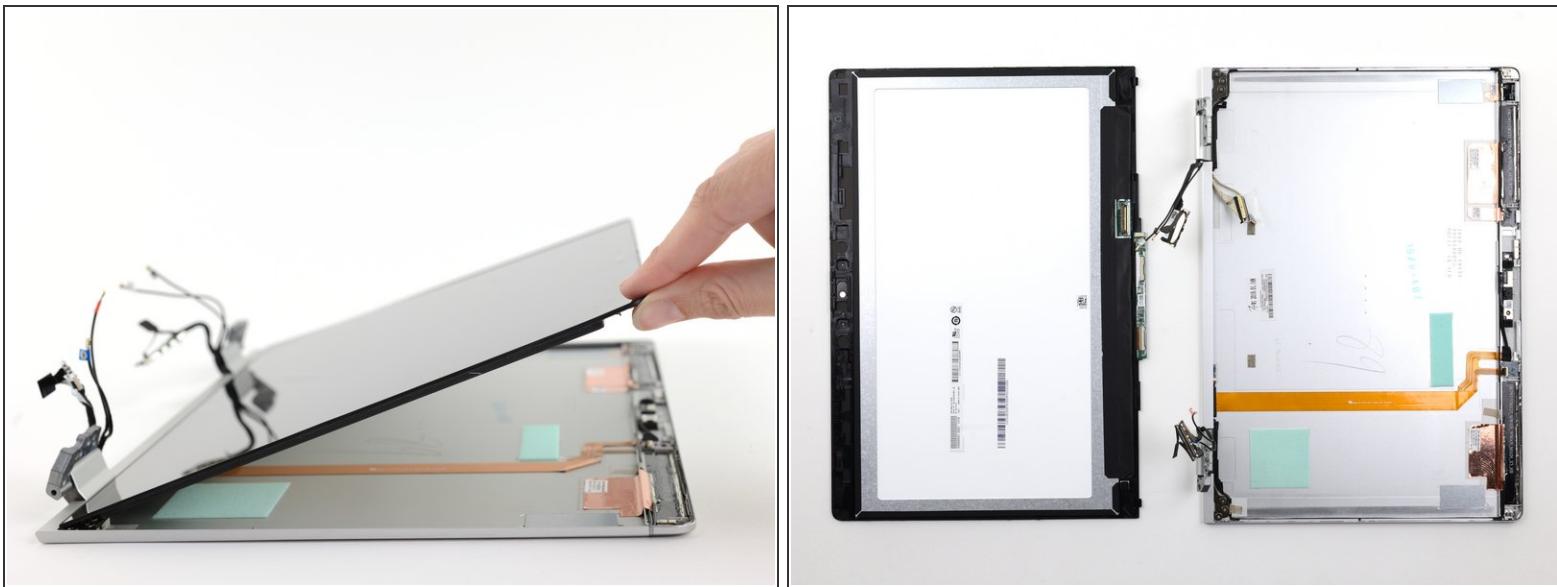
Step 8

- The webcam slider provides a fairly safe access point. The thin adhesive is easy to slice through, and the lack of breakable plastic clips makes removal and reassembly much easier.
- The display must be opened from the top so that the bottom end can slide out. Starting from the base will likely break clips and maybe a board.
- The plastic bezel did not separate in display removal this time around, making the repair easier. If the bezel needs to be transferred to a new part, it may be damaged in the process.
- The display is quite easy to disconnect, and no cables or components are in danger during the prying procedure.
- The display houses no additional components, allowing for quicker replacement.
- Remaining in the display case are the upper sensor assembly and several antennas secured by copper tape, which may be a challenge to remove and replace intact.

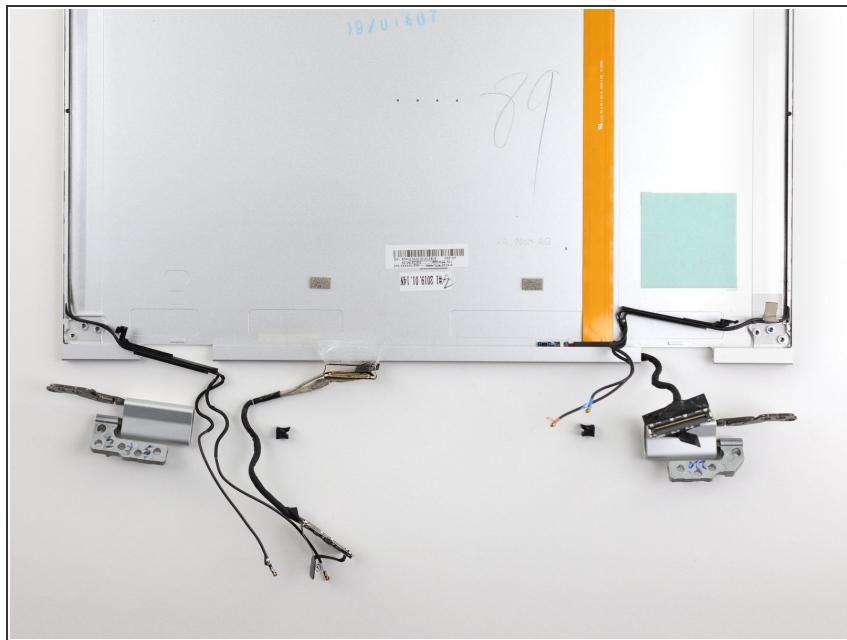
Step 9

- The labeled hinges with labeled plastic cable securers are the final items to be removed.
- Ideally the aforementioned antennas won't fail, but their cables run through the hinges, which stresses them over time. The copper tape will complicate replacement.

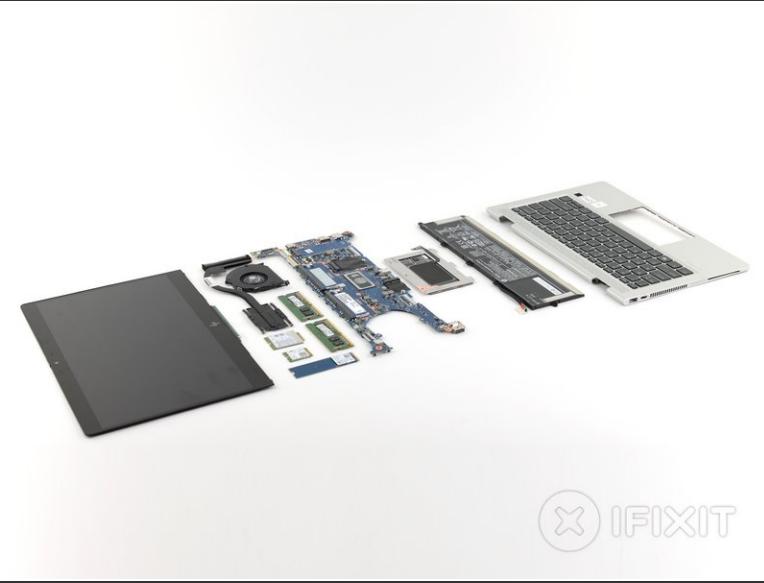
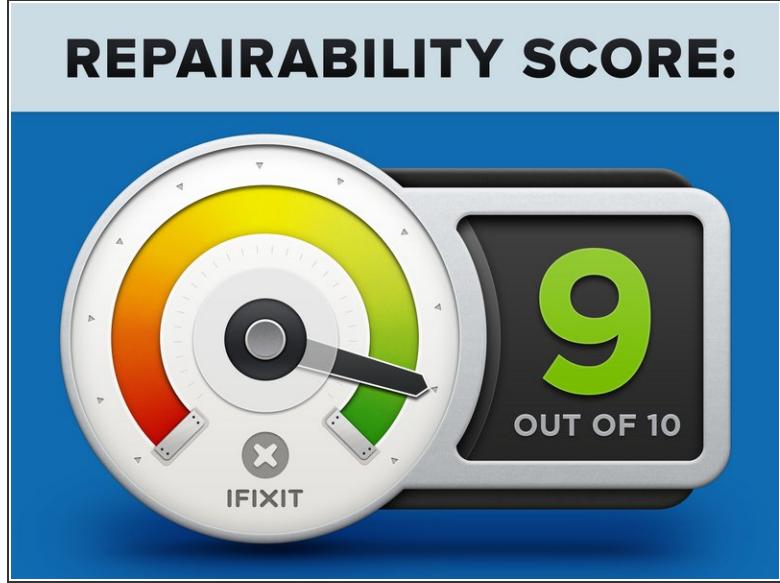
Step 10

- The HP EliteBook 830 x360 G6 earns a 9 out of 10 on our repairability scale (10 is the easiest to repair):
 - SSD, RAM, and battery are accessible and removable.
 - Manufacturer provides free user-accessible repair documentation.
 - All screws are standard Phillips and Torx.
 - Overall mostly modular, but the motherboard contains both ports and CPU making for expensive repairs.
