Hisense Sero 8 Charging Port Replacement

This guide demonstrates how to replace the charging port in the Hisense Sero 8.

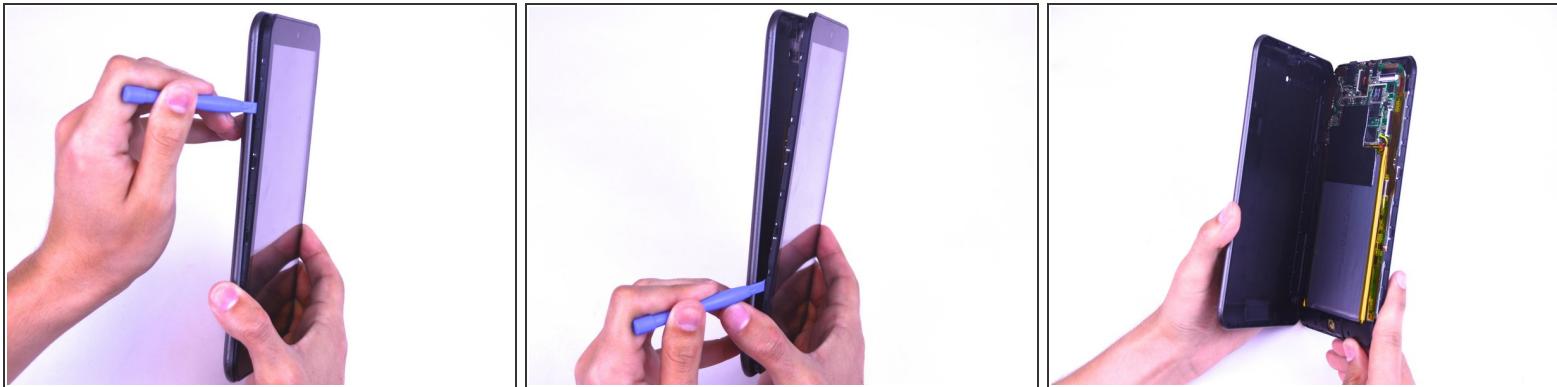
Step 1 — Charging Port

- Remove the back cover of the device using a combination of both plastic opening tools.
- Use your plastic opening tool pry open a corner of the device, then continue down the side of the device with the tool to completely open the device.

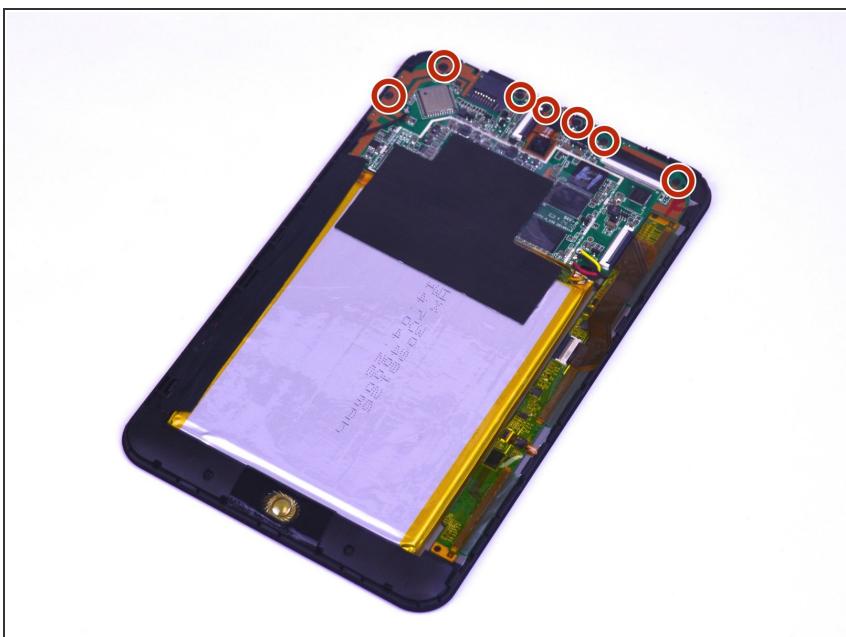
Step 2

- Remove seven of the 4.43mm screws using the Philips #00 screwdriver.
- *(i)* It is not necessary to remove the bottom two 4.43mm screws that keep the speakers in place.

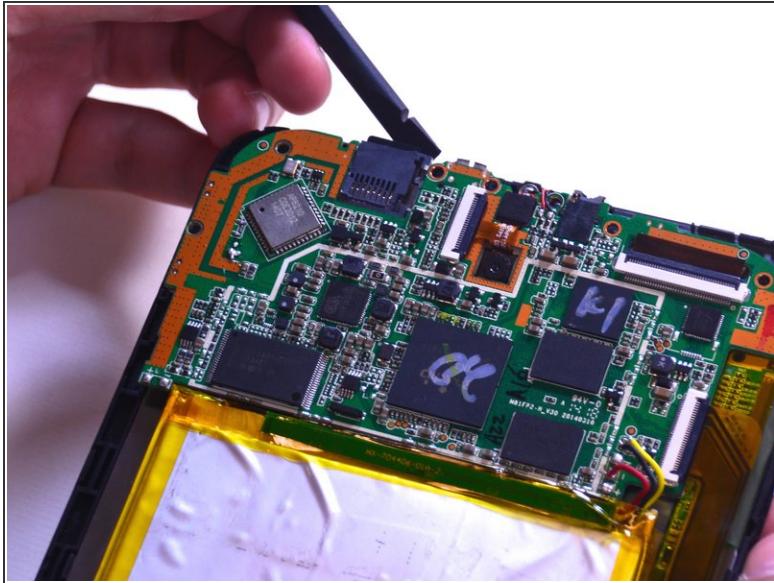
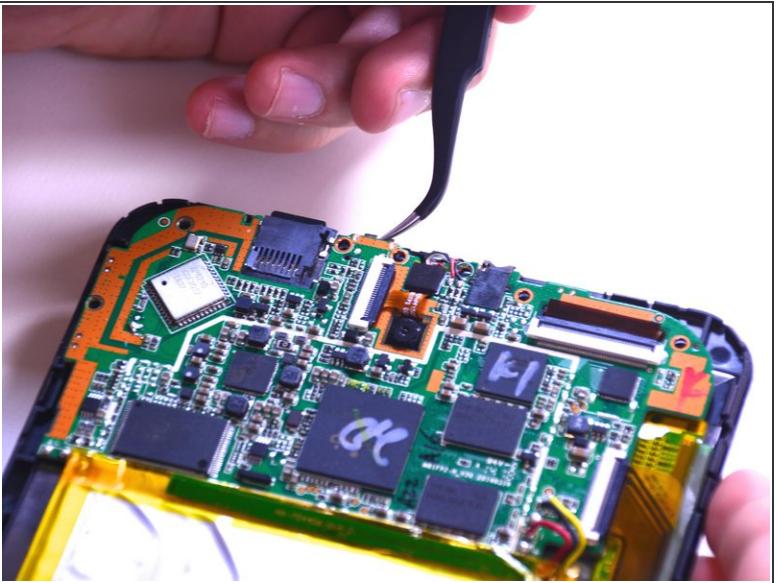
Step 3

- Gently lift the motherboard up to extract the charging port out with the tweezers.

Be cautious not to disconnect any wires or ribbon cables.
