Hitachi GST Deskstar HDS721010CLA332 Hard Drive Controller Replacement

INTRODUCTION

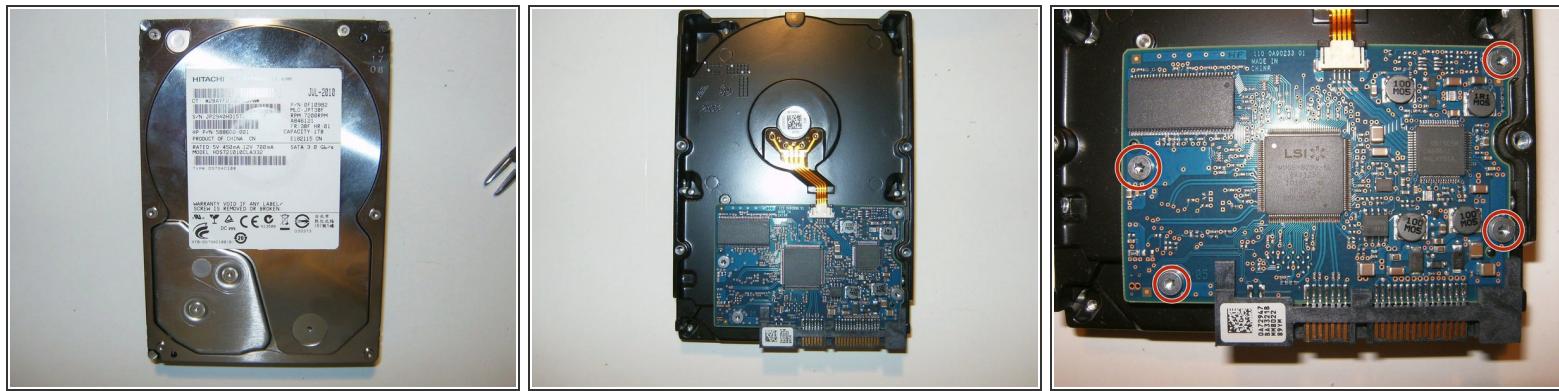
Step 1 — Controller

- Here is the failed Hitachi HDS721010CLA332. It does not get recognized by the computers BIOS and cannot get accessed by any other means. No clicking or other mechanical noises present
- Turn the drive over to get to the controller PCB
- Remove the four T8 screws from the PCB

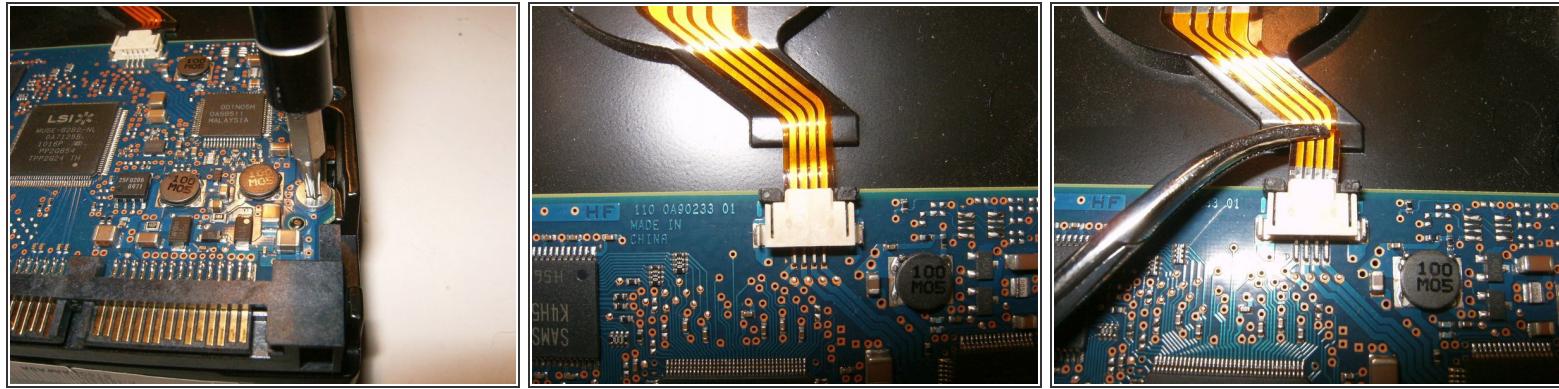
Step 2

- Here is the T8 driver to remove the screws
- The drive flex cable is a simple compression fitting.
- Use a tool like hemostat or your fingers to remove the cable....

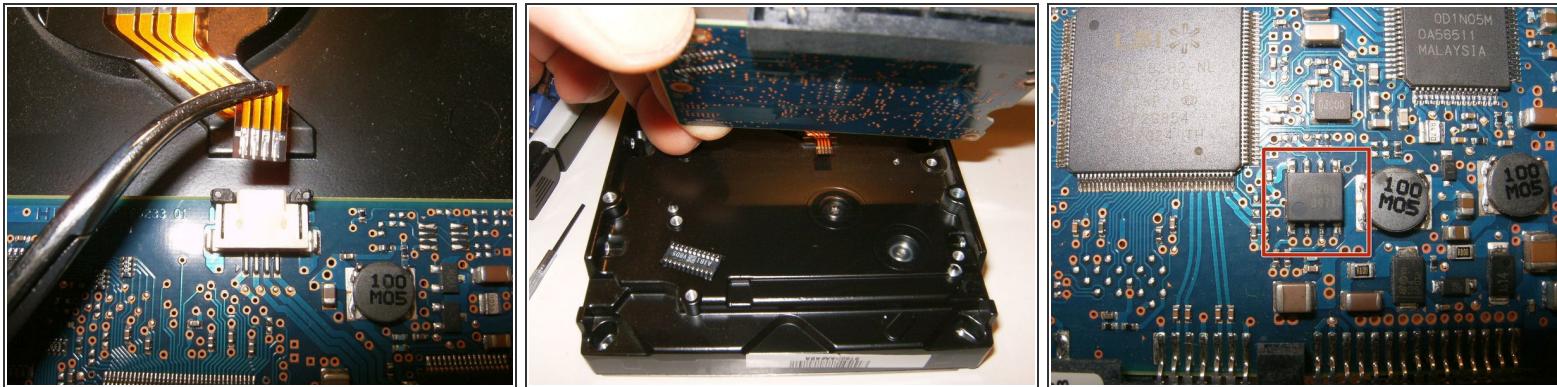
Step 3

-by simply pulling it out to the back of the connector
- Remove the controller PCB from the drive.
- Locate the controller board BIOS IC. This BIOS contains the unique configuration data for this drive. Without changing it the files on the drive cannot be recovered.

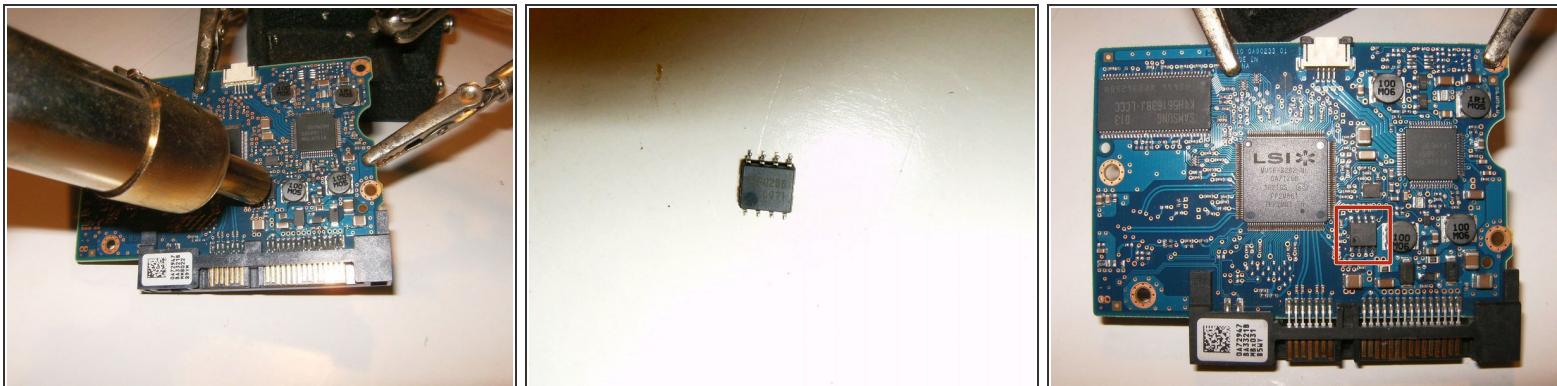
Step 4

- Use a hot air rework station or a soldering iron to remove the BIOS IC
- Here is the removed BIOS IC. This is the one that will have to be transplanted to the new controller PCB. Ensure that this IC does not get mixed up. Keep it separate
- Here is the new controller PCB with the BIOS IC that needs to be replaced.

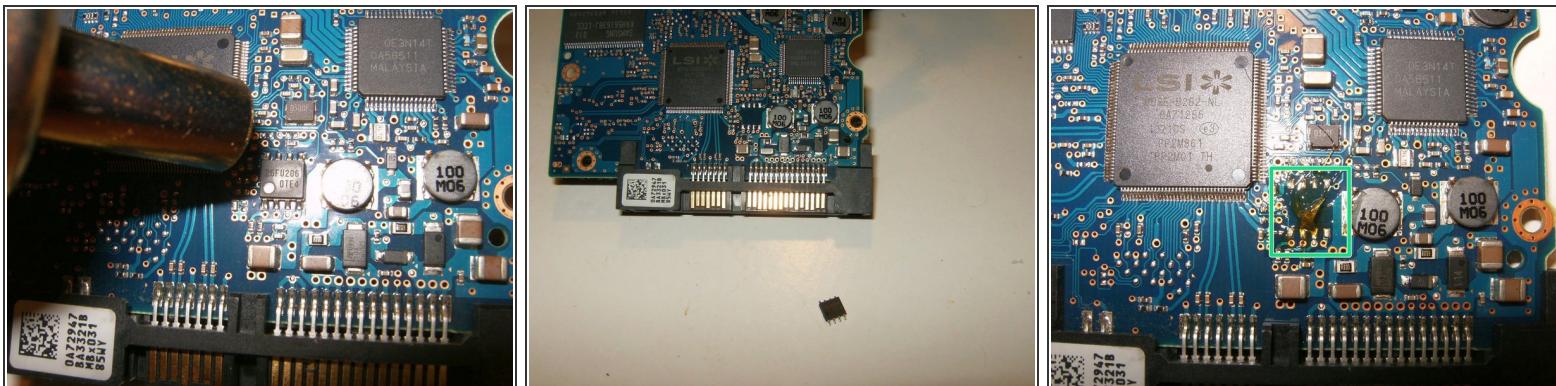
Step 5

- Remove the BIOS IC from the new PCB by using a hot air rework station or a soldering iron.
- BIOS IC removed from the new controller PCB.
- Next clean the solder pads on the new PCB where the BIOS IC sat. Apply flux

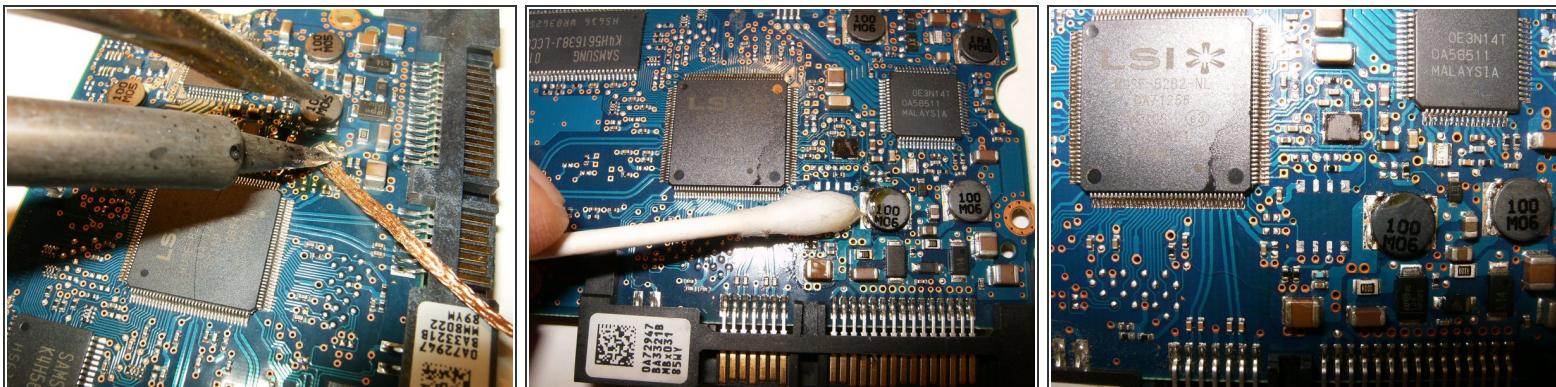
Step 6

- Use a soldering iron and desoldering braid to clean the solder pads
- Clean the flux with some high grade isopropyl alcohol and a cotton swab
- Here are the cleaned solder pads.

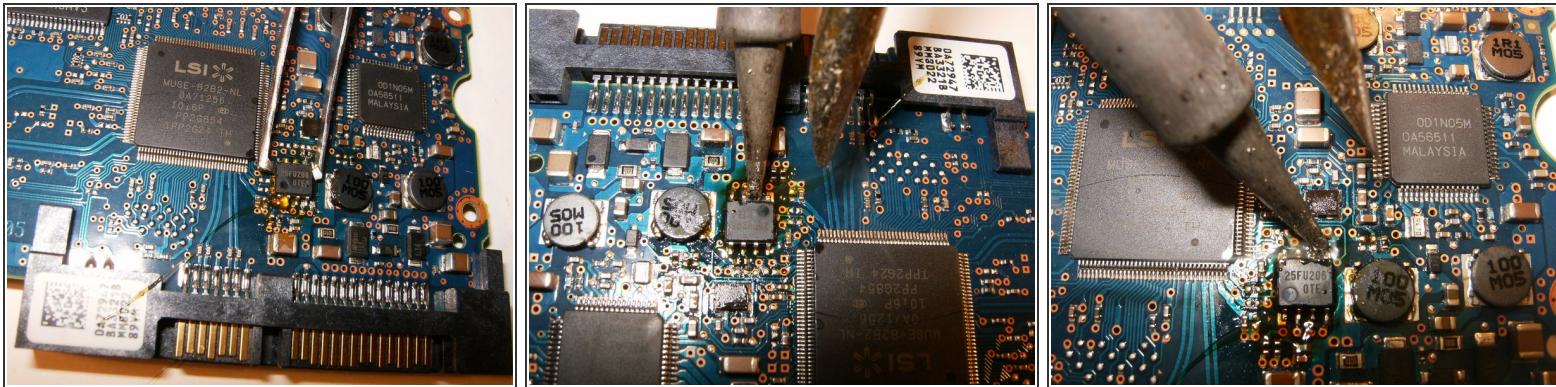
Step 7

- Apply some flux to the solder pads and place the old BIOS IC onto the solder pads of the new controller PCB. Ensure the proper placement of the IC.
- Solder the BIOS IC into place
- Ensure that the soldering iron does not accidentally heat up the components next to the BIOS IC, particular the ones at the top end.

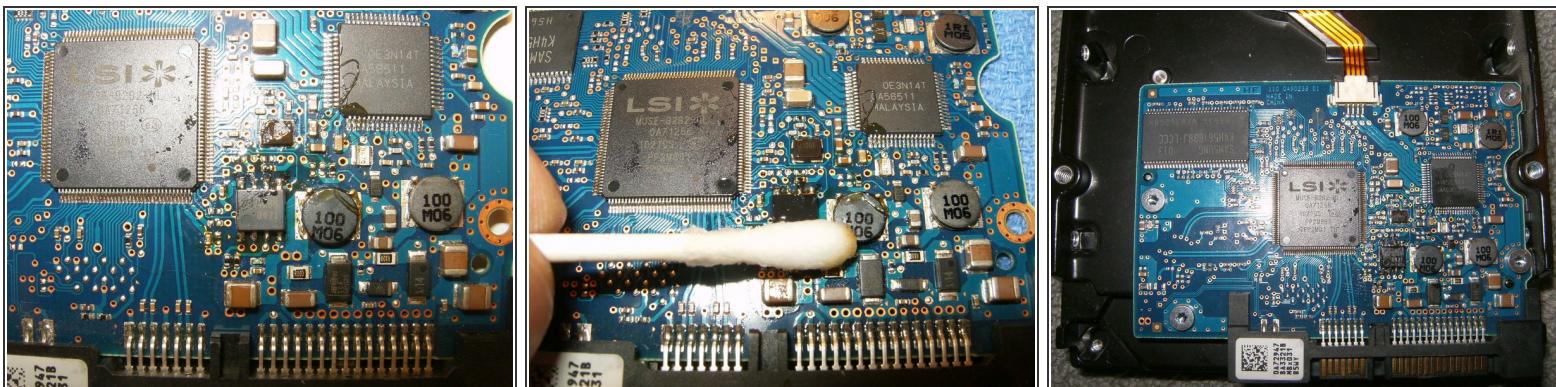
Step 8

- BIOS IC properly placed and soldered onto the new controller PCB
- Clean the flux with some high grade isopropyl alcohol and a cotton swab
- Last step is to reinstall the new controller PCB with the old drives BIOS IC which contains the unique data for this drive.

After replacing the board and replacing the BIOS IC from the original board, the drive was once more recognized. This allowed for the data recovery of some 1000 pictures as well as other documents.
