How to Fix Keurig K75 Platinum Brewing System Water Pump Leak

This guide will show you how to fix internal water leaks for the Keurig B70 Platinum Brewing System.

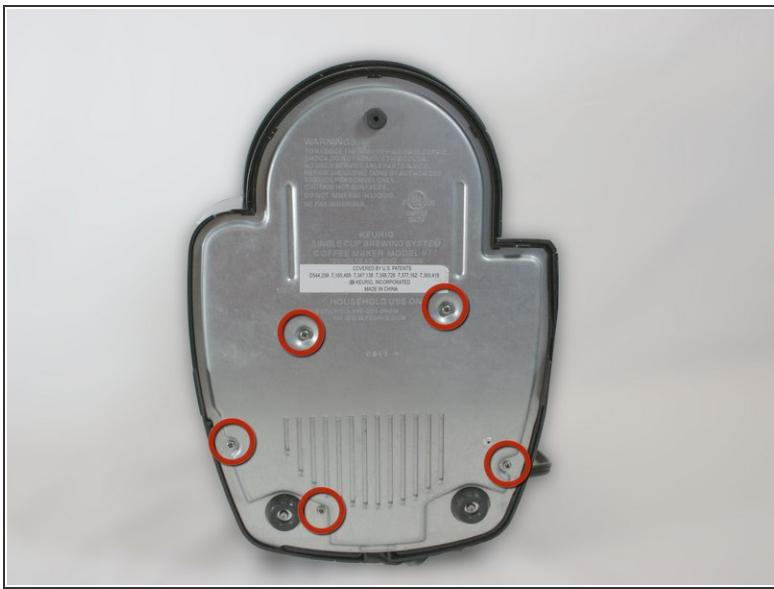
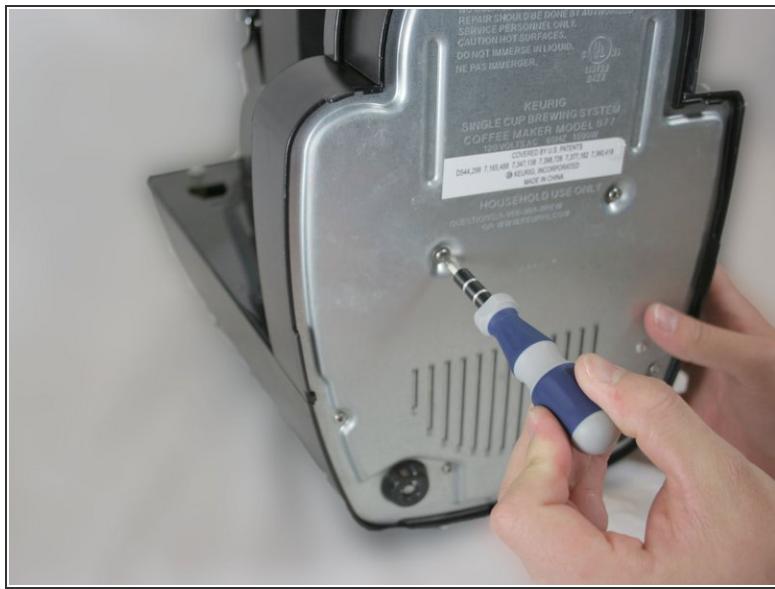
Step 1 — Baseplate

- Move the brewer so that the metal baseplate is easily accessible.
- Remove the five silver 4 mm Phillips #2 screws from the baseplate.

⚠ Before beginning the repair, turn off the brewer and disconnect it from any power source.

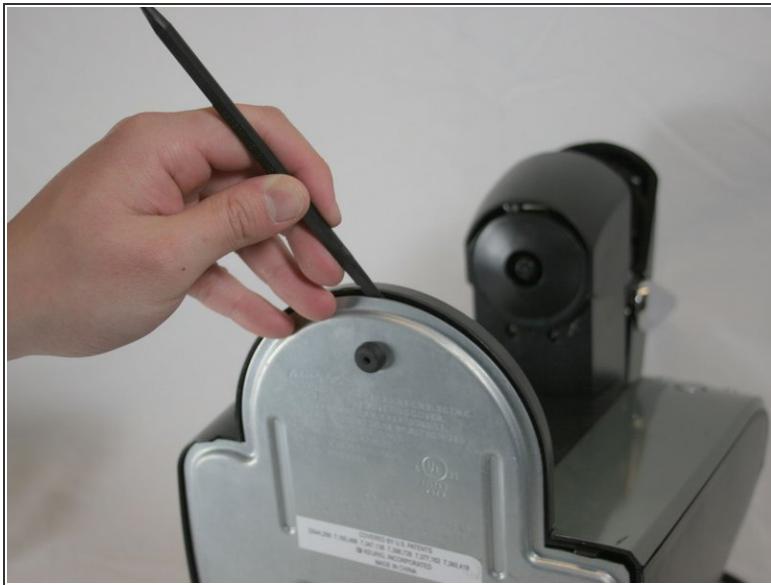
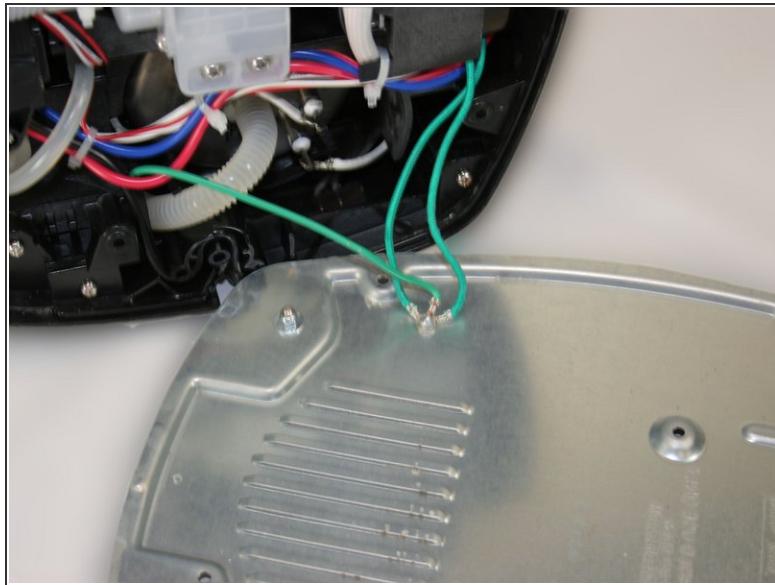
Step 2

- Using a spudger, gently pry the metal baseplate from the brewer.
- Gently set down the baseplate.

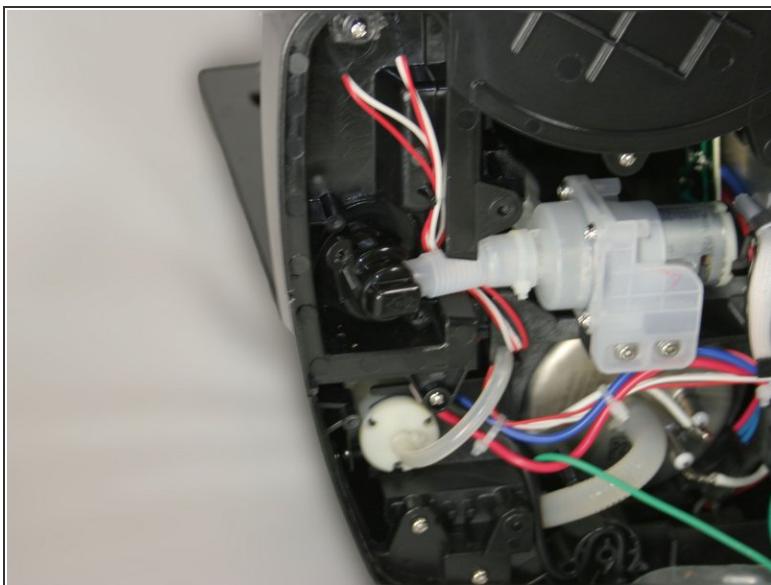
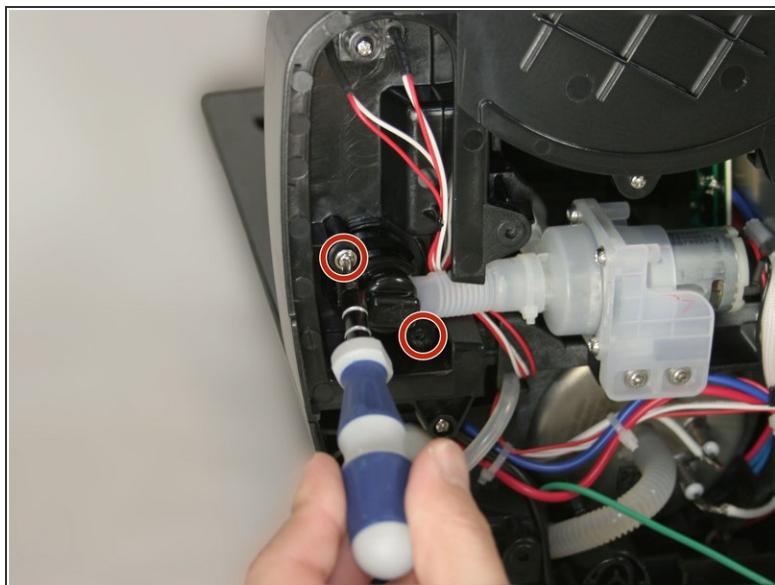
Step 3 — How to Fix Keurig K75 Platinum Brewing System Water Pump Leak

- Remove the two silver 4mm Phillips #2 screws that hold the water pump in place.

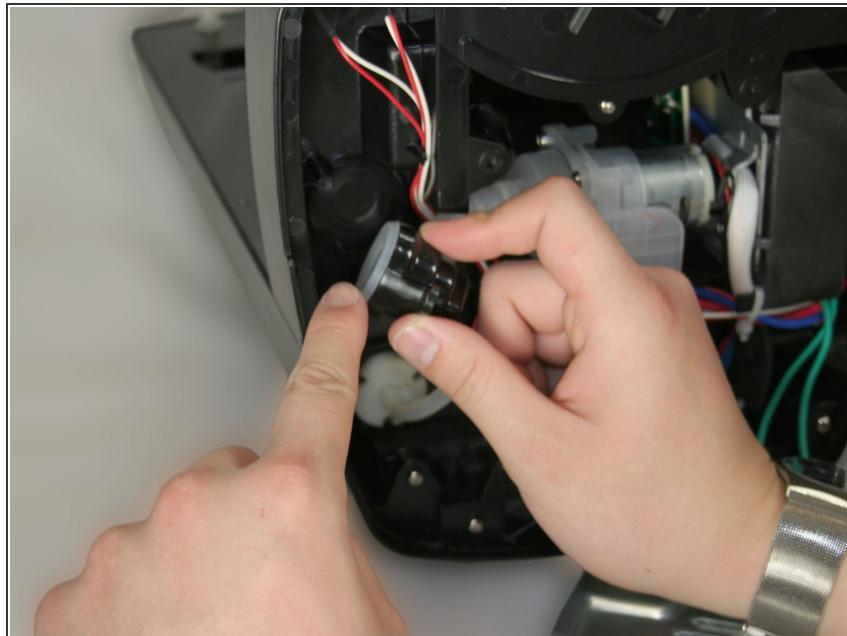
Step 4

- Realign the rubber gasket of the water pump to create a tight fit.

To reassemble your device, follow these instructions in reverse order.
