How to Fix Leaking Dolce Gusto Genio

These devices suffer from two common problems: Water leaking from the side of the capsules, and water leaking from the bottom of the device. This guide focusses on repairing the water leakage from the bottom.

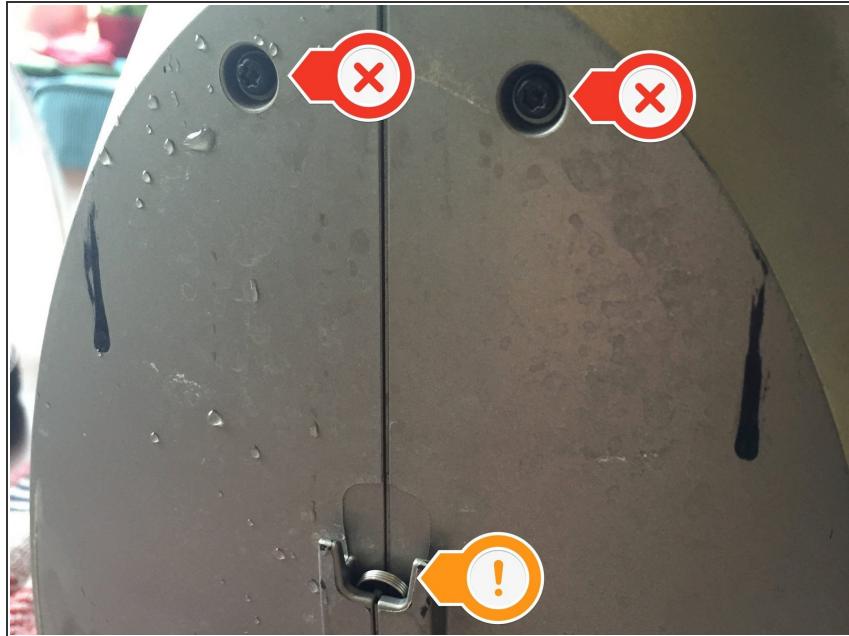
Step 1 — Opening it up

- Be sure to unplug the device first
- Remove the water tank, then with the TR10 screwdriver, first remove the two screws behind the tank (red arrows)
- Now carefully remove the spring from it's holder (orange arrow)

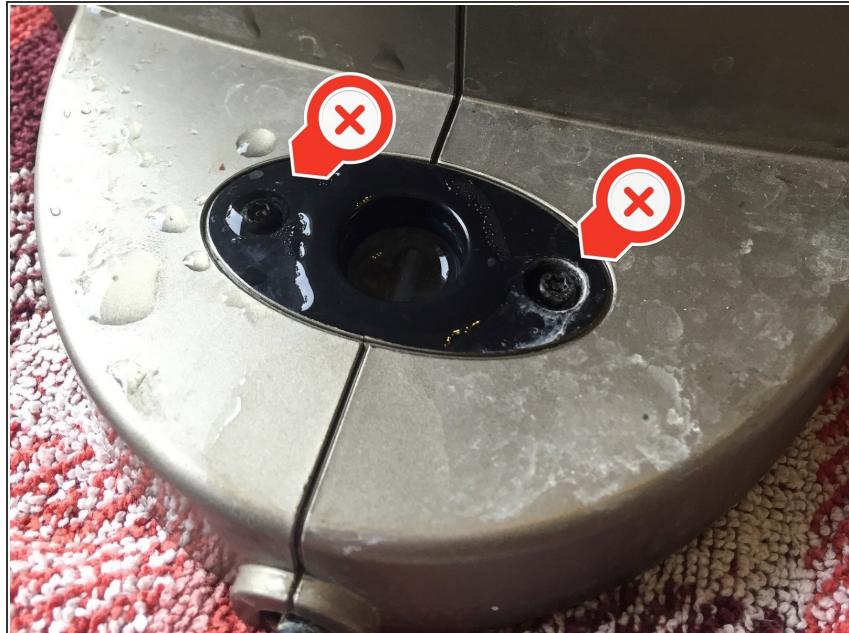
Step 2 — Opening it up (2)

- Remove the two TR10 screws from the bottom part

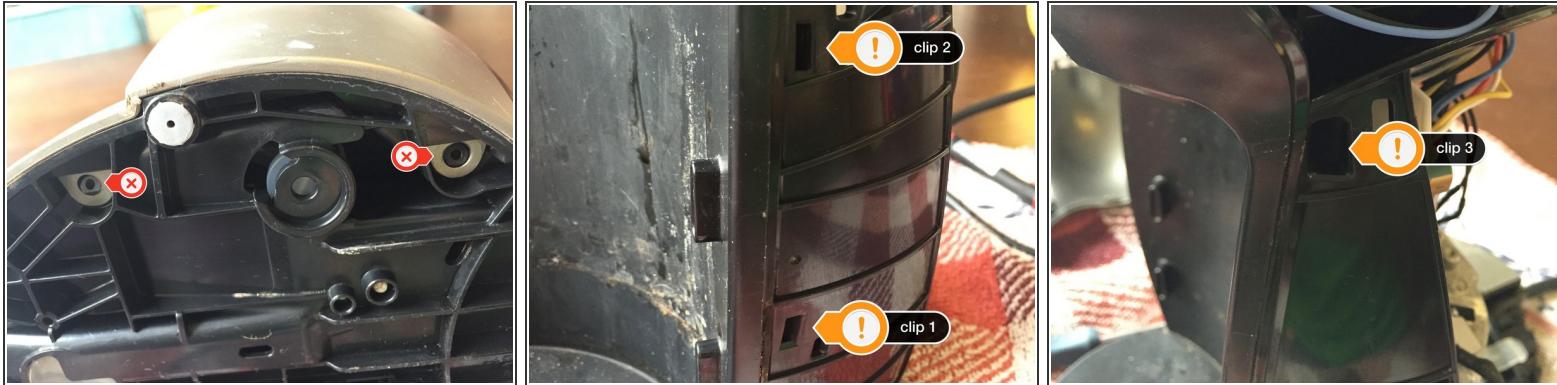
Step 3 — Opening it up (3)

- With the back of the device towards you, start on the left panel
- It is connected with 6 clips at the lower part, and several more for the top part
- Carefully pry loose the clips from the bottom upwards, starting with the clips on the bottom (red arrows)
- next open up the clip next to the power cord
- open up the three clips on the side of the panel (orange arrows). Locktabs grip the holes in the orange clips 1 and 2. They will let go if they are lifted directly outwards from their base. Just next to the locktabs are guide pins. they don't offer resistance during removal.

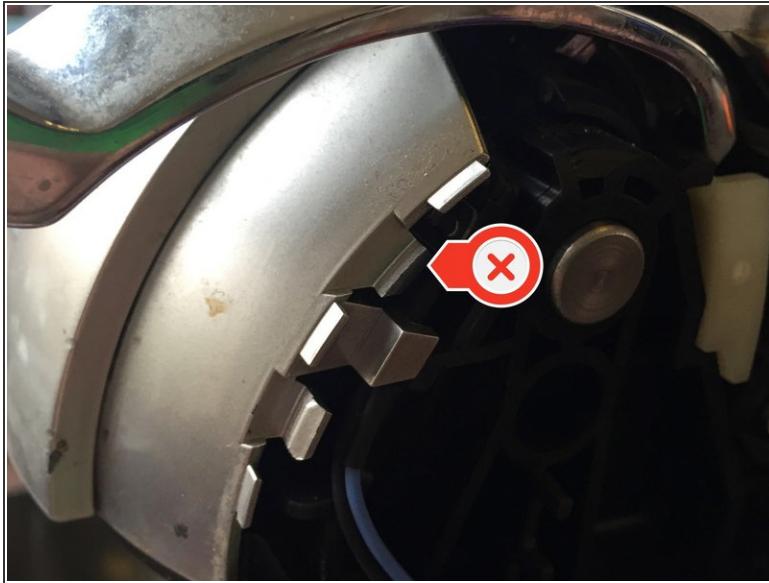
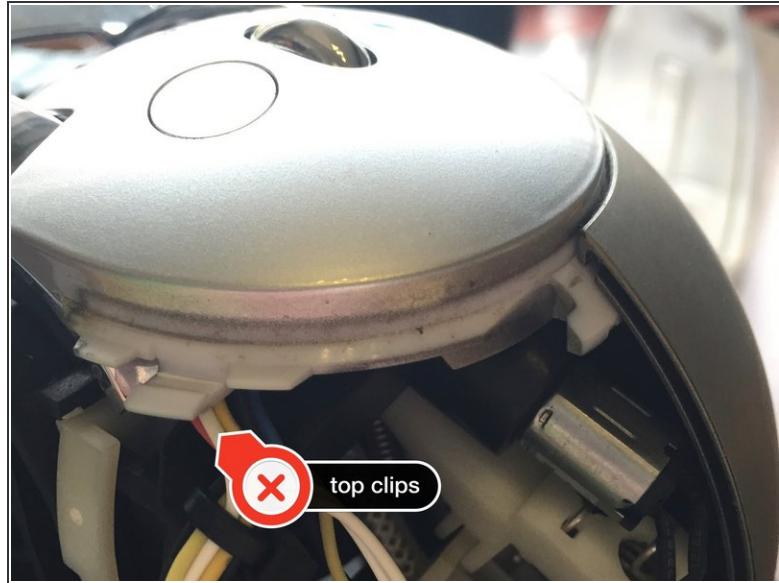
Step 4 — Opening it up (4)

- Now continue with the top part. It is connected at two places, with a big mess of clips and placeholders. Some force might be needed to pull them apart.
- First tackle the bottom row of clips (red arrow)
- Then pry the top row apart (other red arrow)
- You can now remove the entire left side and put it aside

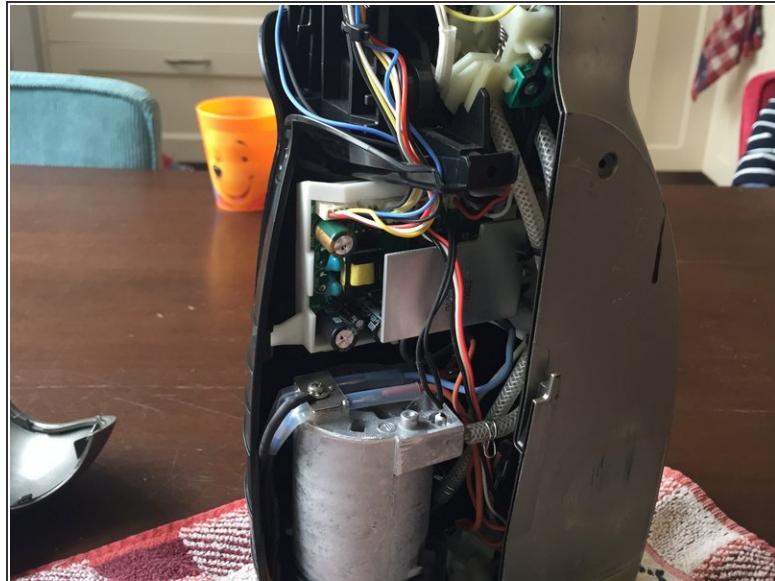
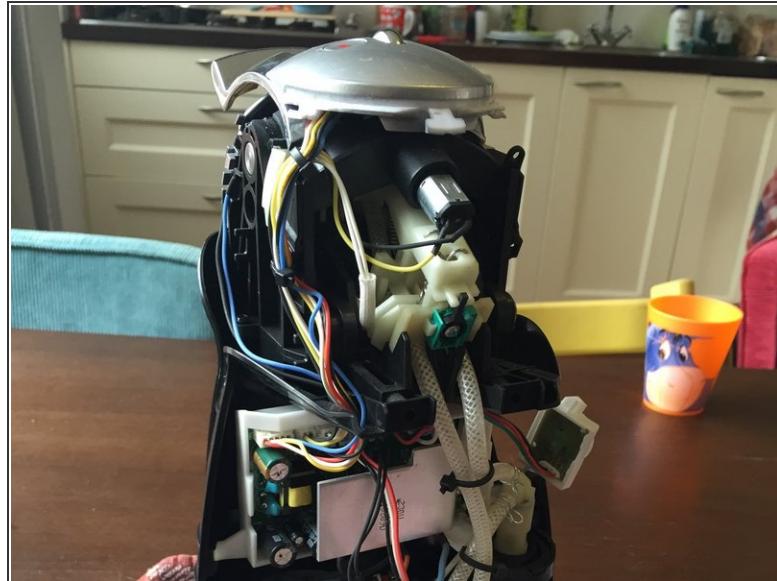
Step 5 — Opening it up (5)

- Remove the right side following the same procedure as for the left side. Once the right side is fully loosened, disconnect the power button from the panel. It is held in its place by two small clips, which are easily loosened with the flathead screwdriver or spludger.
- We now have full access to the penguin's innards!

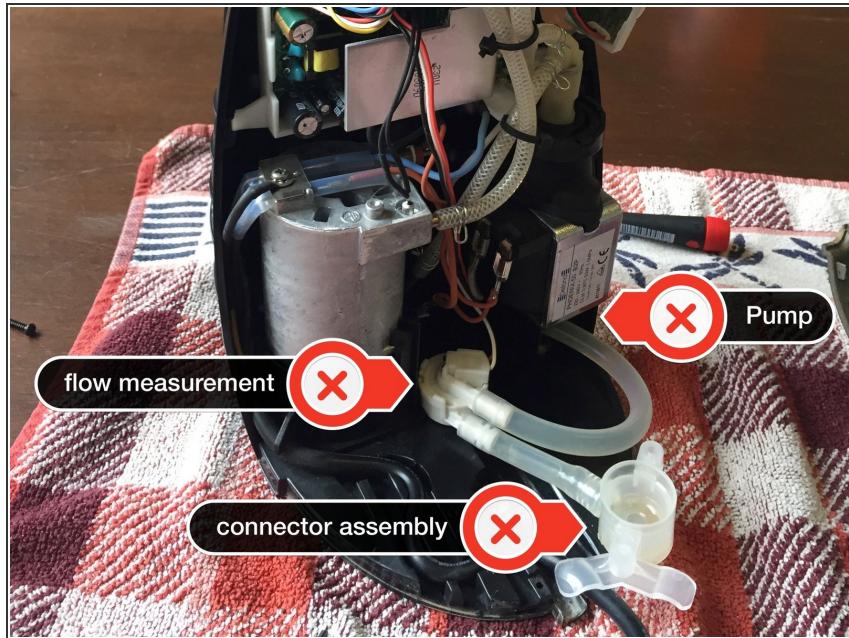
Step 6 — Identifying the leak

- There are three common places for the leak to occur. The flow rate measurement, the connector assembly to the water tank and the pump assembly.
- To identify which of those is leaking, simply look for water where it's not expected. All couplings should be fully dry.
- Of the three common places of leaks, most stem from calcification of the connector assembly. Since the standard decalcification methods (with the satches) doesn't touch these parts, it easily gets clogged up and water leaks in between the sealings.
- When one of the couplings did fail, or the flow measurement or connector assembly is cracked, replace those parts first

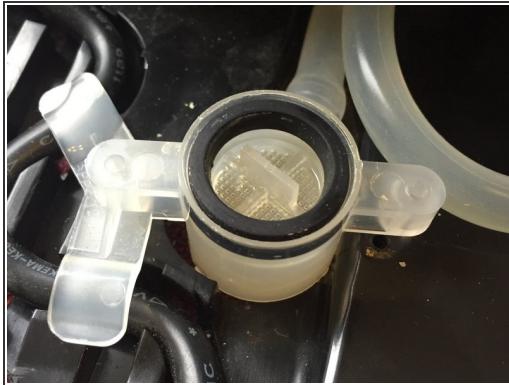
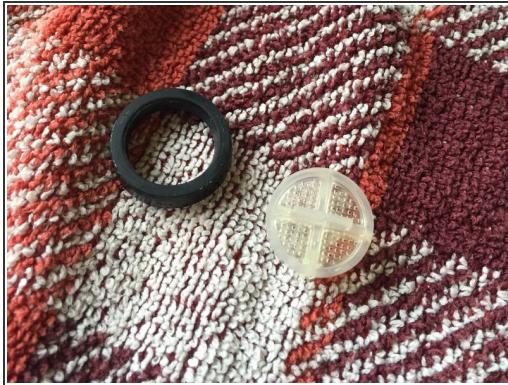
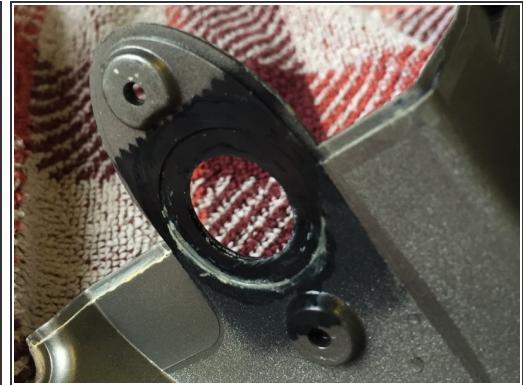
Step 7 — Cleaning the connector assembly

- Loosen the connector assembly. It is not glued or held back by clips, so a slight wiggle is enough to pull it.
- Pull out the sealing rubber and filter
- Carefully but thoroughly clean the housing, the seal and the filter of any calcified remains.
- Clean the underside of the housing where the assembly is connected to the housing. Remove all calcified remains from here as well
