How to Fix iPhone 7 No Service

iPhone 7 No Service Troubleshooting Tips

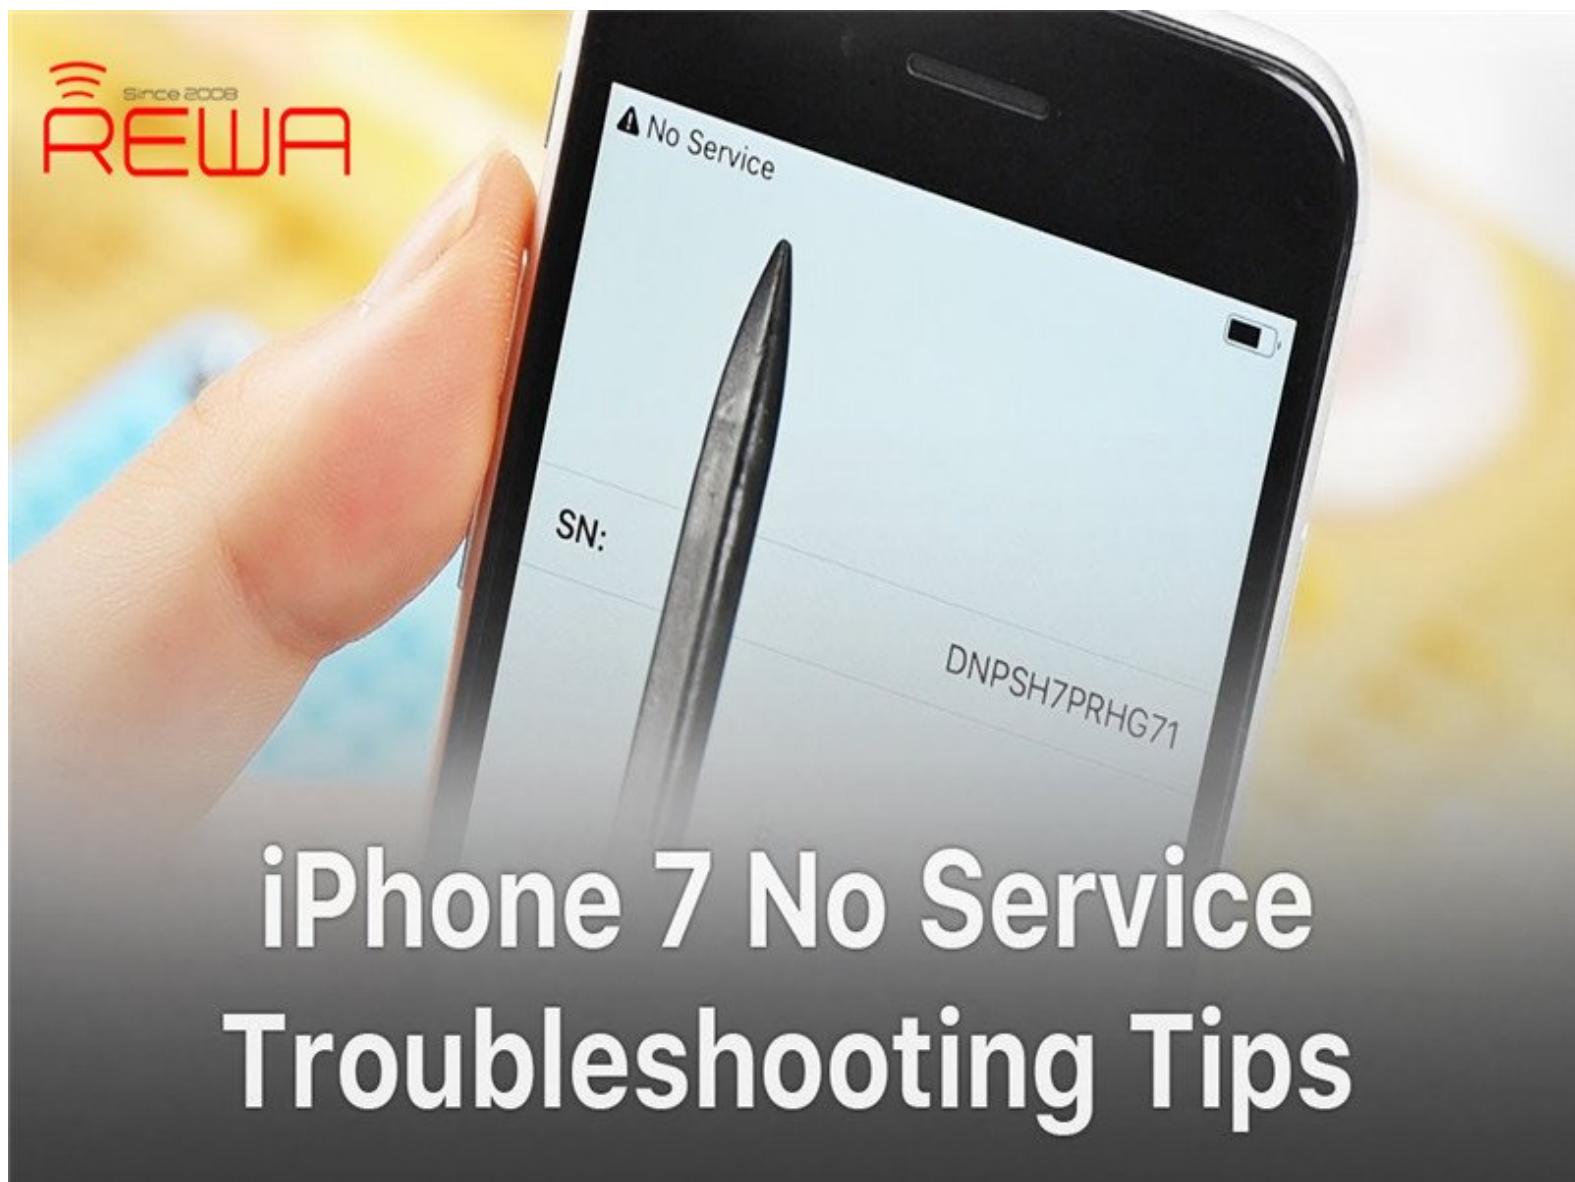
As a common issue of iPhone 7, No Service is mainly caused by two reasons. The baseband PMU has been pseudo soldered. Or, the baseband CPU has shorted. For pseudo soldering problem, we can fix it by re-soldering the baseband PMU. As for the shorted baseband CPU, since the baseband CPU cannot be replaced alone, we need to replace CPU, baseband CPU, and baseband PMU at the same time. Or, we can just replace the logic board.

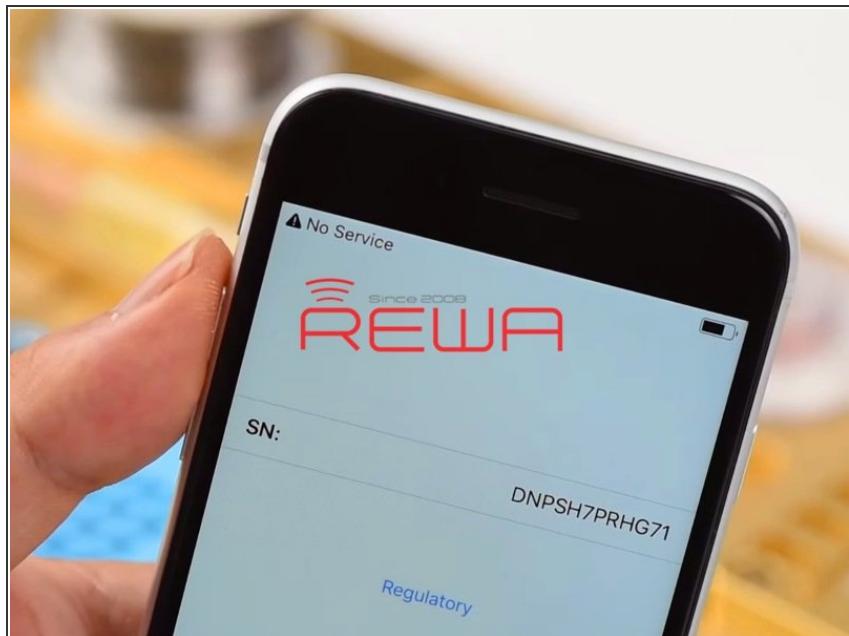
Step 1 — Fault Analyzing

- Hold the power button to turn on the phone. The phone goes with activation process.
- Click the icon at the bottom right corner. Serial number displays normally on the screen. No IMEI number on the screen. The phone shows a No Service error in the upper-left corner.
- Judging by this, the baseband circuit has malfunctioned.

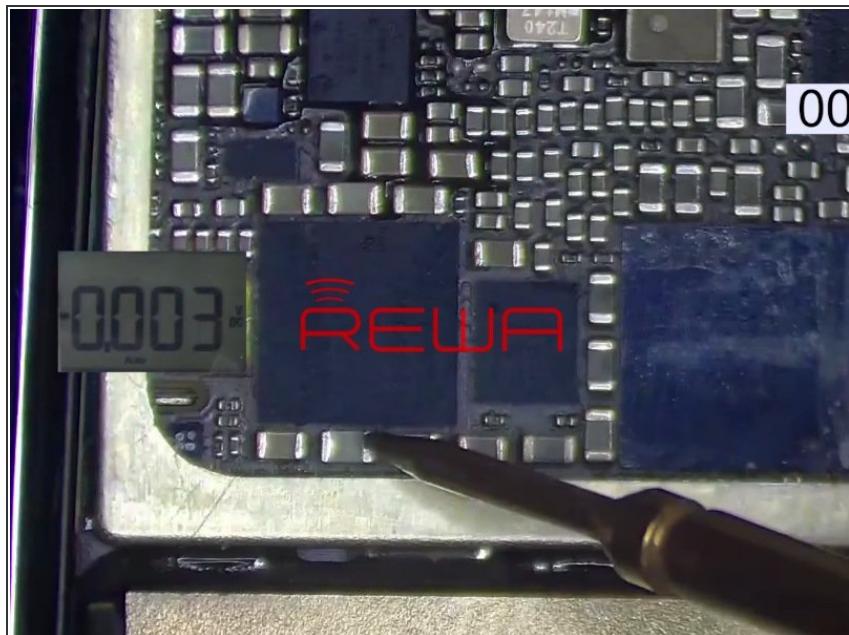
Step 2 — Repair Thoughts Of A Beginner

- Measure the boot current. Current reading on the ammeter is normal.
- First, let's measure the power supply of baseband PMU. There is no voltage value measured on C5630 and C5703. Which indicates that the power supply of baseband PMU is abnormal.

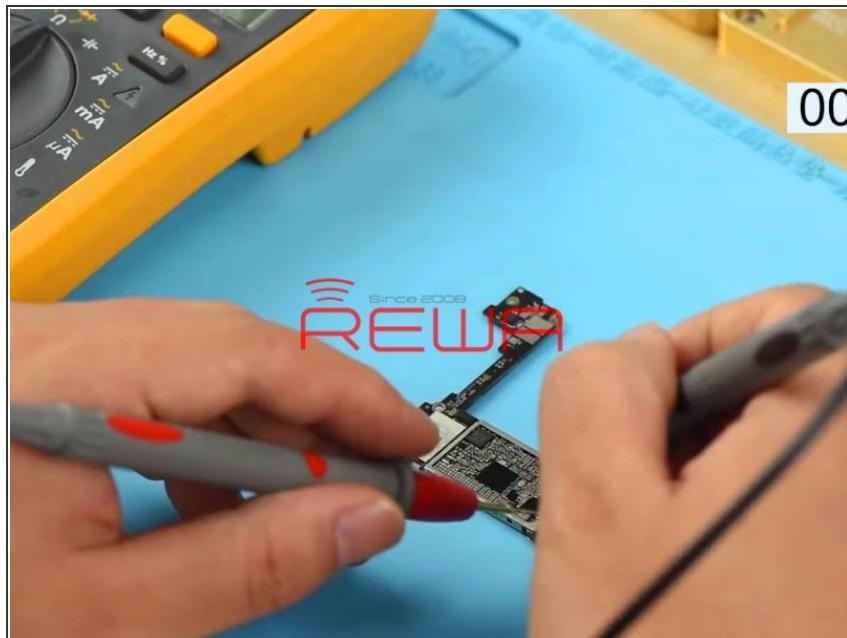
Step 3

- Continue to run diode mode measurement of C5630 and C5703.
- Judging by the measured value, C5630 and C5703 have shorted.

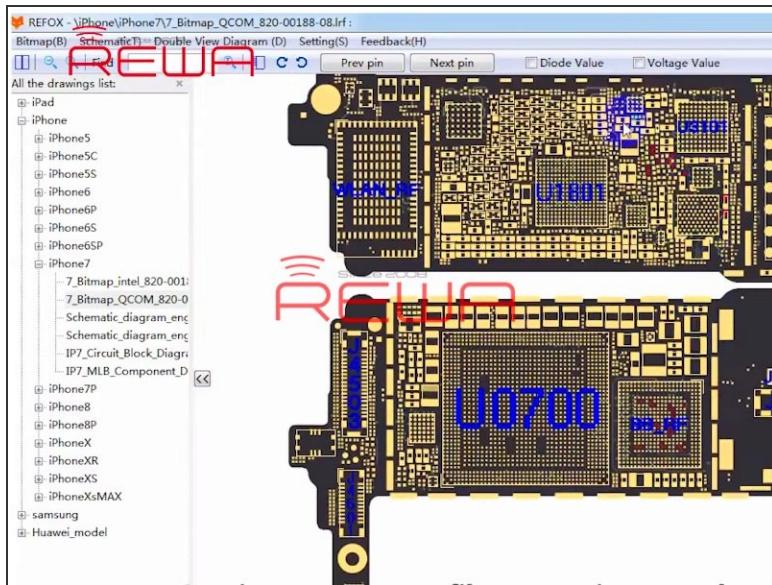
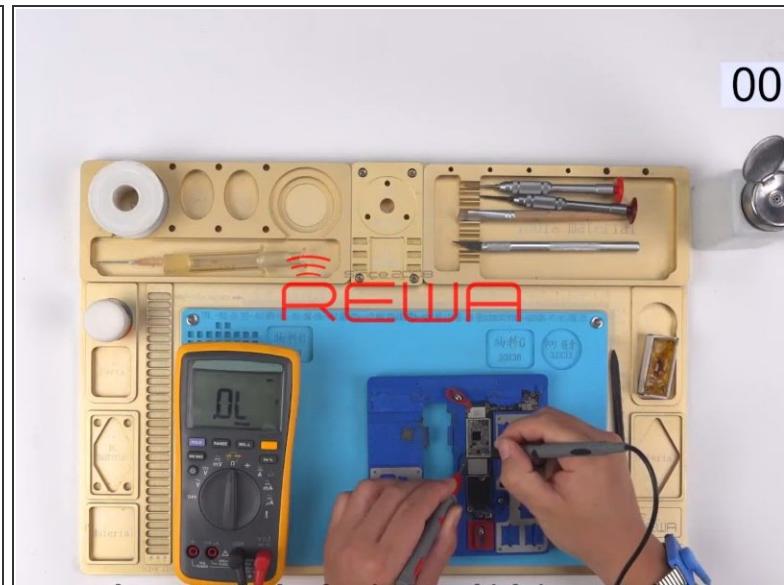
Step 4

- Refer to [Refox](#). We can see that the circuit related to C5630 and C5703 consists of the baseband PMU, the baseband CPU and multiple filter capacitors.
- Let's start with the baseband PMU.
- Remove the baseband PMU with Hot Air Gun. Again, run diode mode measurement of C5630. Judging by the measured value, C5630 has shorted.
- Which indicates that the baseband PMU is not the faulty component.

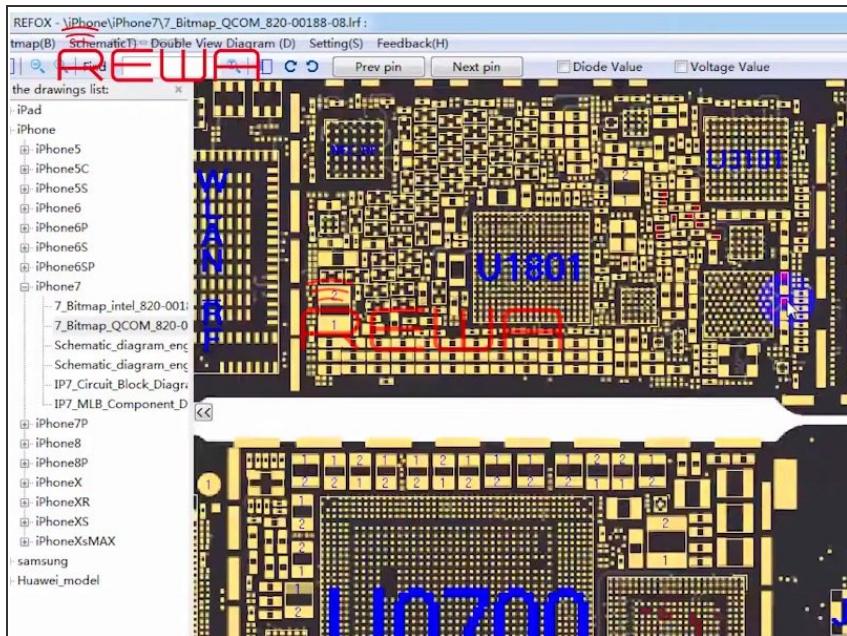
Step 5

- Continue to remove filter capacitors on the circuit with Hot Air Gun and run diode mode measurement of C5630's bonding pad.
- The measured value indicates a shorted condition.
- So these filter capacitors also have nothing to do with the fault.

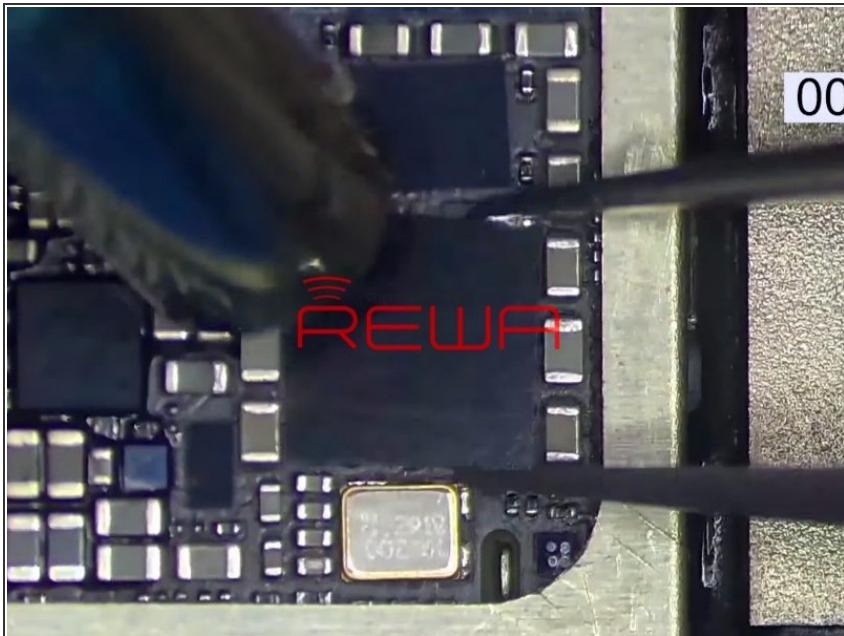
Step 6

- Continue to remove the baseband CPU with Hot Air Gun. Then run diode mode measurement of C5630's bonding pad. The measured value is OL, which is normal.
- We can confirm now that the fault is related to the baseband CPU.

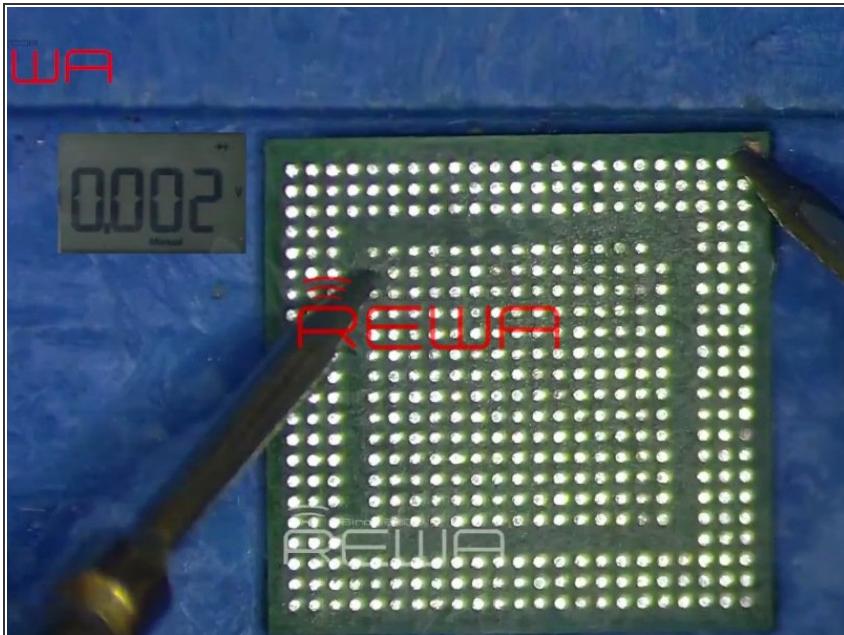
Step 7

- Run diode mode measurement of the detached baseband CPU. Judging by the measured value, the baseband CPU has shorted.

ⓘ As we all know, the baseband CPU cannot be replaced alone once damaged. We need to replace CPU, baseband CPU, and baseband PMU at the same time.

ⓘ Or we can fix the problem by replacing the logic board. In this case, there is no need to proceed with the repair.

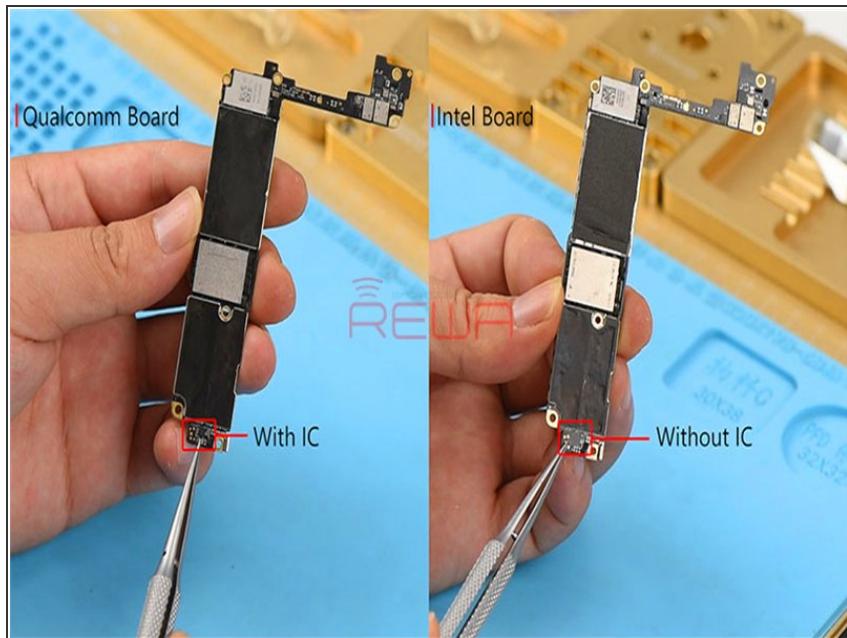
Step 8 — Repair Thoughts Of An Experienced Technician

- First, confirm the version of the logic board.
- We are dealing with a Qualcomm version logic board.

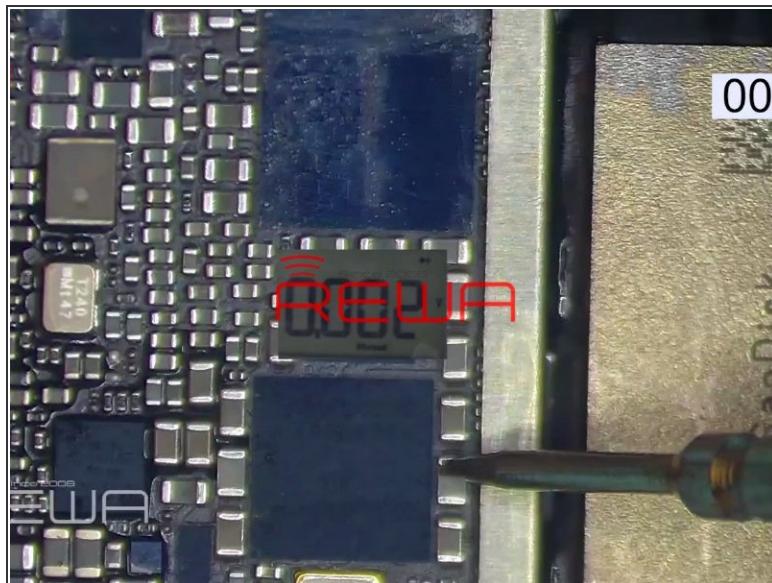
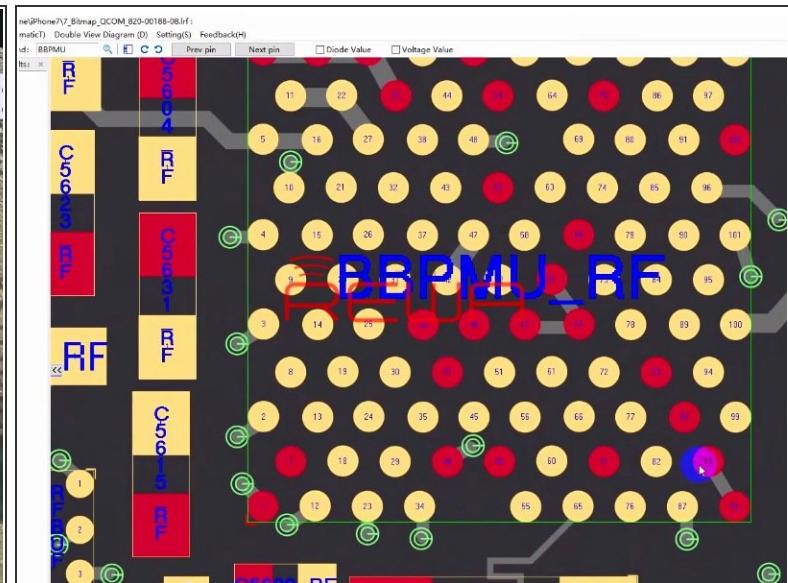
Step 9

- Run diode mode measurement of C5630 or C5703. The measured value is 0. Judging by this, the baseband CPU has shorted.

⚠ Due to the PCB design defect of iPhone 7 Qualcomm logic board, bonding pads of Pin 93 and Pin 98 of baseband PMU are easy to fall off. Which results in the abnormal voltage and large current flowing outputted from the baseband PMU to the baseband CPU and then the burnout of the baseband CPU.

- In this case, there is no need to proceed with the repair. You can just replace the logic board.
