How to Fix iPhone X Face ID Not Available

Due to the vulnerability of the Face ID parts, it can be easily damaged when the phone is dropped or during screen replacement. Today let's see a repair case about iPhone X Face ID Not Available caused by broken flex cable of the Face ID parts. This is also a reminder. Please be careful in your daily use of the phone! To fully understand Face ID, you can also check [Face ID Teardown](#) here.

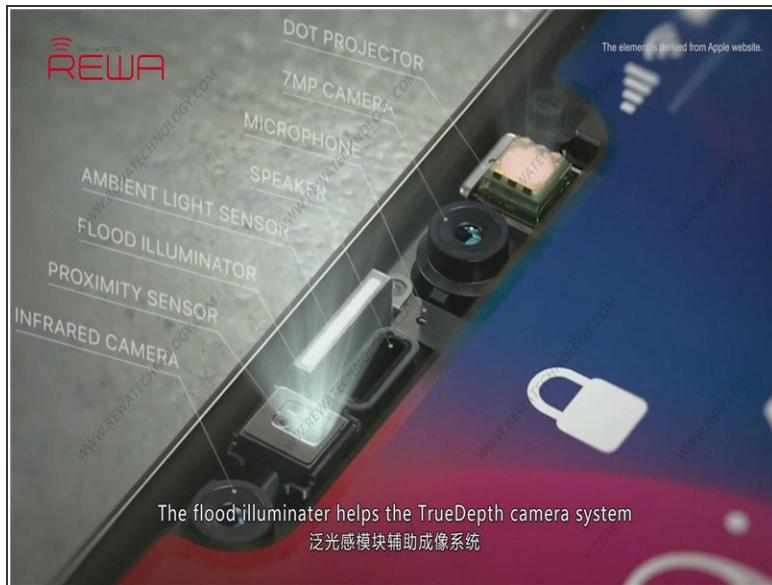
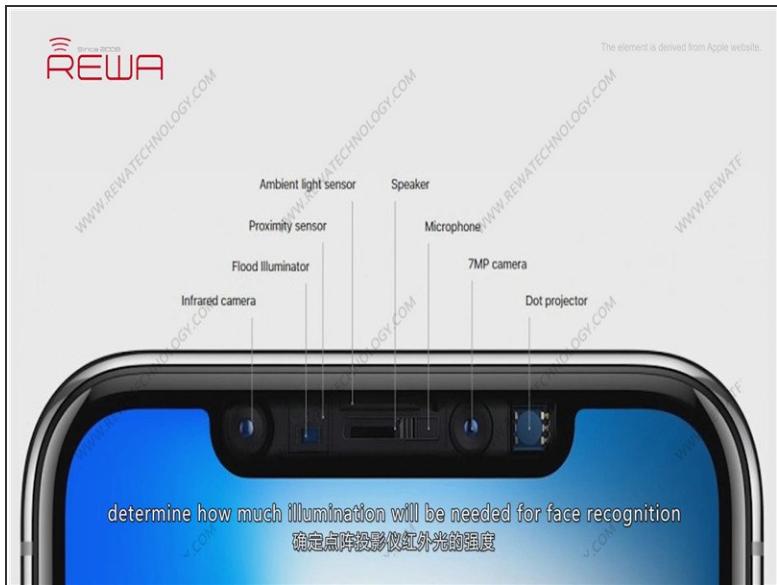
Step 1 — How Does Face ID Work

- With user's face closing to the screen, the proximity sensor starts the recognition process. The flood illuminator helps the TrueDepth camera system determine how much illumination will be needed for face recognition.
- The dot projector projects over 30,000 dots in a known pattern onto the user's face. Those dots are then photographed by infrared camera for analysis.
- A 3D map of user's face are then completed. The 3D model is then compared against the stored template. The phone authenticates the identity and unlocks or authorizes a payment.

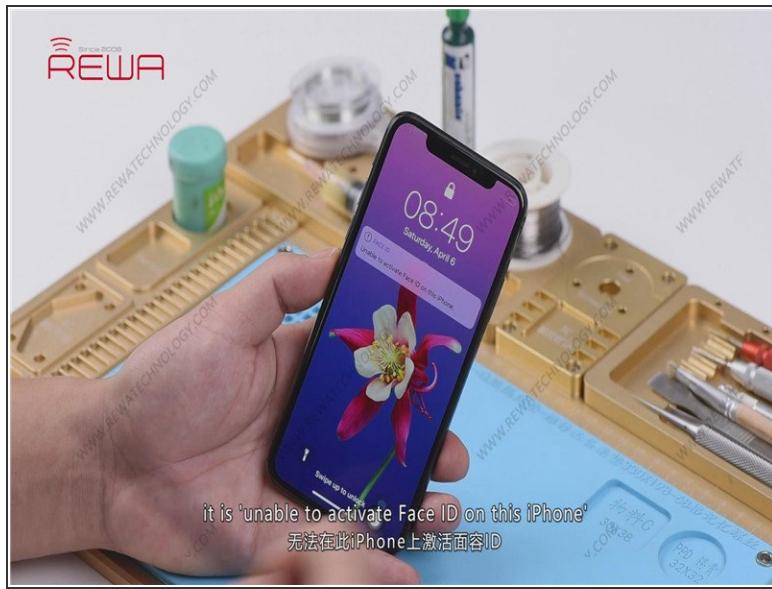
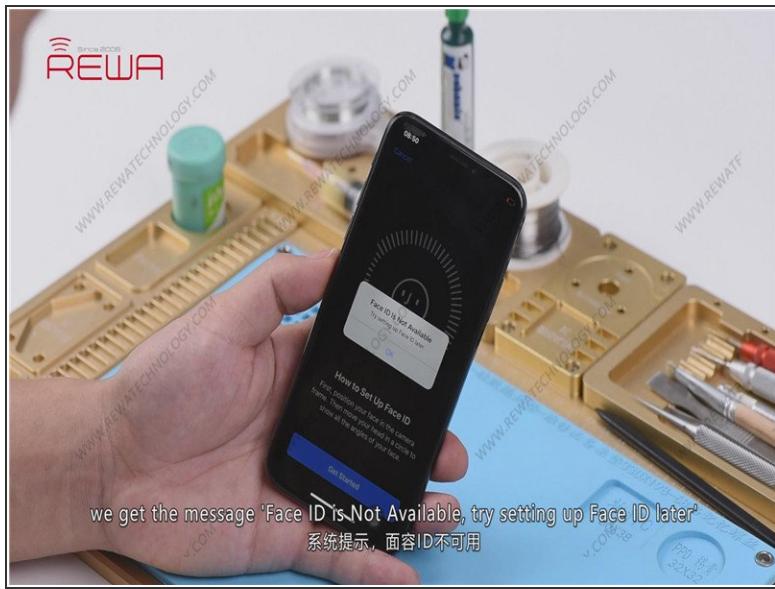
Step 2 — Test

- The iPhone X shows an alert that says it is 'unable to activate Face ID on this iPhone'.
- When trying to set up Face ID on the iPhone X, we get the message 'Face ID is Not Available, try setting up Face ID later' .
- Judging by this, Face ID relevant circuit has probably malfunctioned. We need to check components on Face ID relevant circuit

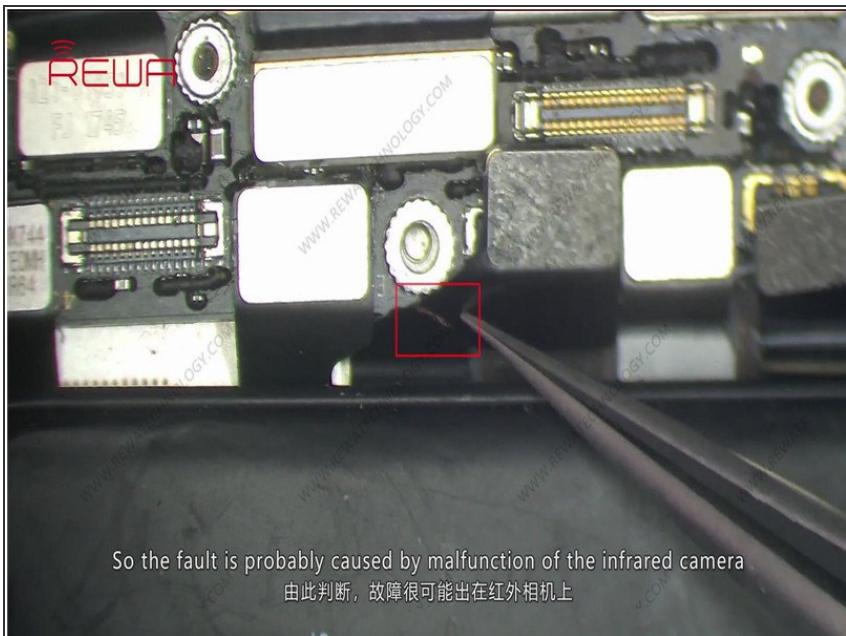
Step 3 — Diagnose

- We can see that the infrared camera module flex cable is broken.
- So the fault is probably caused by malfunction of the infrared camera.
- Remove the Face ID parts. We can see clearly that the infrared camera module flex cable is broken.

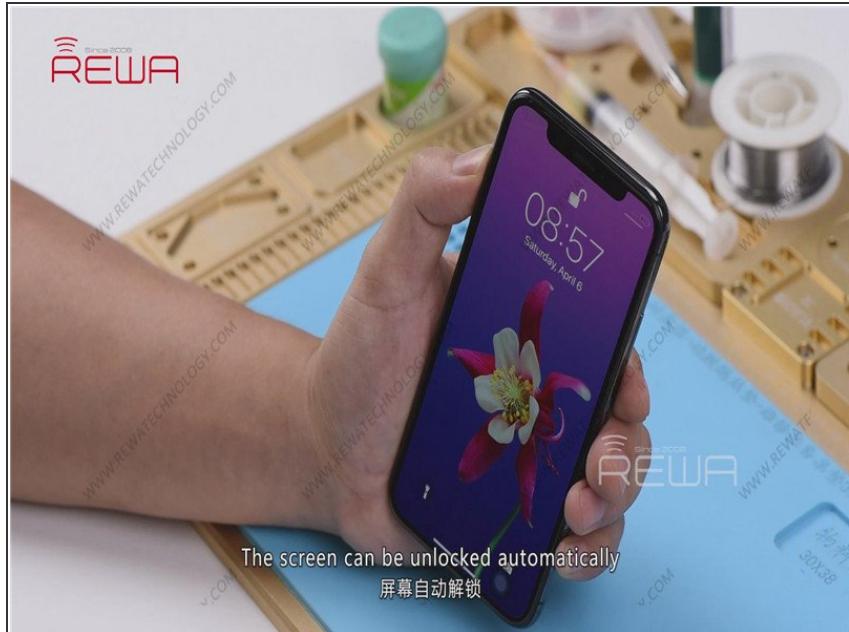
Step 8 — Test

- Face ID can be set up successfully. The screen can be unlocked automatically. Fault cleared.
