How to Repair an Internal Leak in the Steam Wand of a Starbucks Barista

This guide will help you quickly fix an internal leak in the steam wand of the Saeco SN006 model.

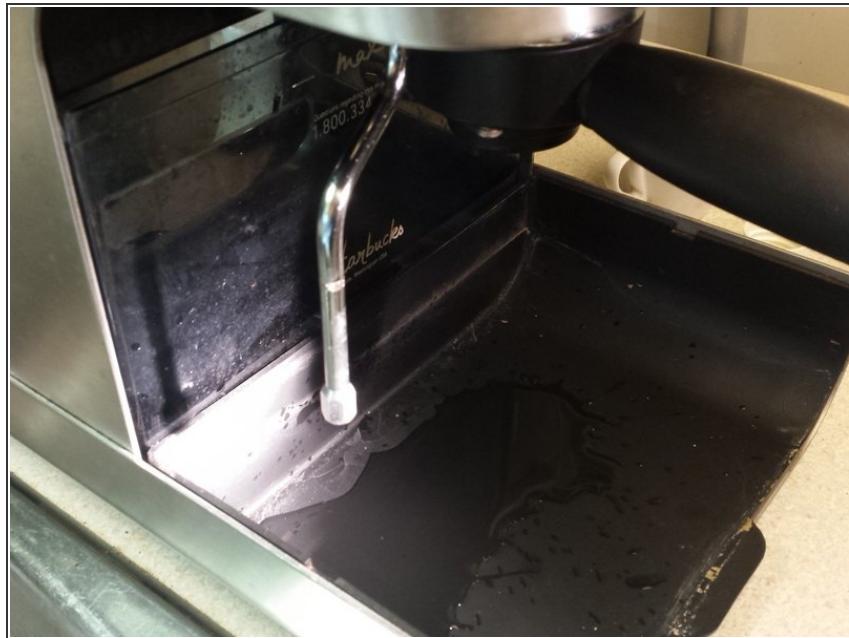
Step 1 — How to Repair an Internal Leak in the Steam Wand of a Starbucks Barista

- When there is water leakage from the steam valve, there are 2 sources, external and internal. External leaks are a matter of replacing bushings and shown elsewhere. This guide shows how to deal with internal leakage. First, descale the machine with a commercial product, like Dezcal. Unplug the machine from the power source then follow the steps:

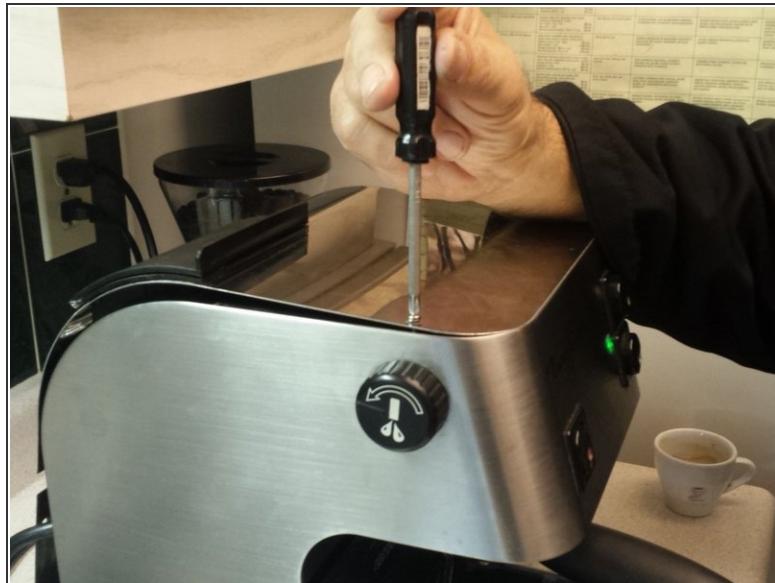
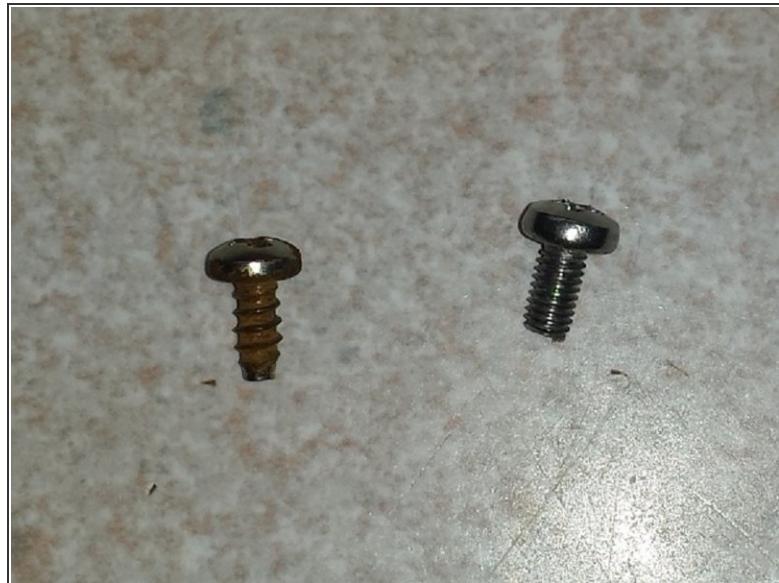
Step 2

- Remove the six screws holding down the cover. Note that the top screws have fine threads, while the four lower screws have coarse threads. Keep this in mind for later reassembly. Once the screws are off, remove the cover.

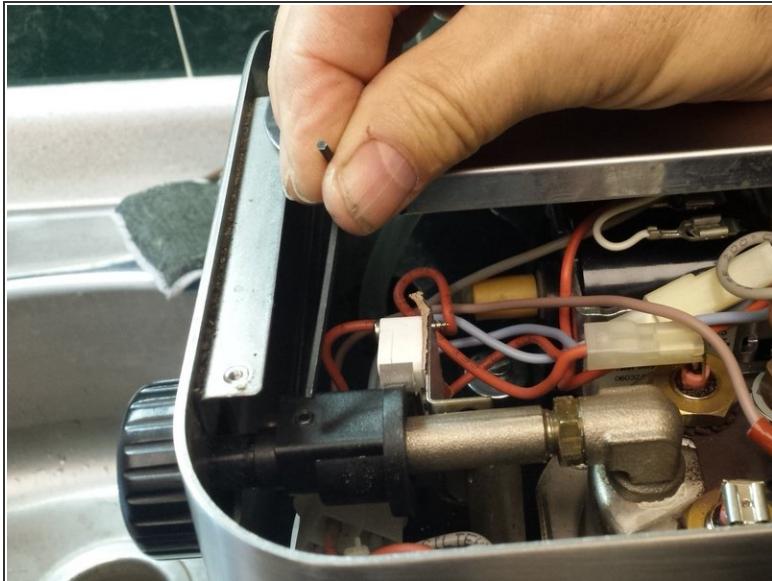
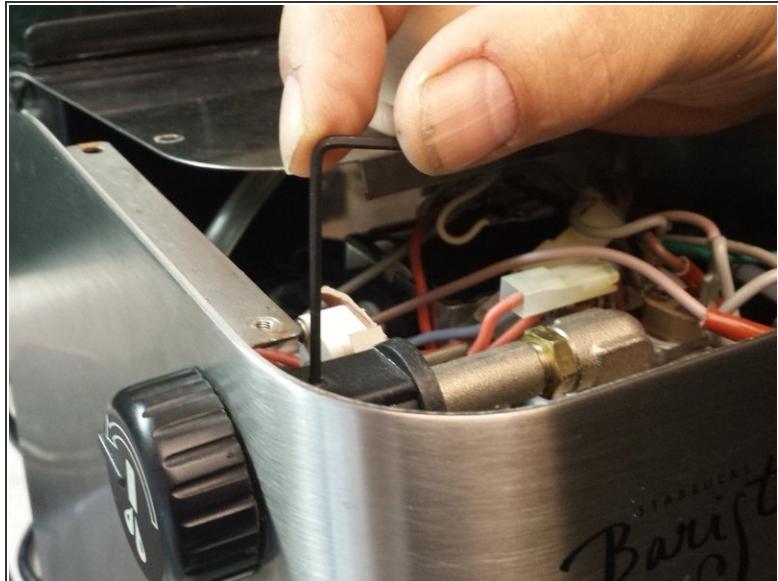
Step 3

- Note where the steam valve knob connects to the valve assemble, at the top is a small hex nut. Use the 2mm hex wrench to loosen the nut by turning it counter clockwise, about 1/4 turn. Hold on to the wrench, keeping the steam knob shaft in the upright position.

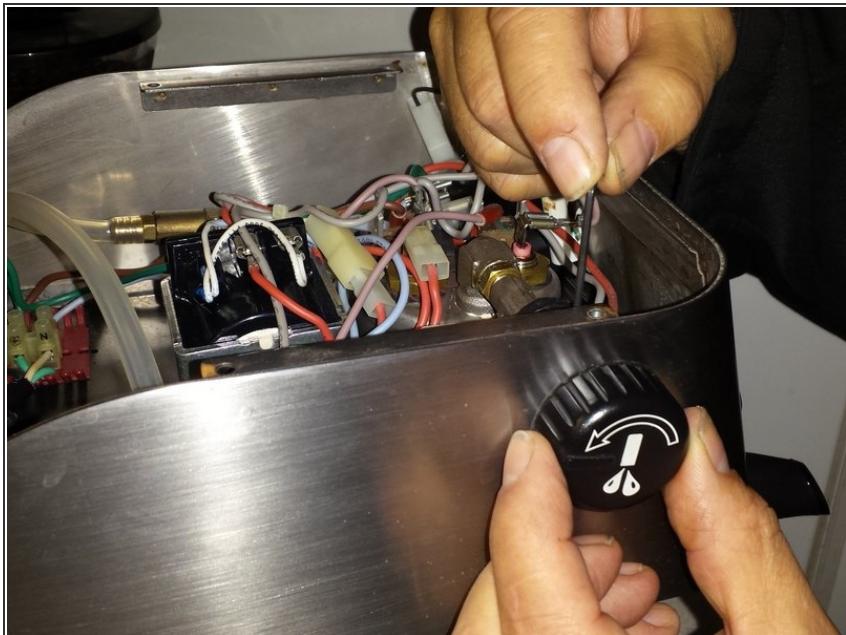
Step 4

- Now, while bracing the hex wrench, turn the steam valve knob slightly in a clockwise direction, perhaps 1/8th of a turn or less. This is compressing the seat of the steam valve plunger to close off the water leak when the machine is on.

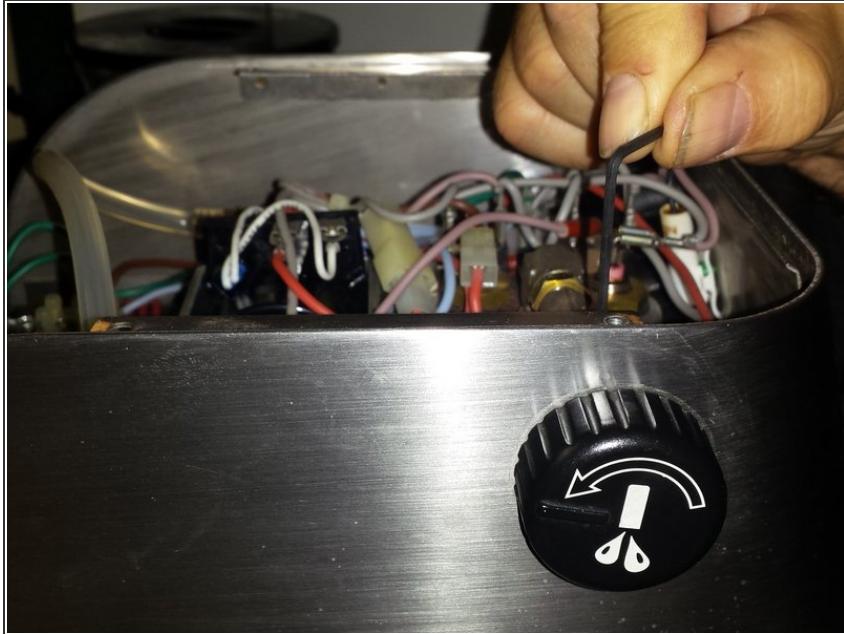
Step 5

- Tighten the hex nut firmly.

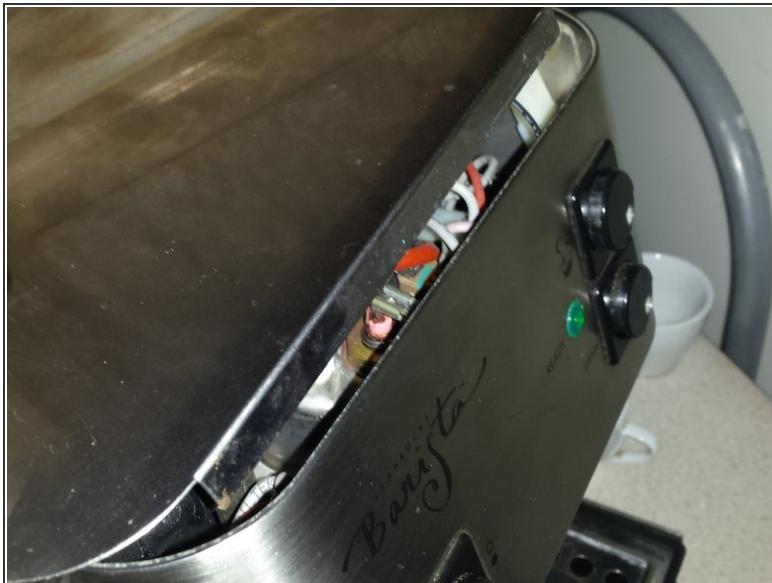
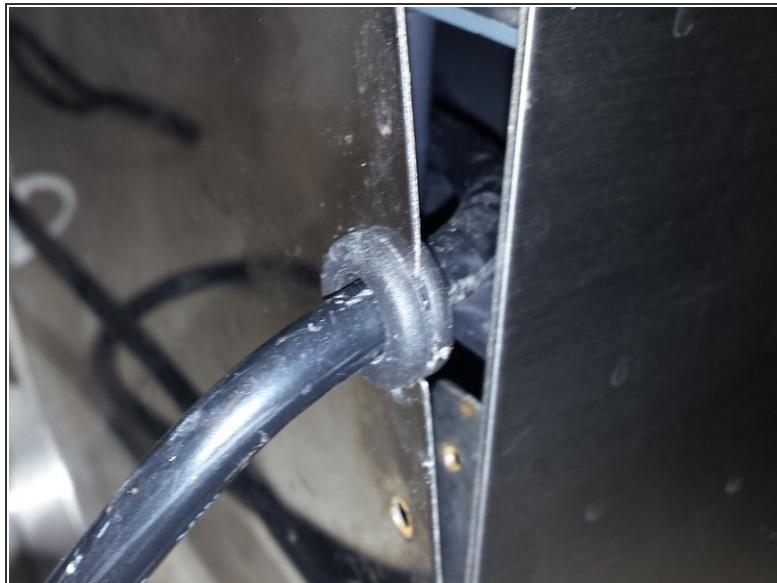
Step 6

- Replace the cover, making sure the steel lip at the front is in its slot, and that the black plastic bushing is in place at the back of the cover. Replace two of the six screws, to save time in case you have to repeat the process.

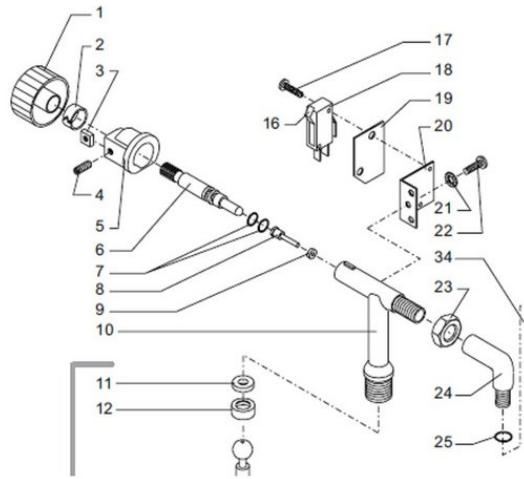
Step 8

- If the steam wand is still leaking after a second try, then the steam valve plunger needs to be replaced. This is part number 8 on the schematic. Overhaul kits can be acquired from sources like espressocare.com. You can follow the tear down instructions on this site, or some of the video sources on youtube.com.

If the wand still leaks after trying this, a more detailed repair is required.
