How to fix problem with 2010 Mazda 5 (3) air conditioner magnetic clutch

Mazda 5 2010 air condition is periodically failing. Cleaning the magnetic clutch solves the problem.

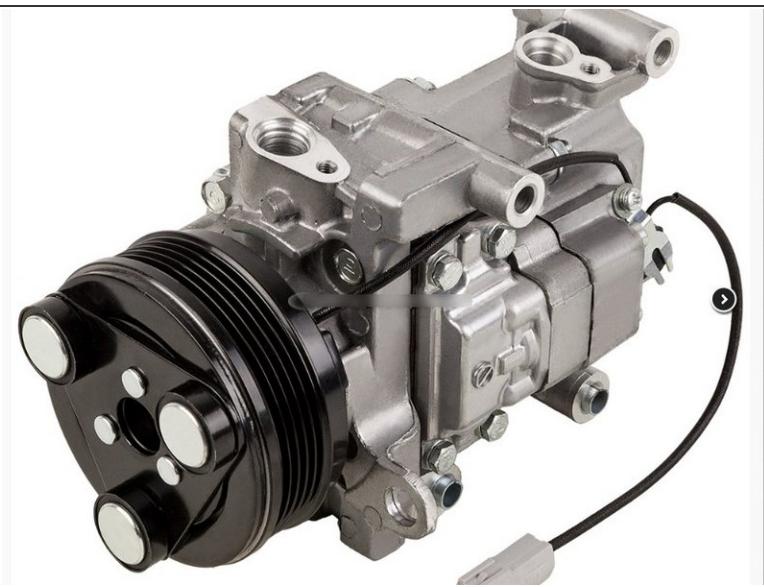
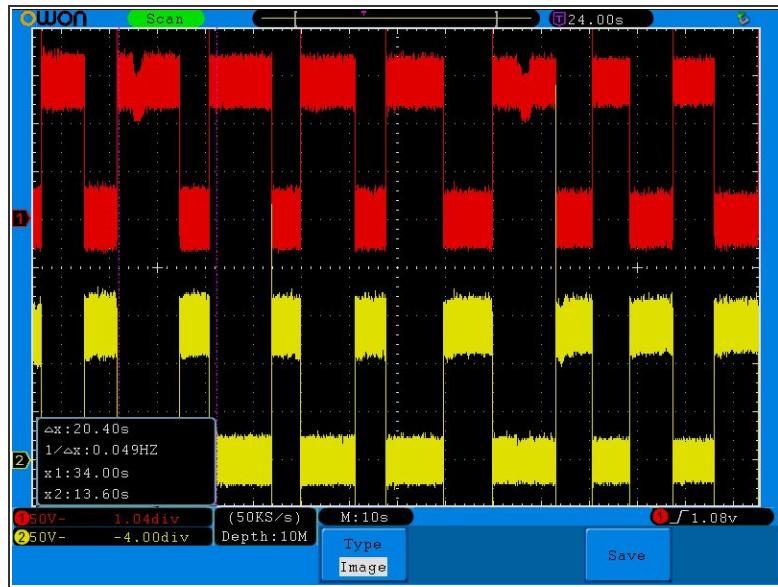
Step 1 — Identifying the problem

- The aircondition is under normal conditions not running permanently, but it is running in intervals, e.g. on for 10s and then off for a similar amount of time.
- On colder days, the 'on' period will be relatively shorter. On hot days, the 'on' period will be relatively longer - ultimately permanently on.

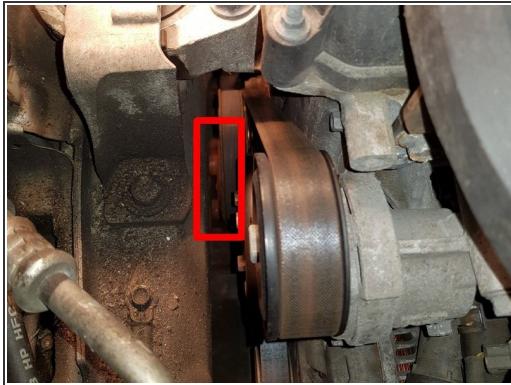
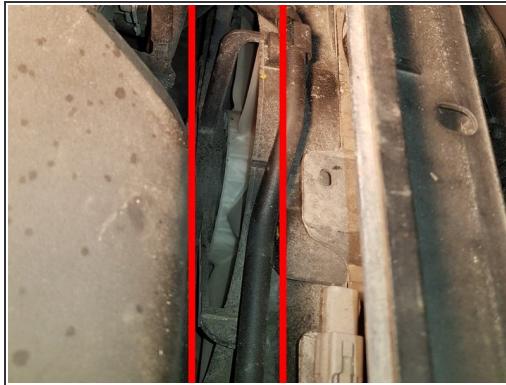
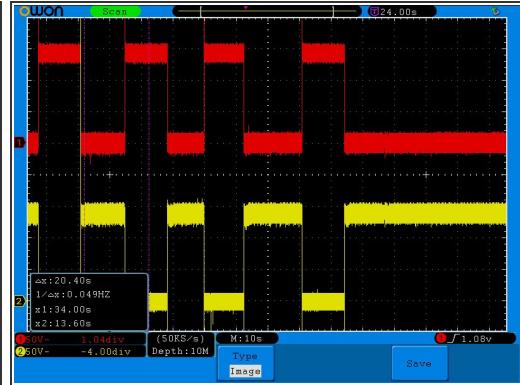
Step 2 — The magnetic clutch and the fan

- When the aircon computer signals 'on', the magnetic clutch will engage and thereby activate the aircon compressor.
- Whenever the magnetic clutch is engaged, the cooling fan is also activated (at least on my Mazda)
- When leaving my the car in idle for around 15 minutes, the aircon suddenly stops working:
 - The magnetic clutch stops engaging, though the computer is telling it to activate (see oscilloscope dump)
 - The cooling fan is permanently on, suggesting that the clutch should also be engaged, which it obviously is not.
- Stopping the car, and letting it cool down for a while (30 minutes?) will normally make the magnetic clutch engage again.

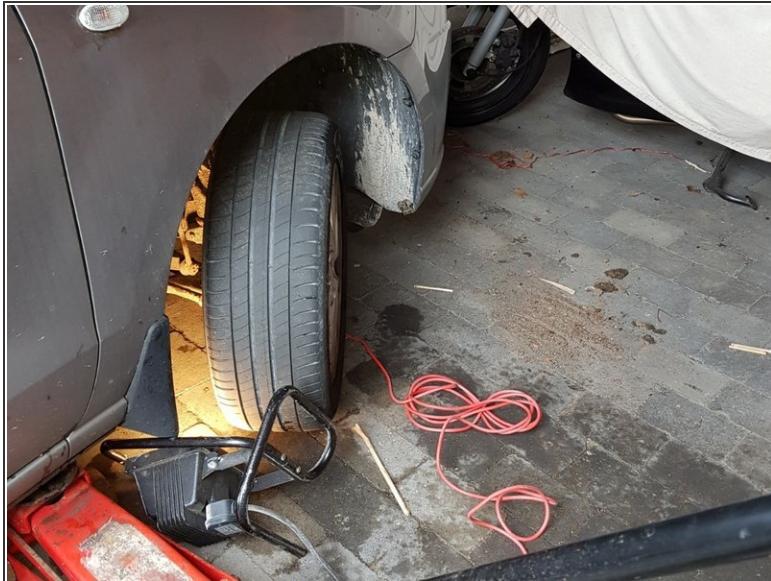
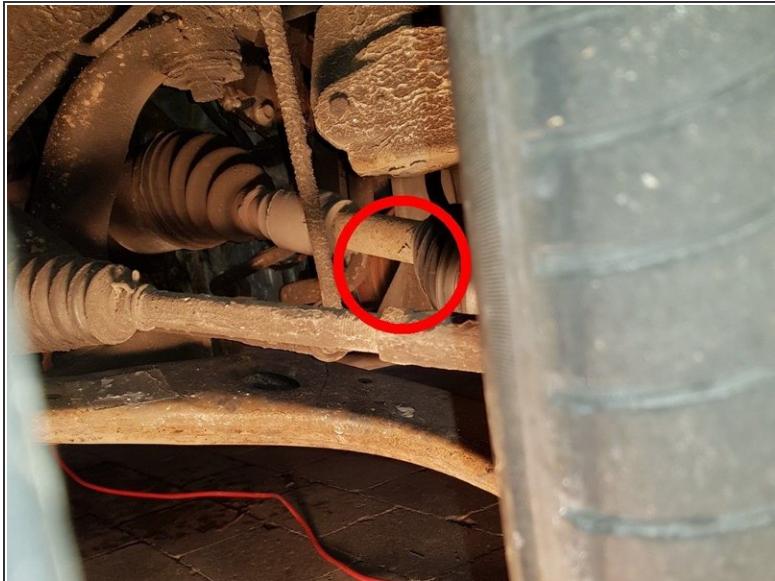
Step 3 — Testing the hypothesis

- So the suspicion is, that the clutch is actually activated by the aircon computer, but for some reason the clutch is unable to engage.
- By turning front wheels, it is possible to partly see the magnetic clutch (it is in the red circle on the photo).
- With a small stick (I used a bamboo stick) I can carefully, but firmly, poke the clutch, and thereby helping it to engage. Be careful - there are a lot of moving parts in there...
- Shortly after the clutch is engaged and cooling is ongoing, the aircon computer will release the clutch again (like during normal operation)
- Next time the aircon computer tries to engage the clutch, it will fail. Again it is necessary to poke it with the stick, to make it engage.
- The above indicates that something is obstructing the normal operation of the magnetic clutch.

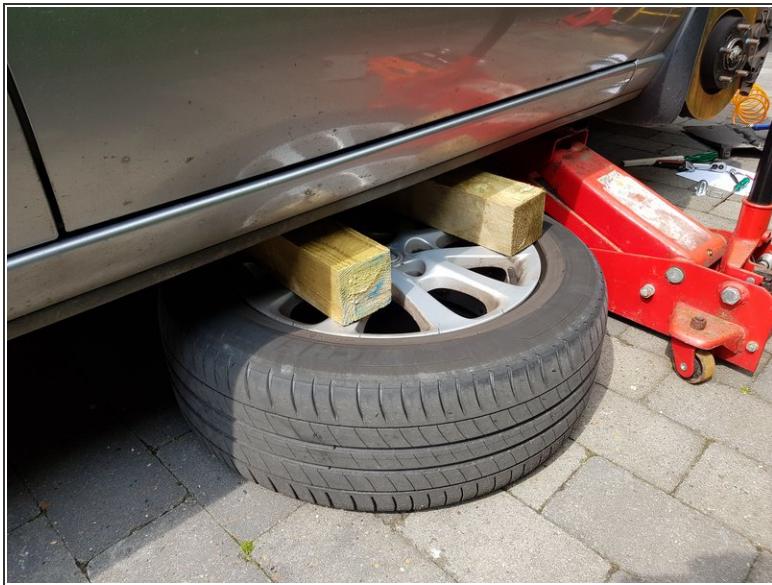
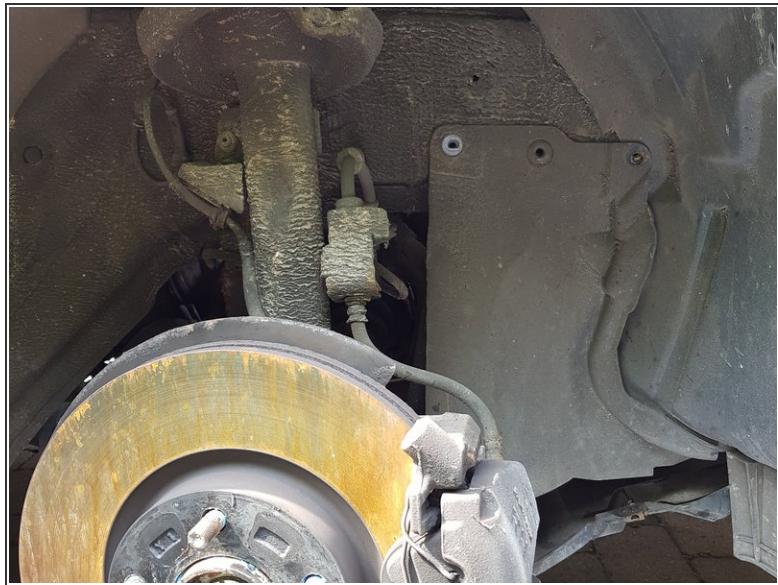
Step 4 — Is the magnetic clutch stuck?

- The magnetic clutch should apparently be able to move a little when you pull/push it with your hands - mine is completely stuck. This video demonstrates this, and it also demonstrates the "poking with a stick" trick. <https://www.youtube.com/watch?v=Hqp9lJ2i...>
- To get better access to the magnetic clutch, lift up the car and remove the right hand front wheel. Place the wheel under the car as a safety precaution.
- Behind the brake disc you can see a plastic shield that is easily removed to access the clutch

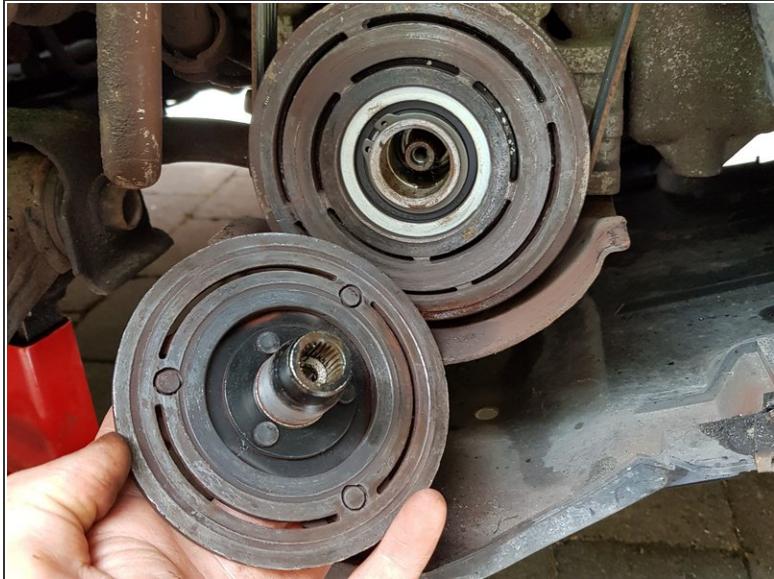
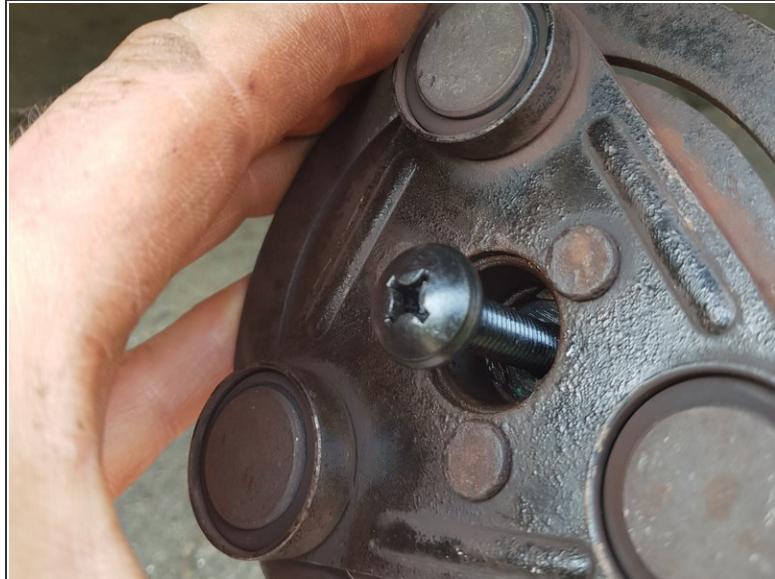
Step 7

- Though it took a bit of brute force to get the plate free, it did not suffer any visible damage. You can barely see the shims inside - be careful not to lose them.
- It was only after I got the plate loosened, that I noticed that it is actually threaded to allow a bolt being screwed in. This could probably have been handy when loosening the clutch plate.

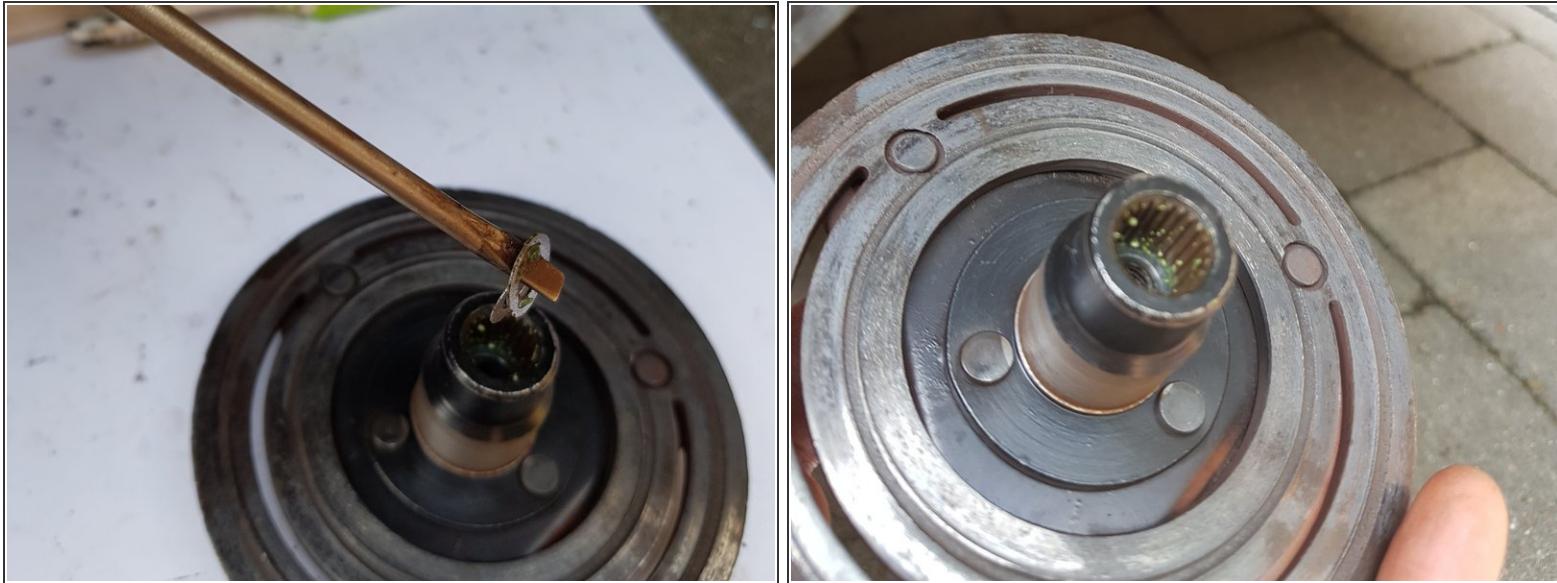
Step 8

- Be careful to get the shims out, so they are not accidentally lost. My clutch had 2 shims.
- Inside the clutch plate, I could see bits of green/corroded debris.

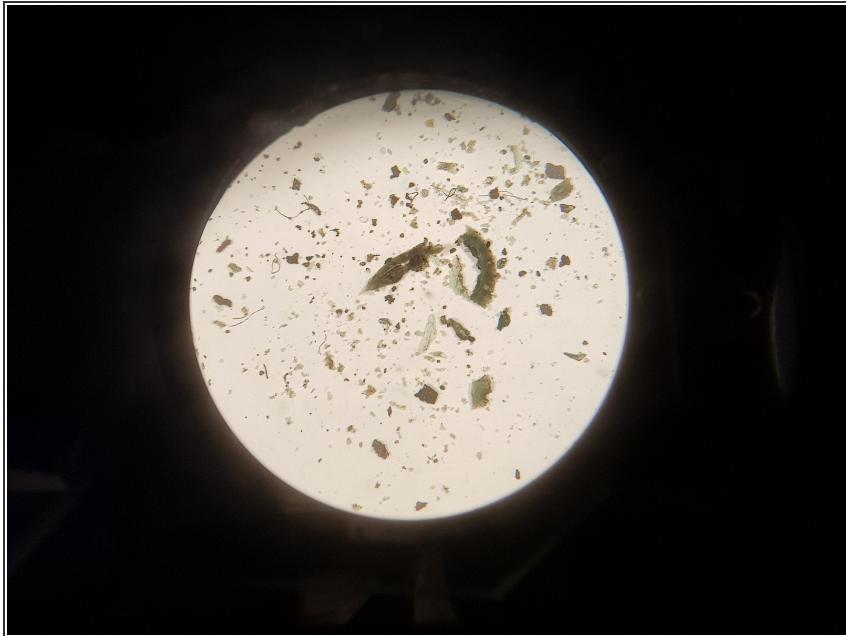
Step 10

- Microscope (4x) view of the debris. I cannot tell where it originates from.
