# Huawei Watch GT Repairability Assessment

Repairability assessment for the Huawei Watch GT from June 2019

Repairability assessment of the Huawei Watch GT, performed July 2019. The model assessed is a black stainless steel FTN-B19.

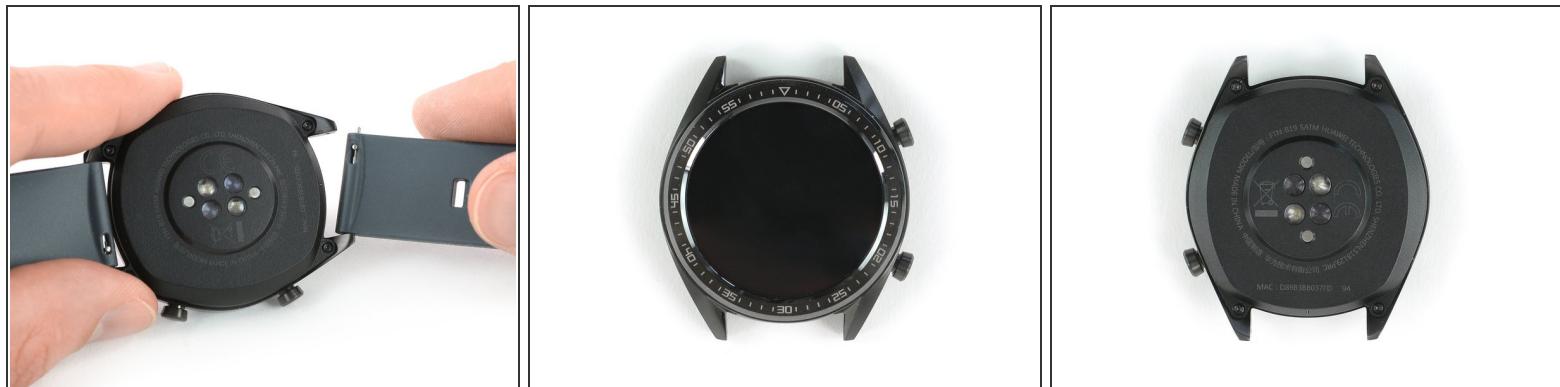
## Step 2

- Two spring bar pins attach the watchbands to the body and allow for easy removal.
- Reference shots of the front and back of the Huawei Watch GT body.

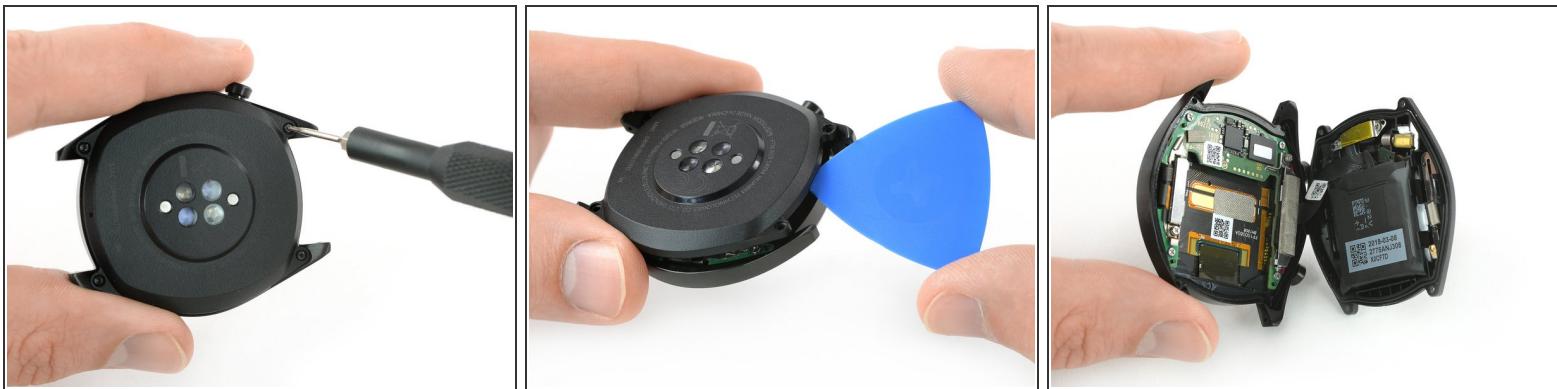
## Step 3

- The plastic rear cover of the Huawei Watch GT is secured by 4 Torx T3 screws (3.6 mm length).
- Applying an opening pick or fingernail to the small notch at the upper edge of the watch is enough to separate the bottom cover.
- At this point it's possible to open the watch but the display and back cover are still connected by a multi purpose interconnect flex cable.

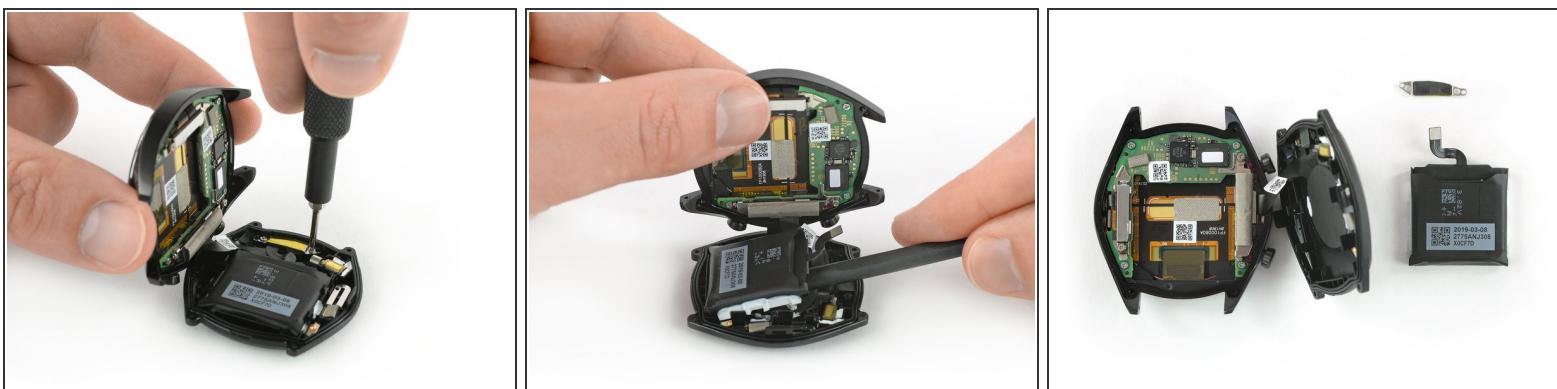
## Step 4

- We go by the book and unplug the battery first by removing two Phillips #00 screws (2.9 mm length) and a metal shield.
- The battery is held in place by mild adhesive and comes out after some gentle heating and prying.

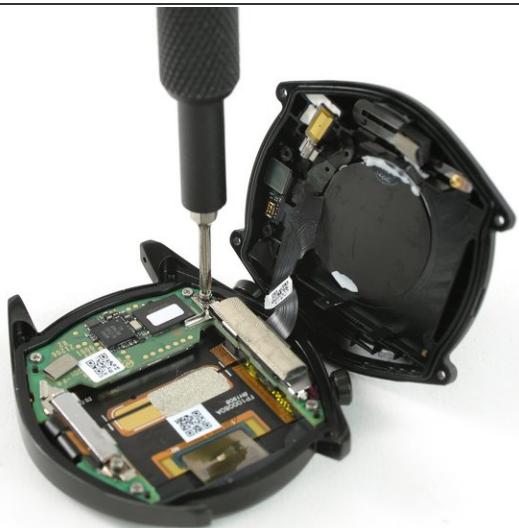
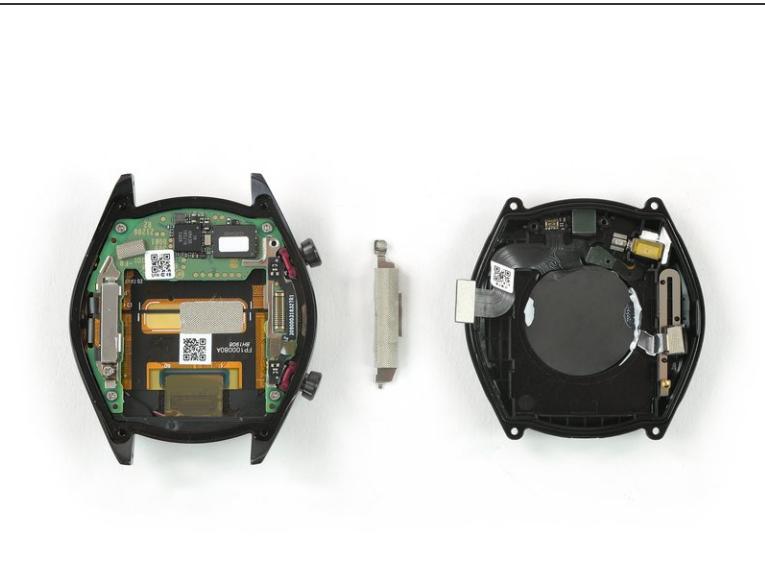
## Step 5

- Unplugging the interconnect cable—carrying the vibration motor and the heart rate sensor—requires removing another pair of screws and a small metal shield.
- *(i)* Seems like the interconnect flex cable can't be removed from the rear cover—bummer.

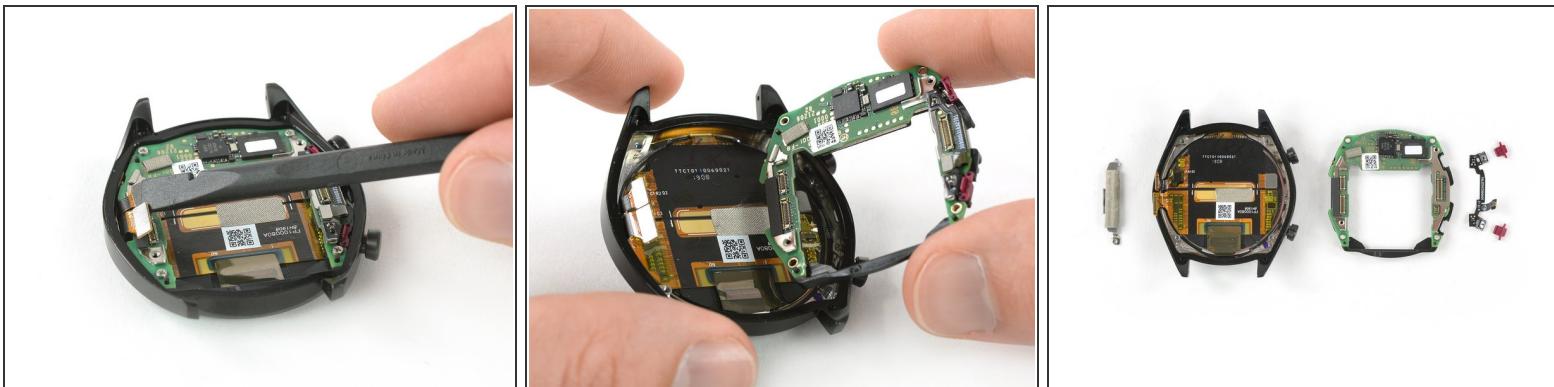
## Step 6

- After removing four more Phillips #00 screws and disconnecting the screen and digitizer connector as well as the side button cable, the motherboard can be removed.
- The flex cable of the two side buttons is glued to the motherboard with mild adhesive and can be peeled off.

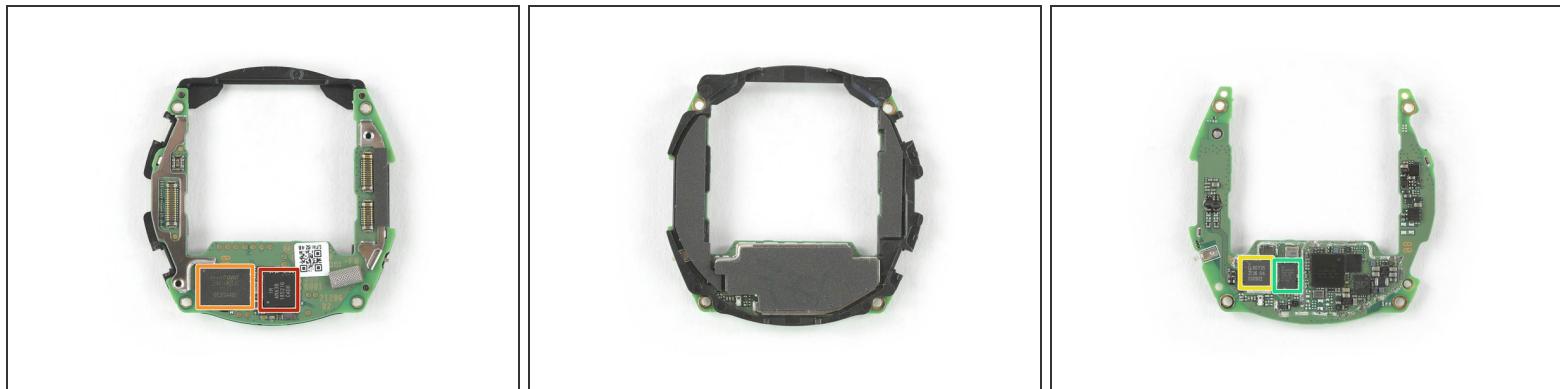
## Step 7

- Ambiq Micro [Apollo3 Blue](#) MCU with ARM Cortex-M4 Processor
- Winbond 1 Gbit serial NAND flash
- NXP 80T35 36 04 SSD902, probably NFC controller
- Broadcom BCM47752 GPS receiver

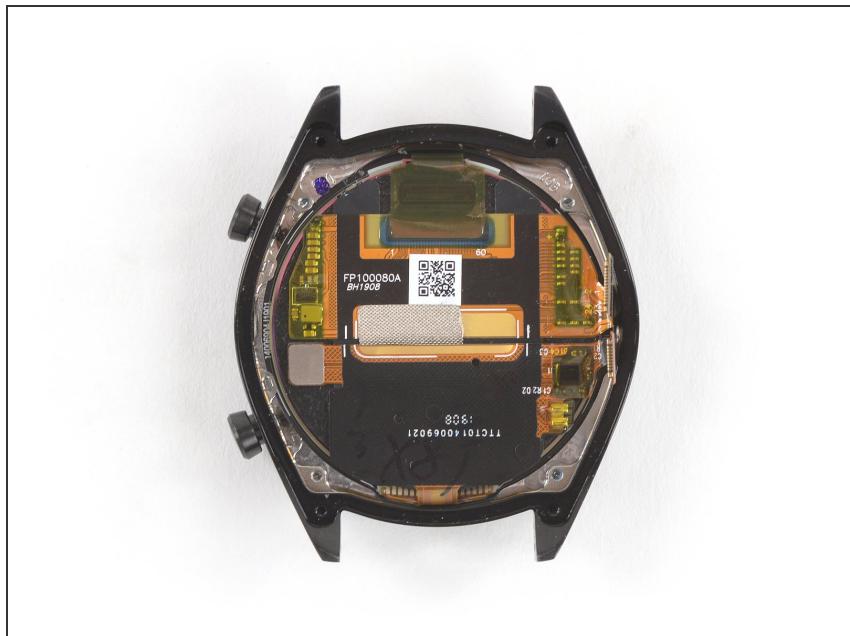
## Step 8

- The screen and digitizer of the Huawei Watch GT are glued to the display frame with strong adhesive and can not be removed without causing damage to them.
- So replacing the screen means replacing the complete top part of the watch.

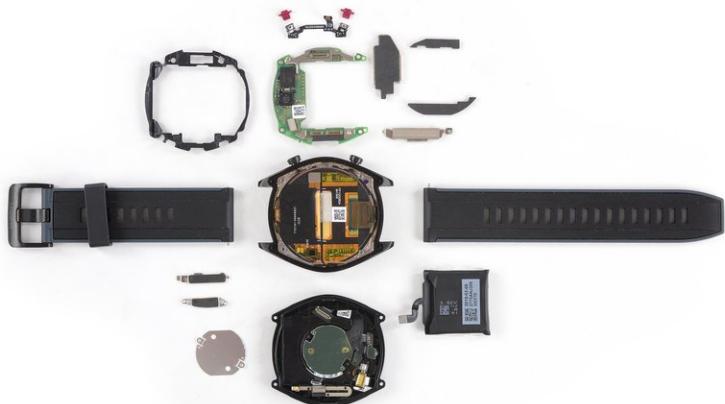
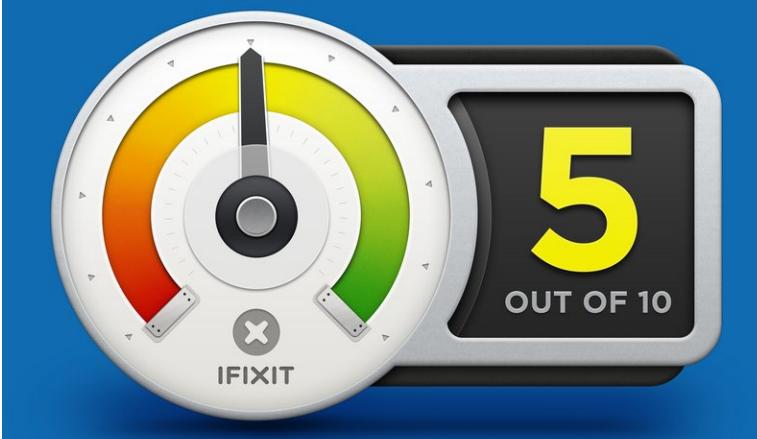
## Step 9

- The Huawei Watch GT earns a **5 out of 10** on our repairability scale (10 is the easiest to repair):
  - Watch band replacements are fast and simple.
  - Easy glueless opening procedure.
  - The battery can be removed independently. The removal procedure needs some prying but isn't too bad.
  - The screen and the digitizer can't be removed separately.
  - The sensor assembly including the vibration motor is soldered to the back cover.
