# Insignia NS-CLIP02 30-Pin Connector Replacement

Written By: Erik

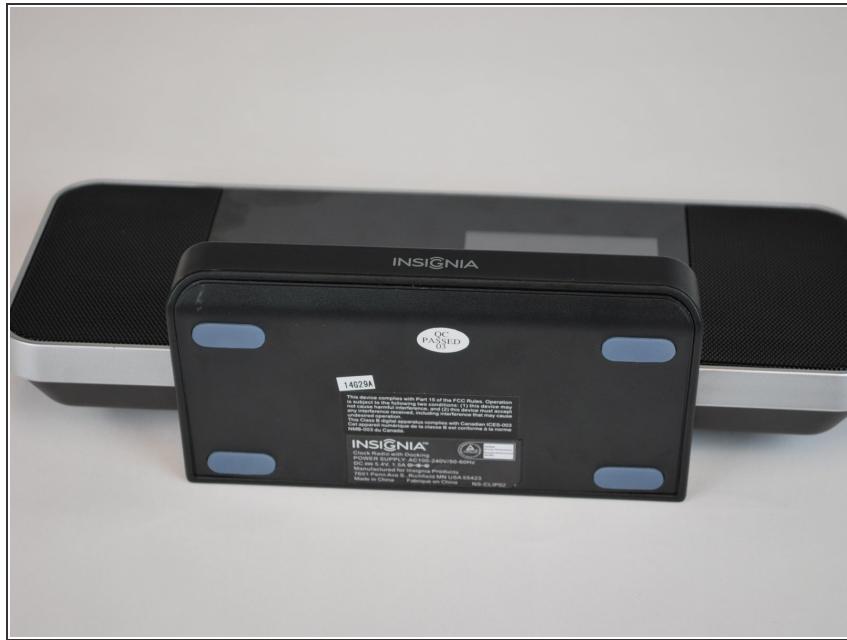
## Step 1 — 30-Pin Connector

- Locate the bottom of the device.

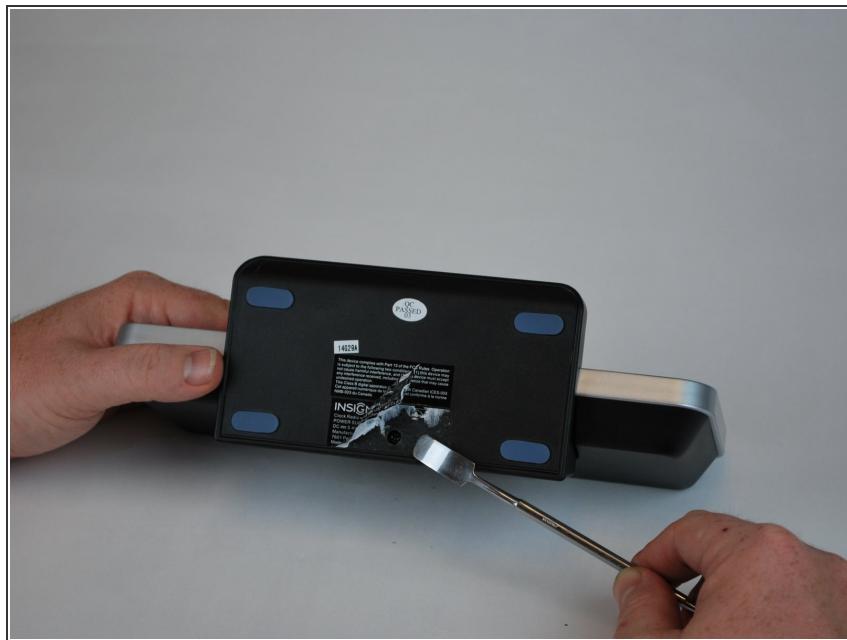
## Step 3

- Locate the 11mm screw beneath the sticker.

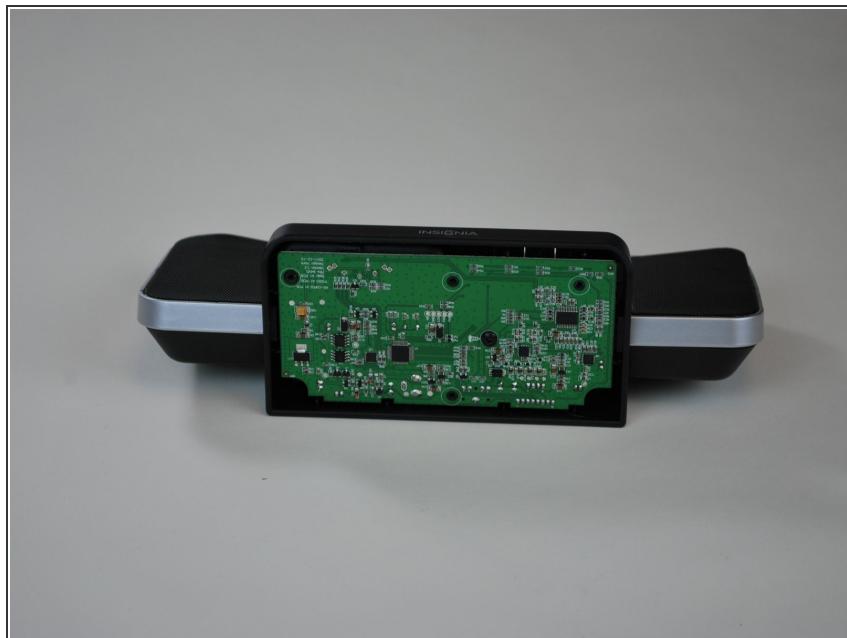
## Step 7

- Once you peel off the bottom from the device, you will see the motherboard.

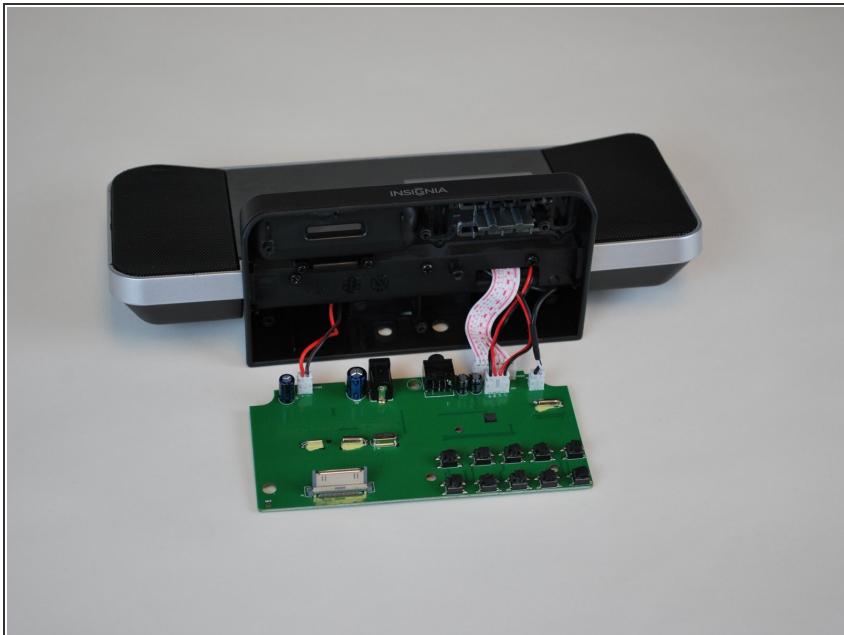
## Step 10

- Locate the four plugs connecting the motherboard to the rest of the device.
