Kenwood DNX571HD CD/DVD Drive Replacement

How to remove and replace the CD/DVD module in a Kenwood DNX571HD.

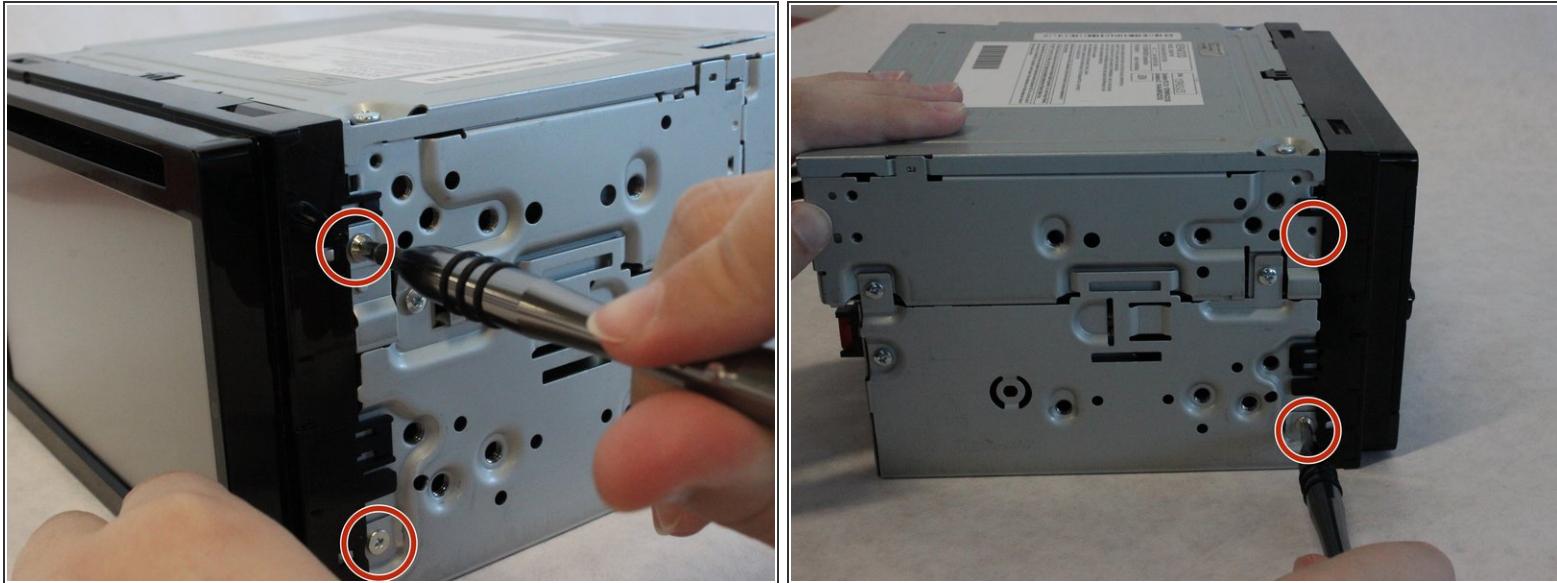
Step 1 — CD/DVD Drive

- Unscrew the four 3.5mm side screws with a Phillips #1 screwdriver.

(i) There are two screws per side.

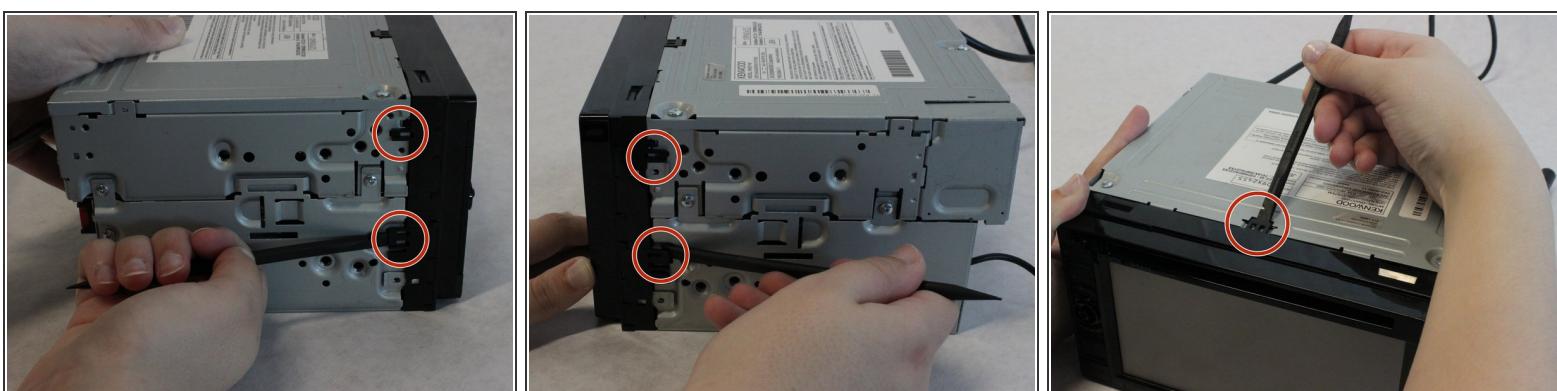
Step 2

- Use a spudger to unhook the plastic clips on the sides and top of the front panel. There are two clips on each side and one clip on the top.
- (i)* Place the spudger between the plastic tab and the metal case and gently lift the spudger away from the case.

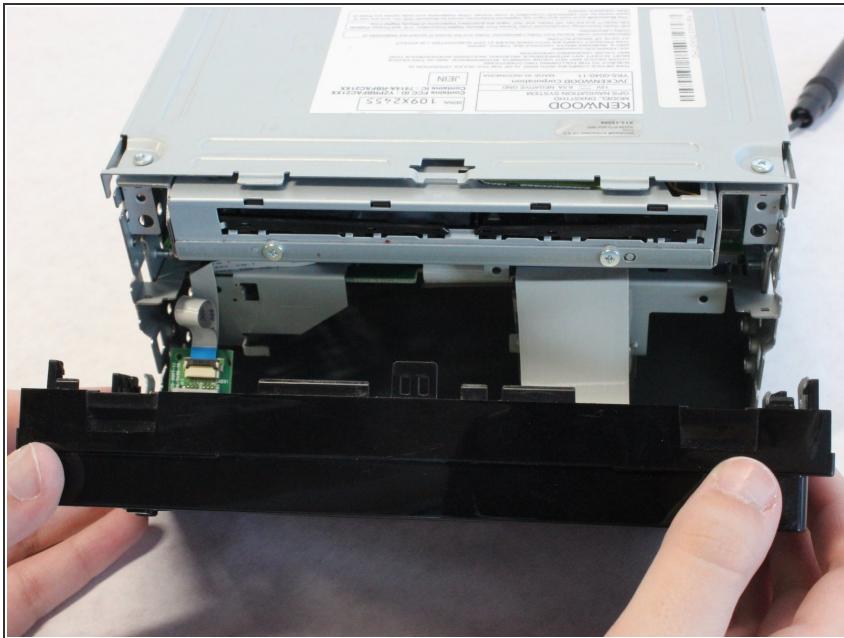
Step 3

- Pull the top of the front panel out and down to remove front panel.
- ⚠ Remove the front panel gently so as not to damage the ribbon cables behind it.

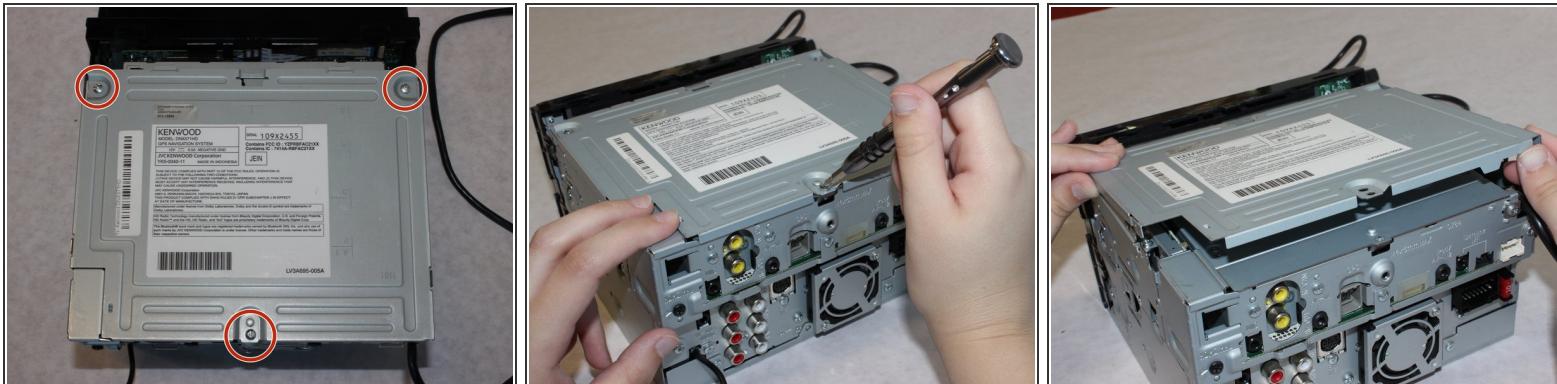
Step 4

- Unscrew the three 5mm screws from the top of the device using a Phillips #1 screwdriver.
- Lift up to remove the top casing.

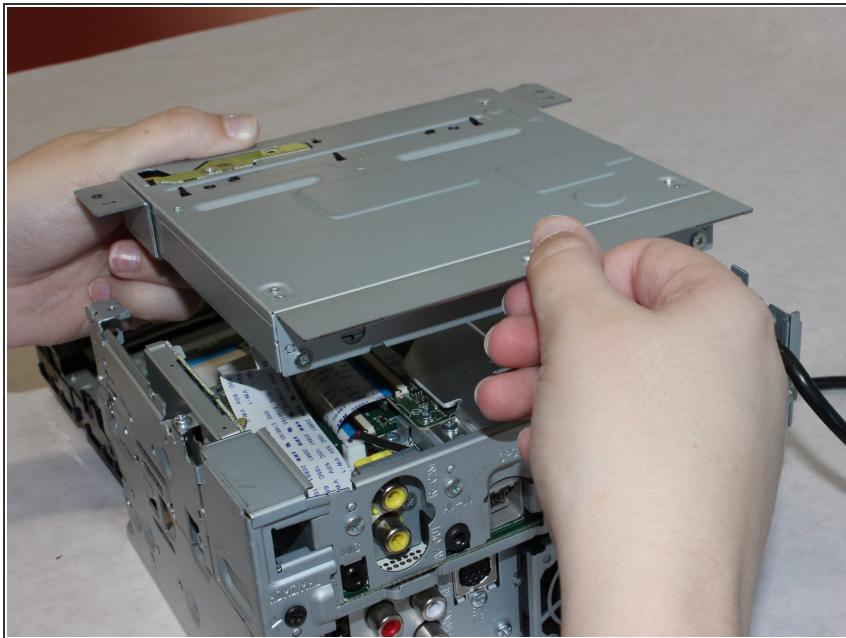
Step 5

⚠ Lift the CD drive carefully to expose the attached cable underneath.

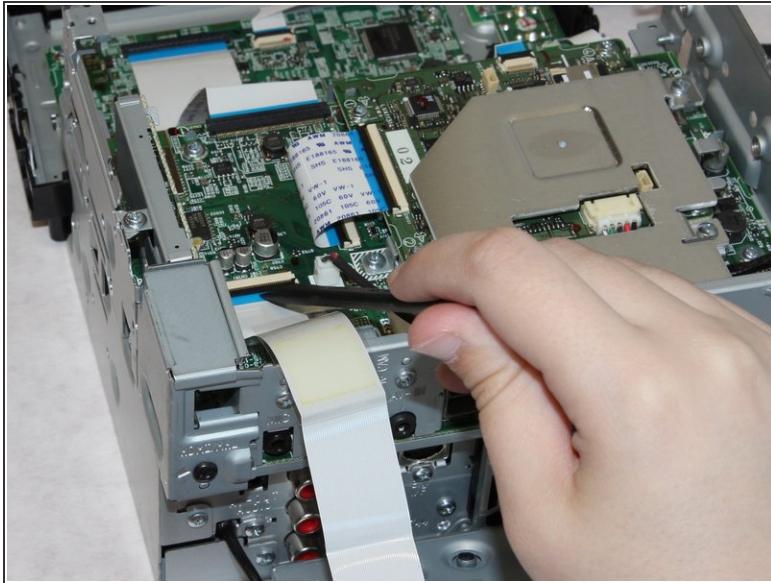
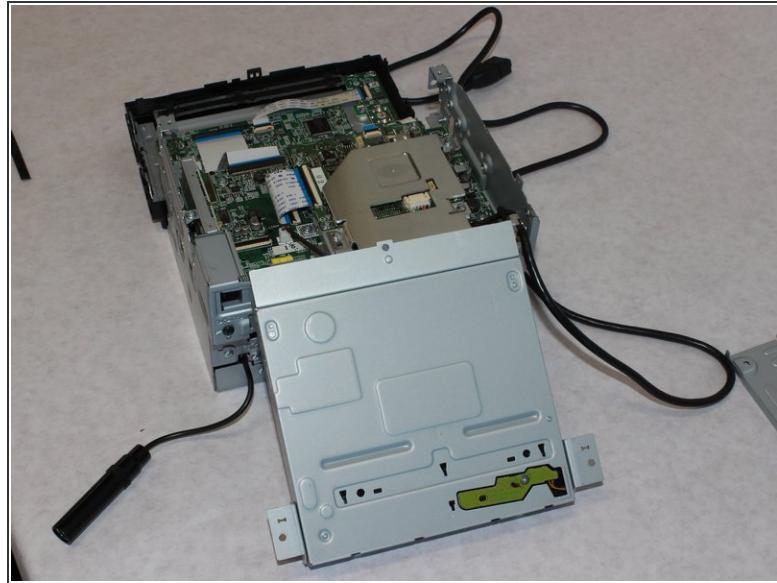
Step 6

- Flip up the black clasp with a spudger to disconnect the large white ribbon cable connecting the CD drive to the board underneath.
