Le Pan S Volume Rocker Replacement

A cracked or bent volume rocker may cause it to become misaligned. It may be necessary to remove and realign the rocker. If the rocker cannot be realigned, it will need to be replaced as shown.

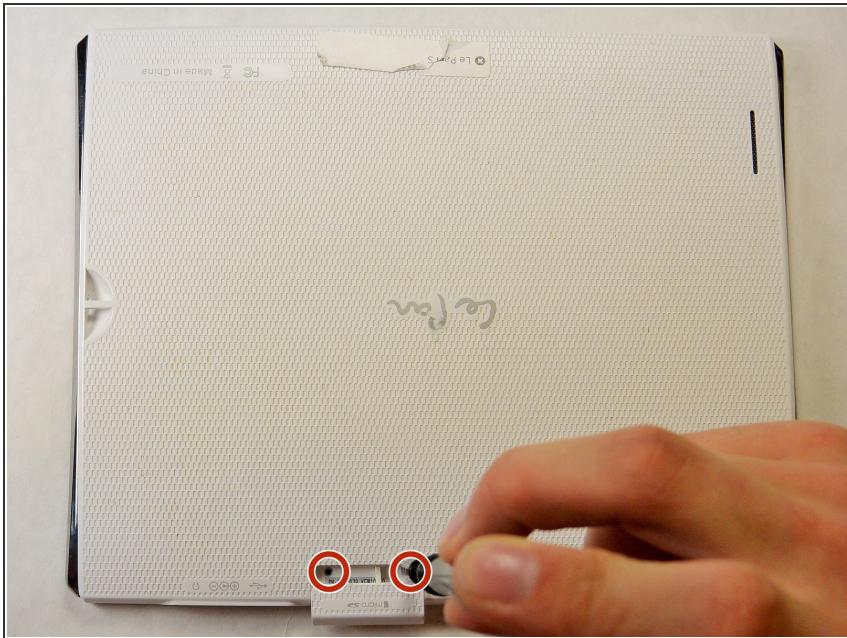
Step 1 — Battery

- Remove the two 3.5 mm Phillips #00 screws that are covered by the micro SD port.
- *(i)* This cover is adjacent to the volume button on the side of the Le Pan S.

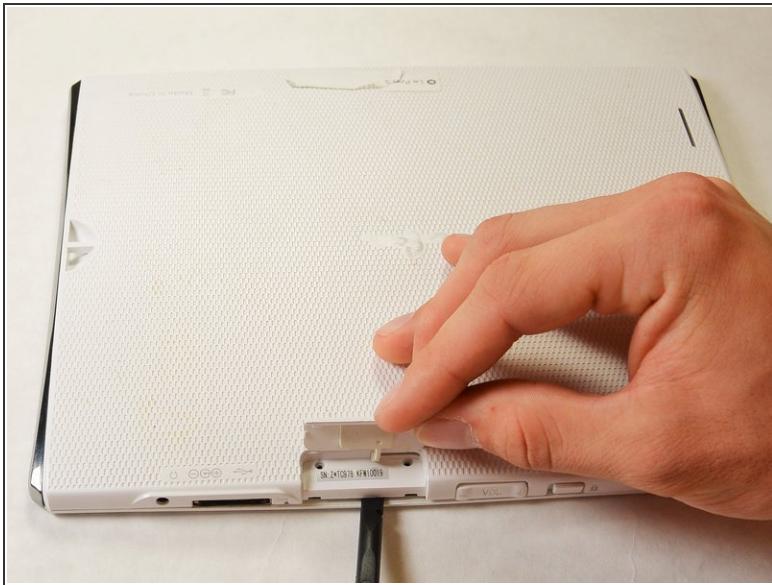
Step 2

- Insert the spudger between the front and back panel in order to pry them apart.
- (i)* Do this beside the volume button and the micro SD cover.
- Pry open the rest of the Le Pan S by dragging the spudger across the side.

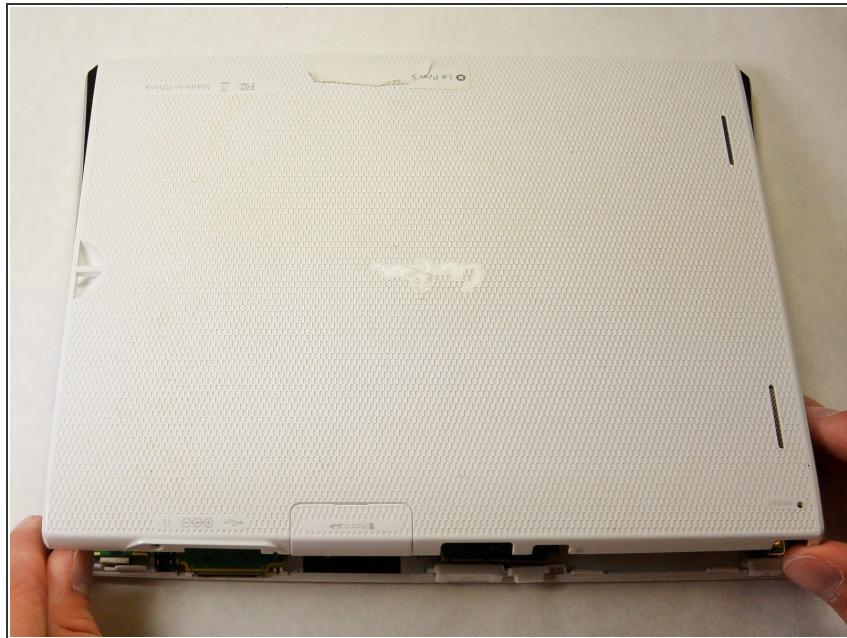
Step 3

- Once the front and back faces are completely separated, remove the back cover to reveal the inside components.

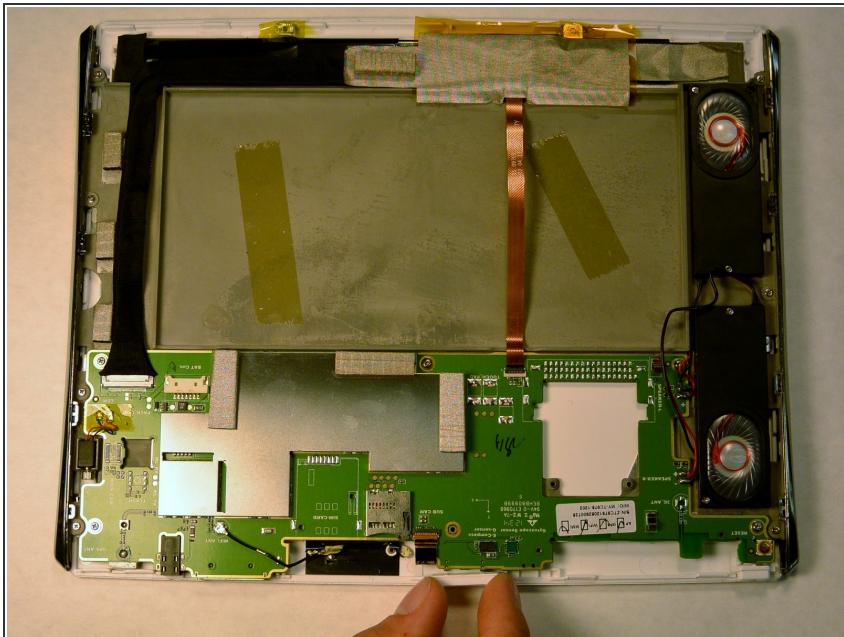
Step 6

- Pull out the volume rocker by carefully moving it side to side with your fingers.
