Lenovo K5 Note Repairability Assessment

Repairability assessment of the Lenovo K5 Note performed on January 5, 2017.

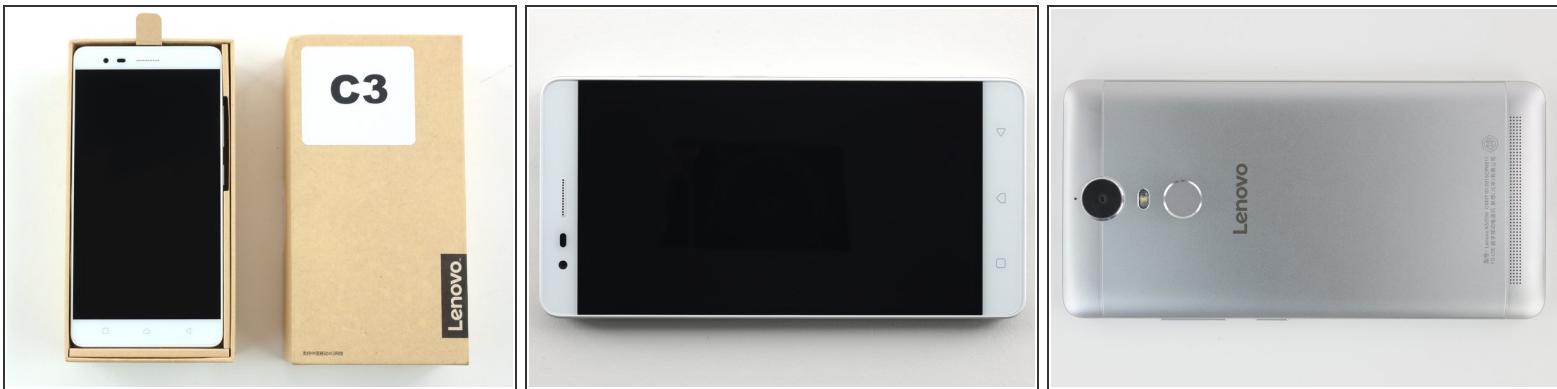
Step 1 — Lenovo K5 Note Repairability Assessment

- Packaging.
- Front and back reference shots.

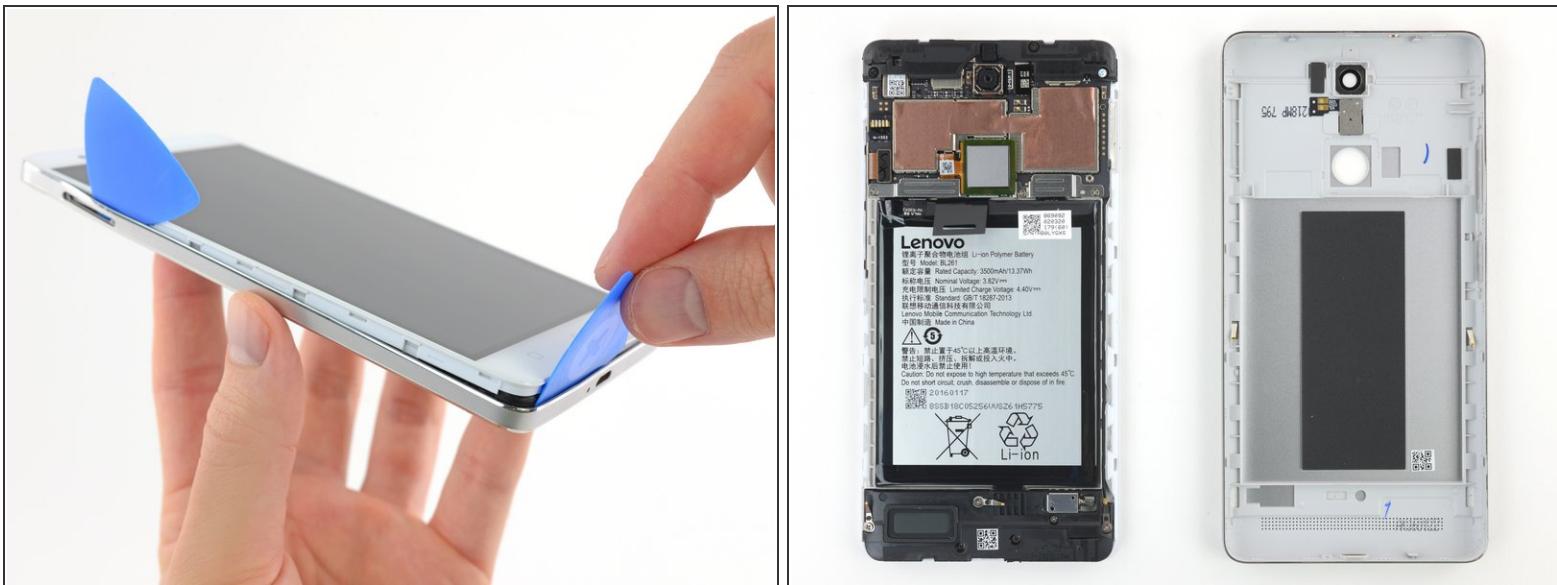
Step 2

- Rear case is a tight fit, but with the SIM card removed it pries off with determination and a couple picks. No screws or glue.
- Spring contacts connect the camera flash module and presumably some case antennas.
- Camera flash module is lightly adhered to the rear case.

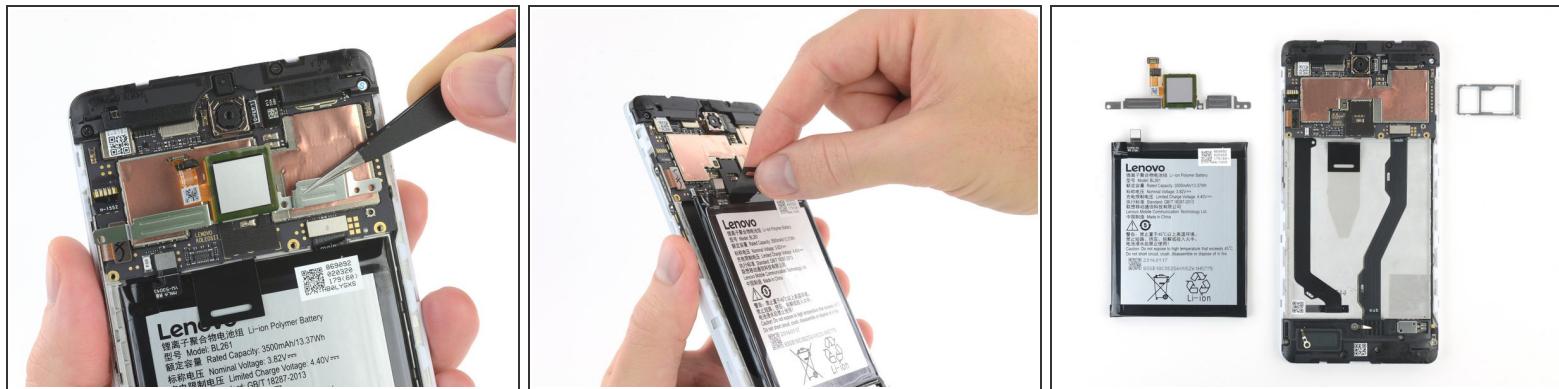
Step 3

- The battery connector is secured underneath a bracket attached to this fingerprint sensor. Three Phillips screws secure the bracket.
- Once the bracket's removed, there's a pull tab for easy battery removal.

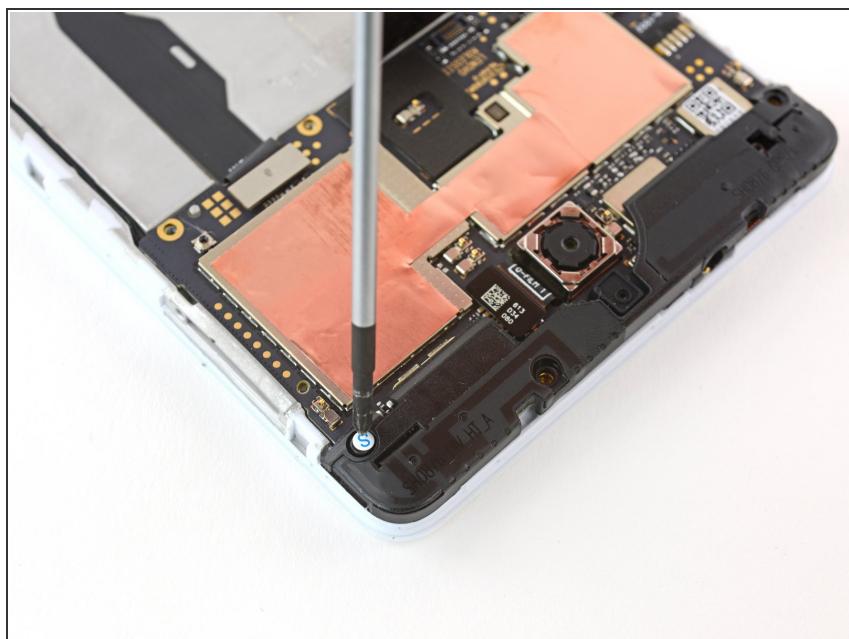
Step 4

- On the way to removing the motherboard we had to break through a tamper-evident sticker.

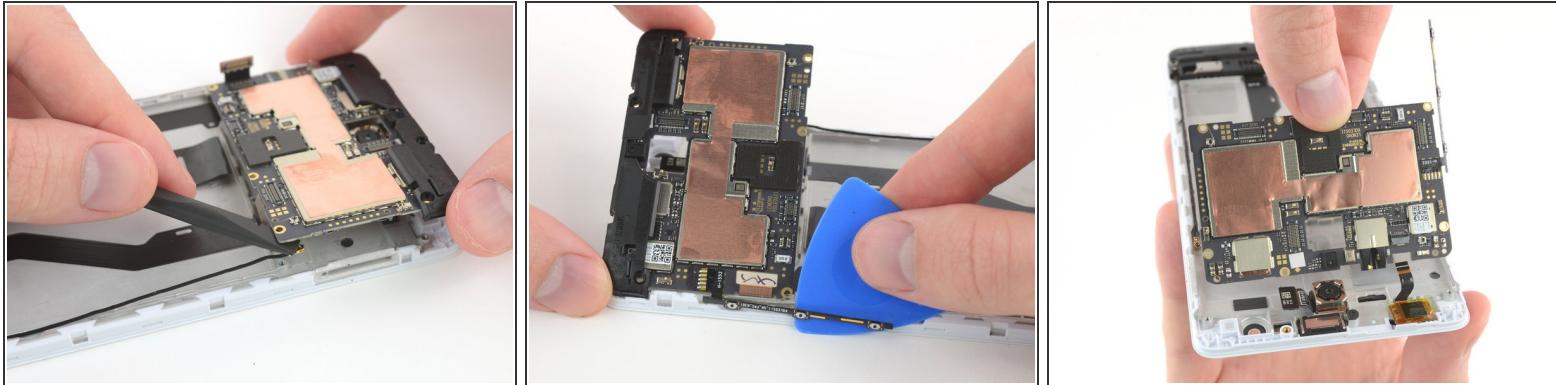
Step 5

- The motherboard is booby-trapped with cables on both sides.
- The power/volume button assembly is glued to the chassis and soldered to the motherboard.
- The headphone jack is soldered to the motherboard.

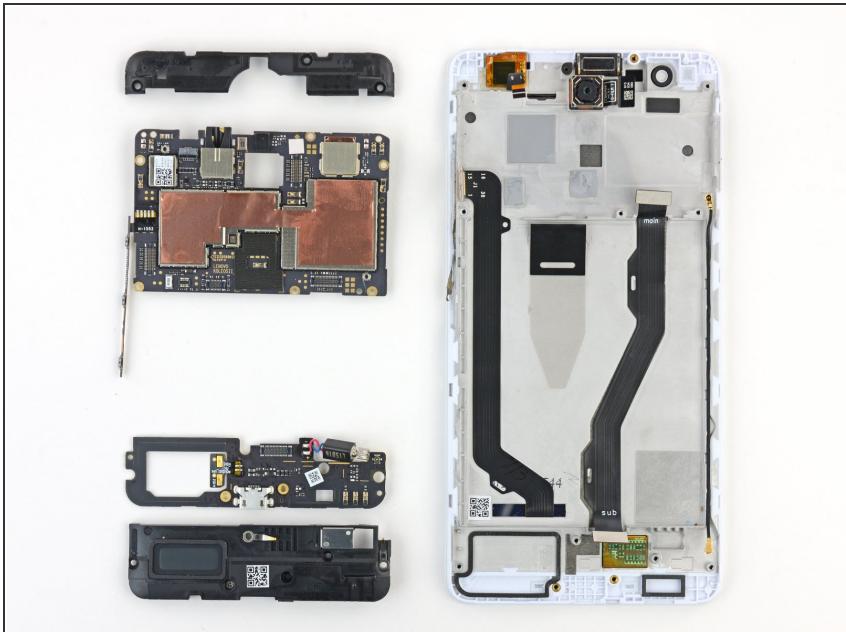
Step 6

- A handful of Phillips screws secure the daughterboard—all the same size.
- The vibrator motor is soldered to the daughterboard.
- The primary speaker connects by way of spring contacts.

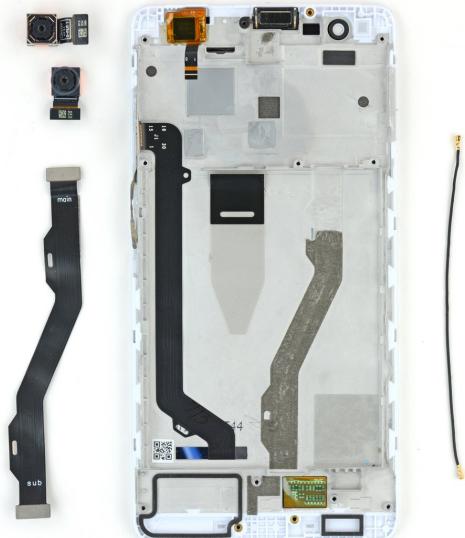
Step 7

- The primary camera is firmly glued to the midframe. It might be possible to extract it without first removing the motherboard, but only with some risk of pry damage to the motherboard.
- The selfie camera is installed on the back of the motherboard, requiring removal of the motherboard for access.
- Both cameras are modular.
- With the interconnect cables out, this is as far as we go. The display looks to be firmly secured to a midframe for rigidity and would be impractical to separate. While it's the most likely component to break, everything else mounts to it—making it effectively the last component to be removed.

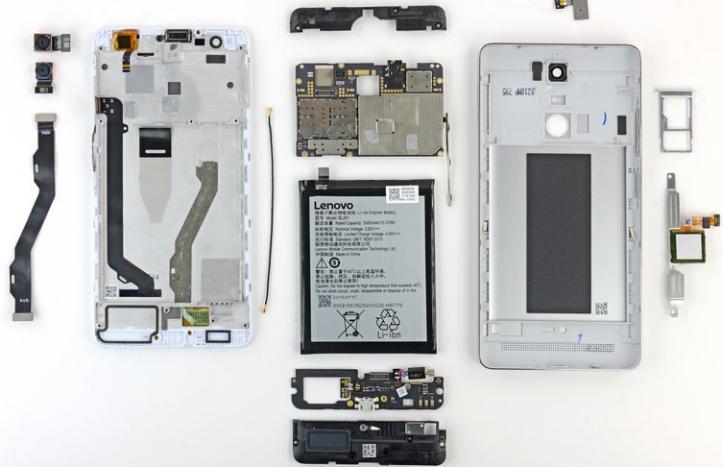
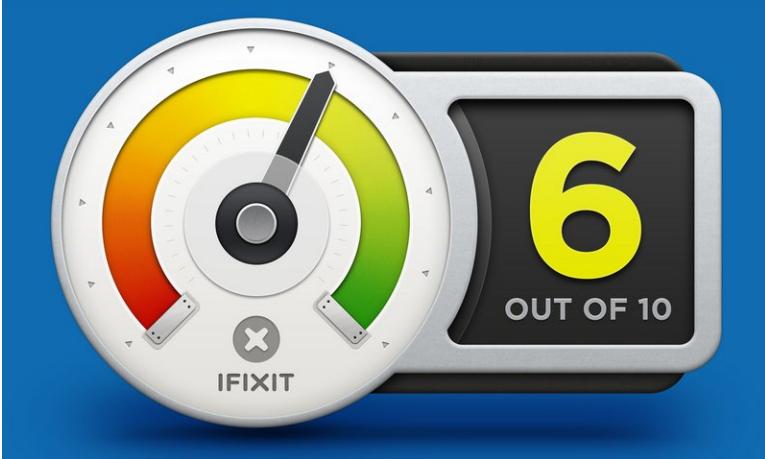
REPAIRABILITY SCORE:

- The Lenovo K5 Note earns a **6 out of 10** on our repairability scale (10 is the easiest to repair):
 - Battery is replaceable with just a couple of tools.
 - A single Phillips 00 driver takes care of all the screws.
 - Some parts are modular, but high-wear components like the headphone jack and charge port are not.
 - Sparing use of adhesive.
 - Replacing the display assembly requires removing every other component from the device first.
 - Manufacturer does not provide user-accessible repair documentation.
