Lenovo Yoga 920-13IKB USB 3.0 Port Replacement

How to replace the USB 3.0 port on the Lenovo Yoga 920-13IKB.

Written By: Alyssa McCulloch

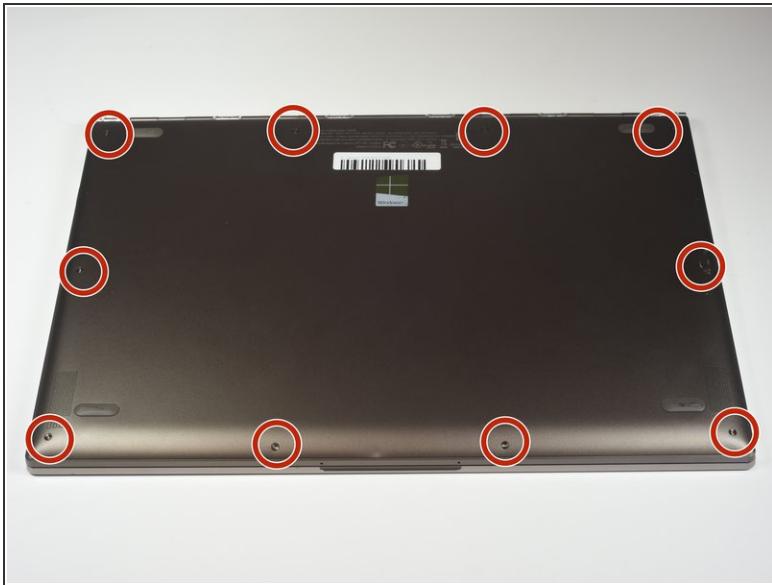
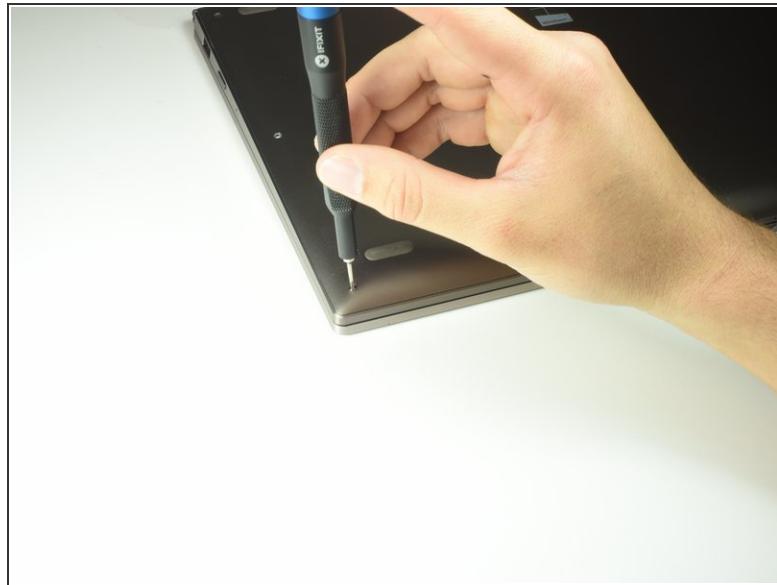
Step 1 — Back Cover

ⓘ Flip the device over to access the screws on the back cover.

- Remove the ten 5mm Torx T5 screws on the back cover to loosen the back cover.

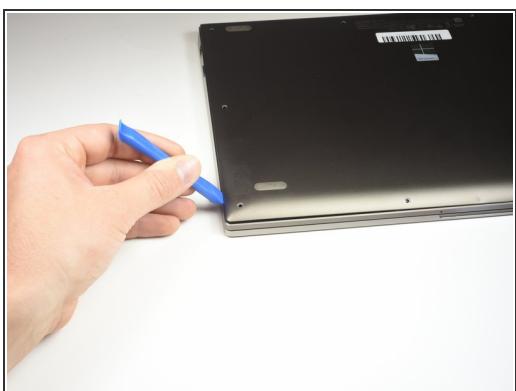
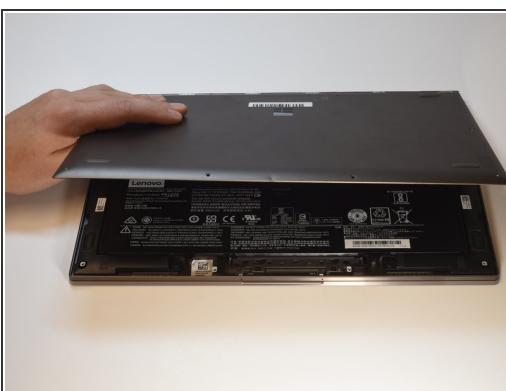
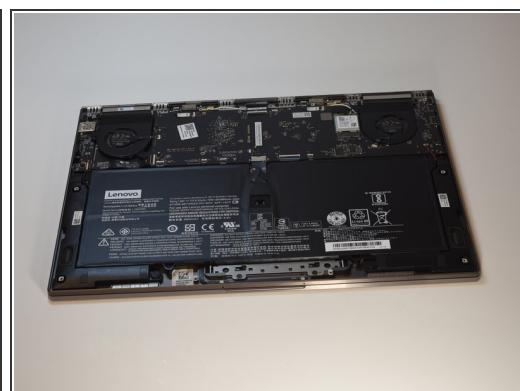
Step 2

- Slide the iFixit Opening Tool under the back cover to lift it up.
- Pull up on the cover with your hand to release the tab holding the center of the cover in place.

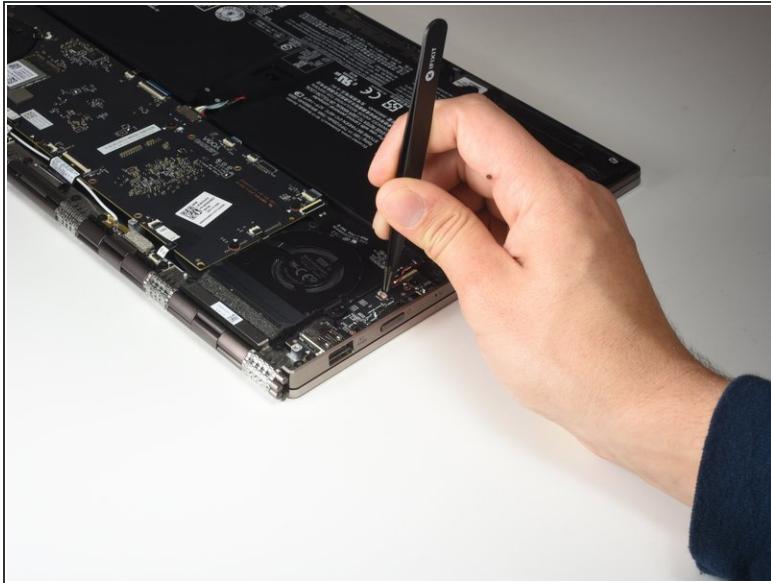
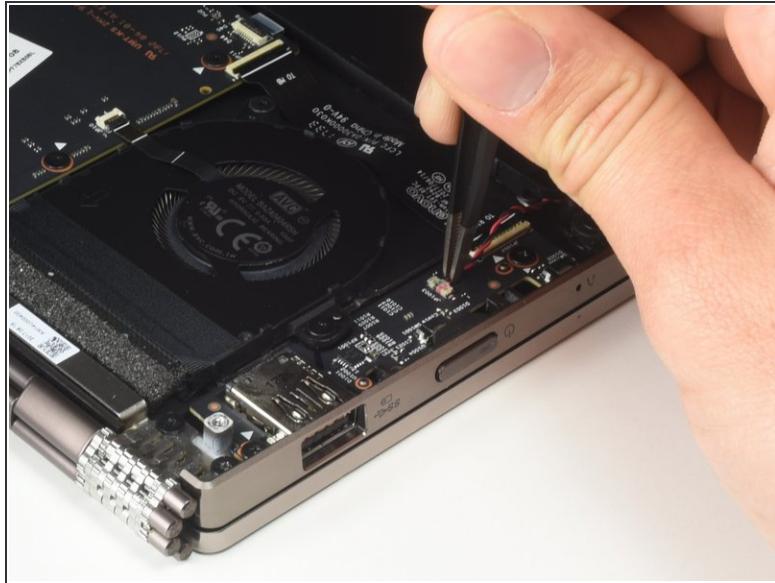
Step 3 — USB 3.0 Port

- Disconnect the red and black wire connected to the speaker using the iFixit Tweezers.

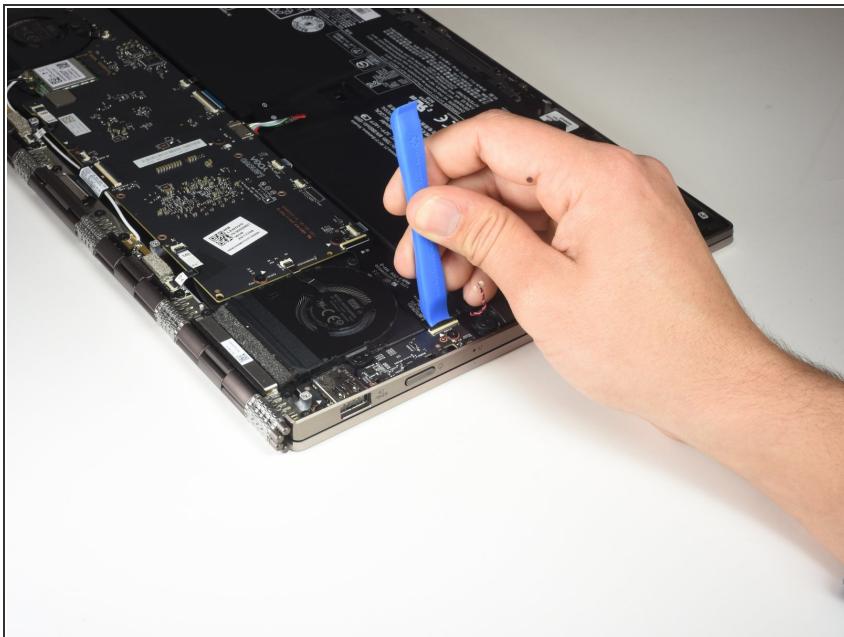
Step 4

- Lift up the black tab on the flat cable connector with the iFixit Opening Tool.

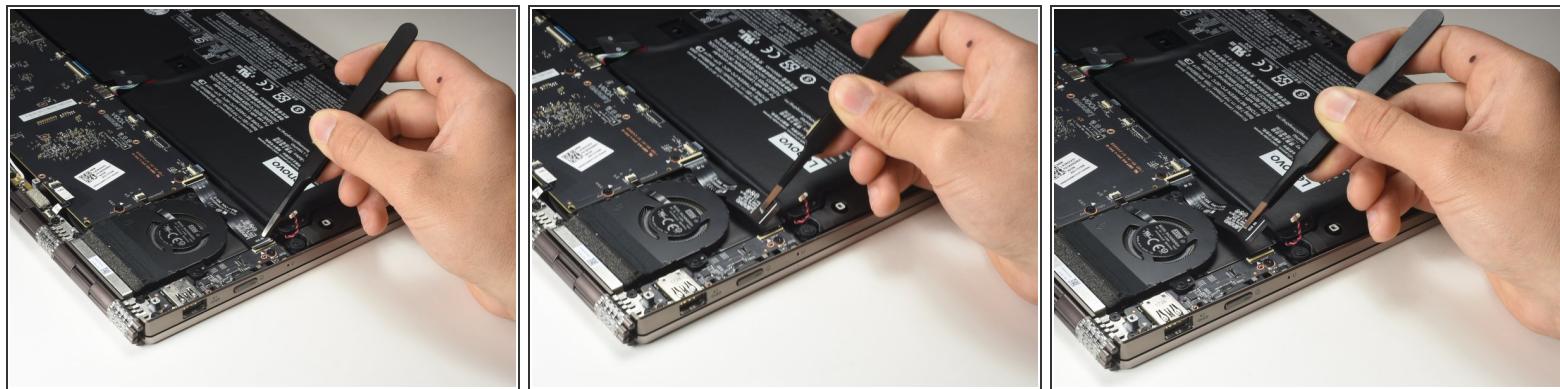
Step 5

- Flip up the tab using the iFixit Tweezers to release the flat cable.

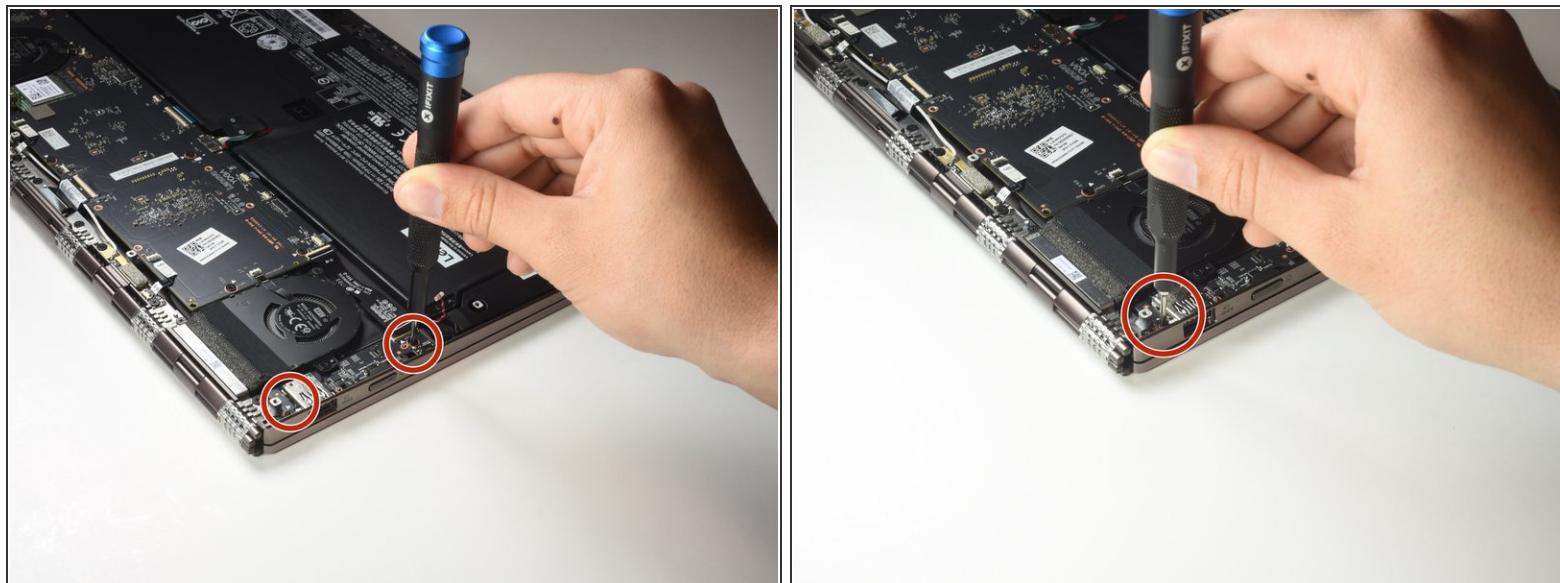
Step 6

- Undo the two 3mm Phillips #00 screws to loosen the USB 3.0 board.

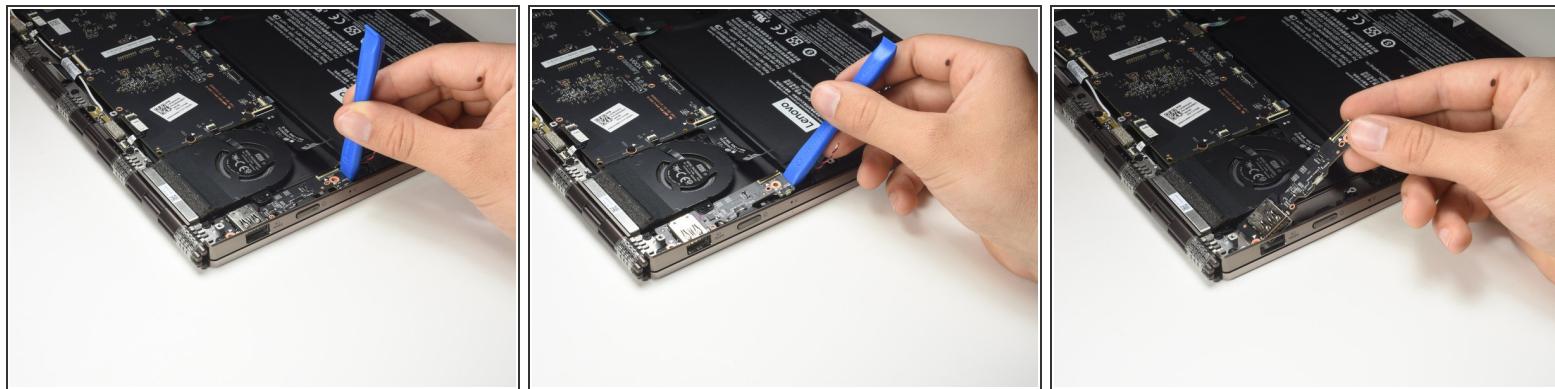
Step 7

- Remove the USB 3.0 Board from the device using the iFixit Opening Tool.

To reassemble your device, follow these instructions in reverse order.
