MSI GT72 2QE Dominator Pro CD Drive Replacement

Removing the CD drive from the MSI GT72 2QE Dominator Pro.

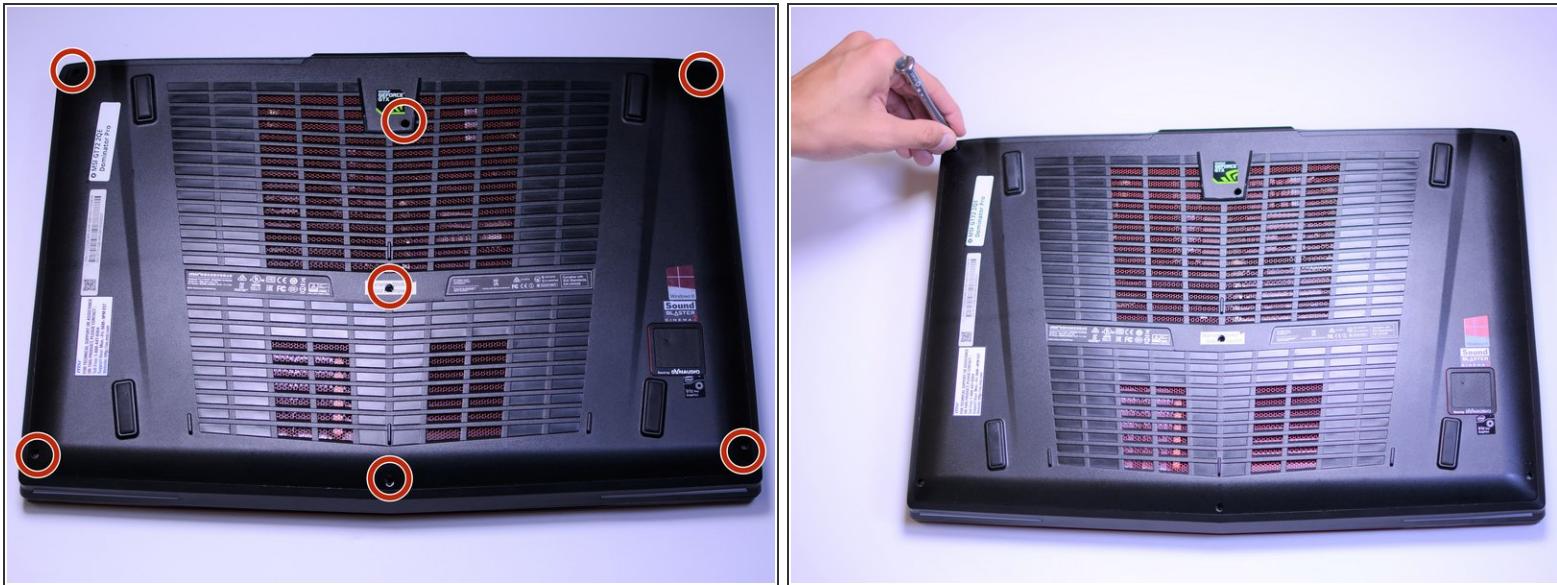
Step 1 — CD Drive

- Remove the indicated seven (7) 6 mm Phillips #0 screws for the back cover.
- *(i)* The same PHO screwdriver bit can be used throughout all the steps.

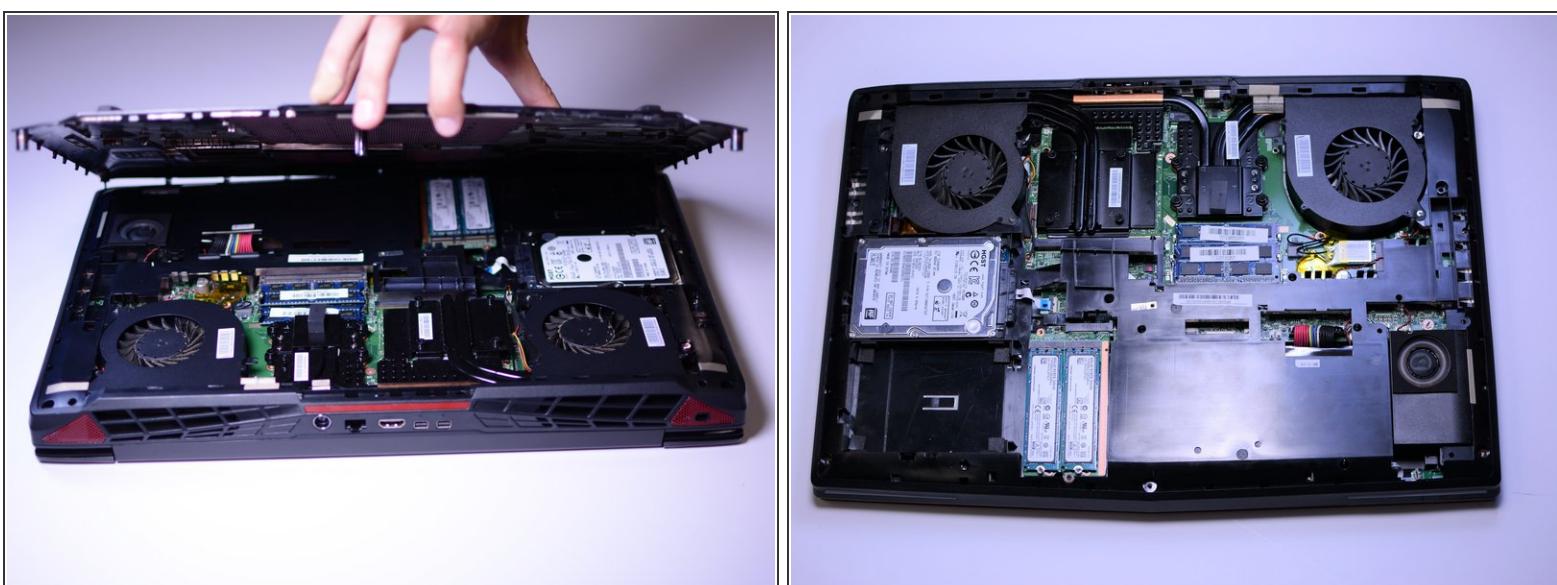
Step 2

- Lift the back cover using the tab to expose the hardware beneath.

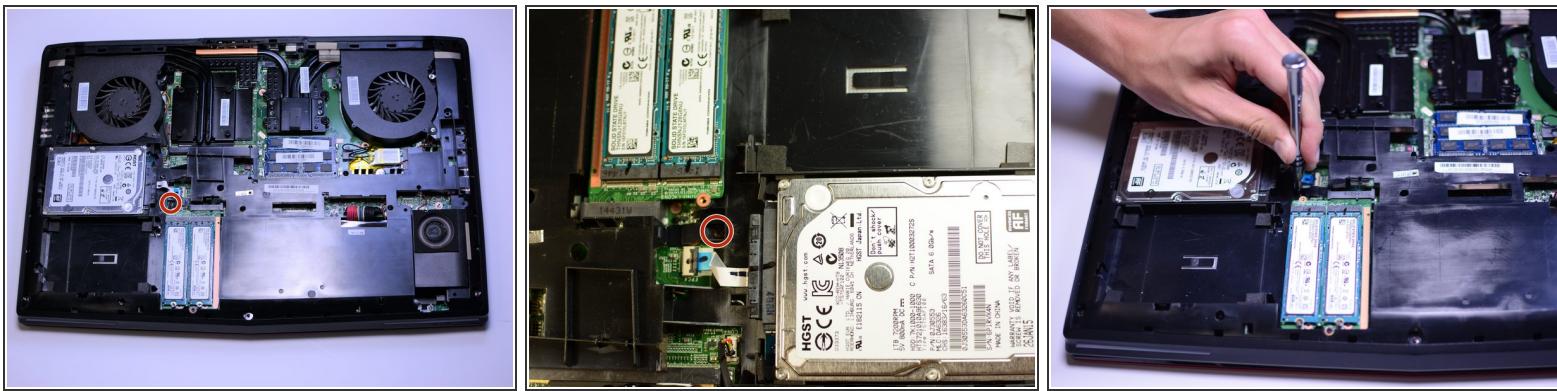
Step 3

- Remove the indicated 5mm Phillips #0 screw.

This is the only screw holding the CD drive in place. Do not lose it.

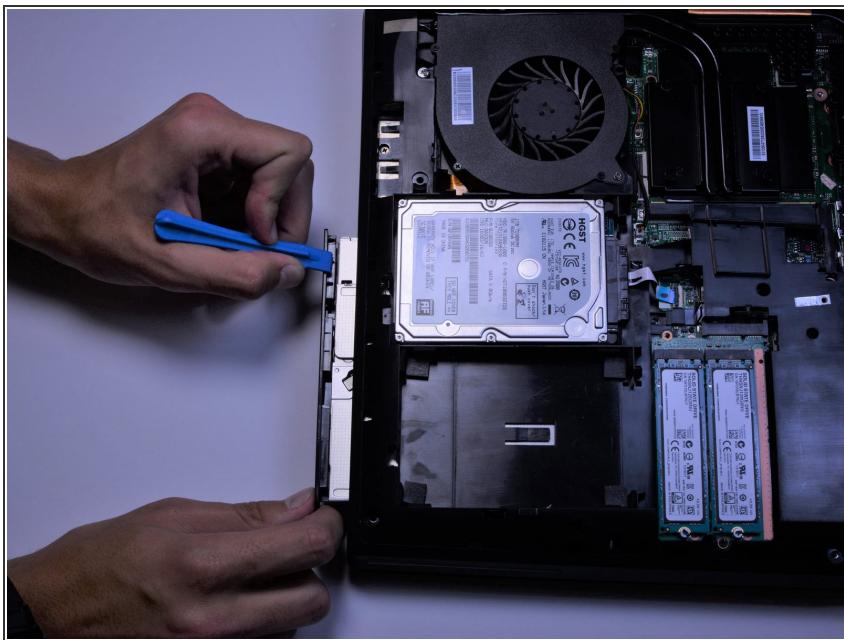
Step 4

- Using the plastic opening tool, pull out the CD drive.

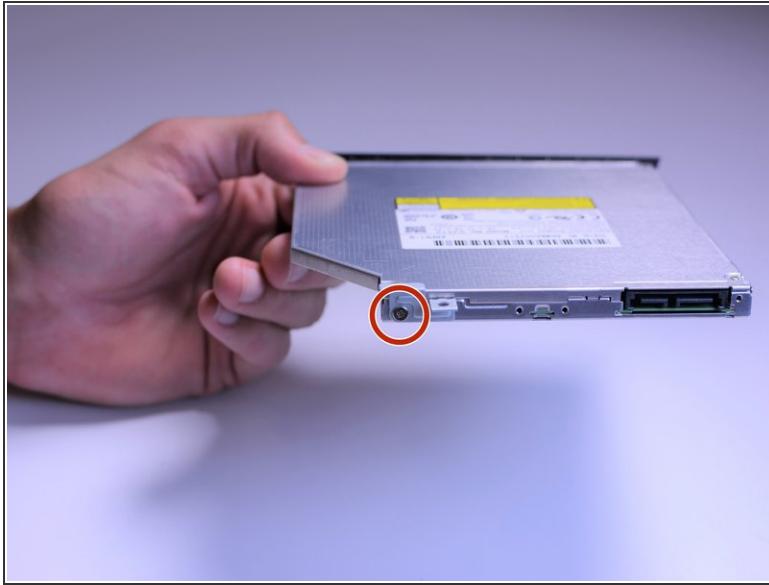
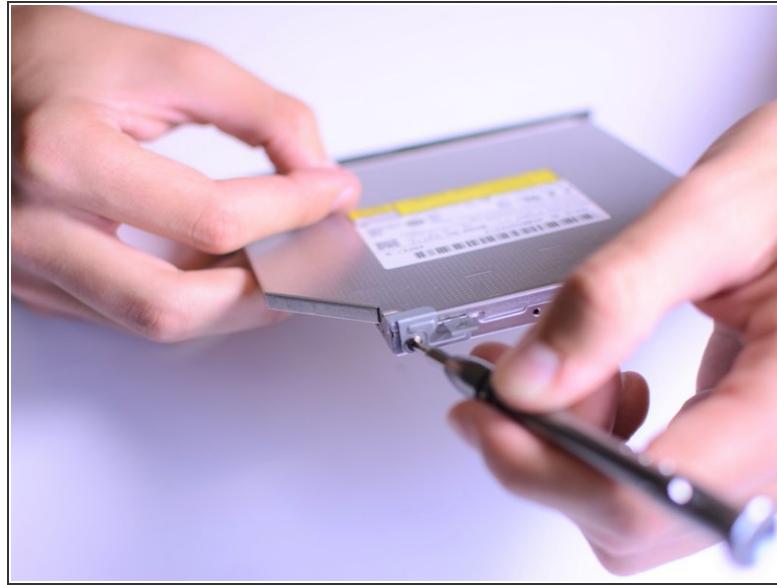
Step 5

- Remove the indicated 4mm Phillips #0 screw and metal hinge.

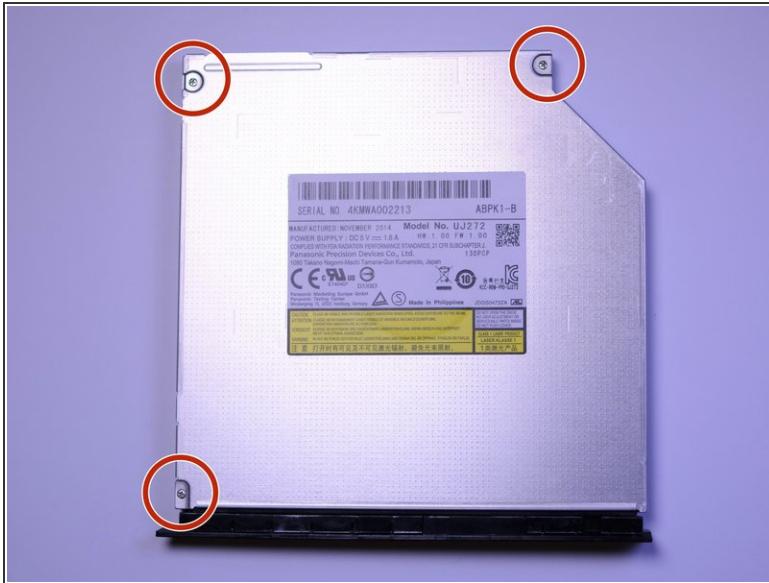
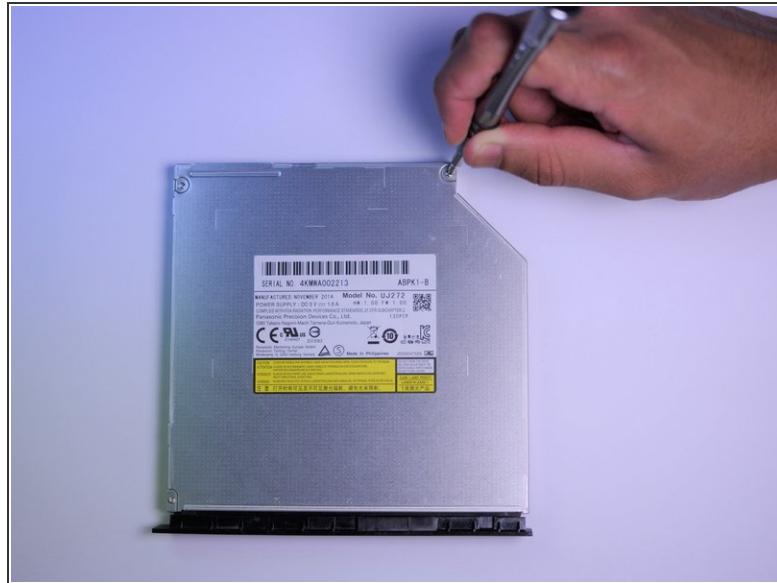
Step 6

- Remove the three (3) indicated 2mm Phillips #0 screws.

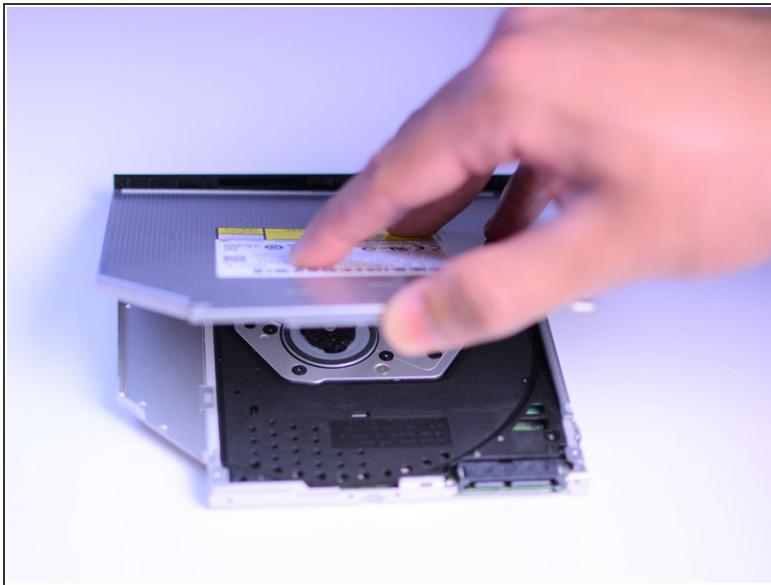
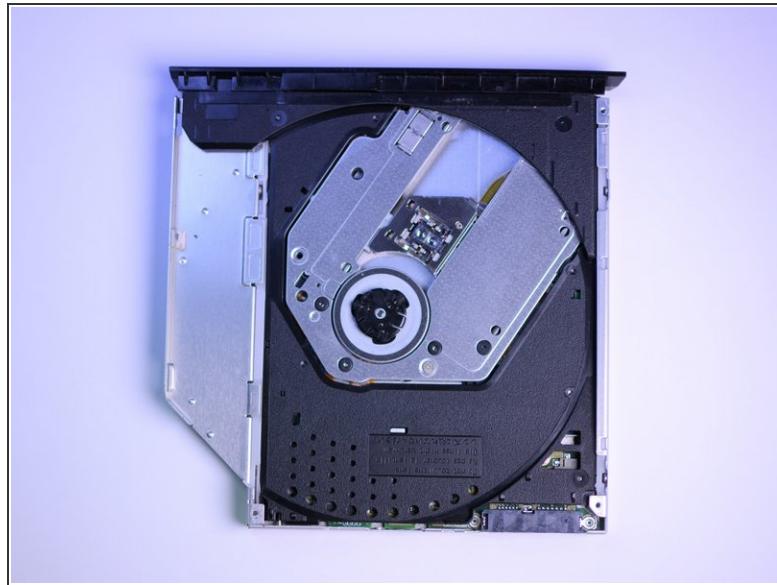
Step 7

- Lift metal cover gently, using the tab like indent located where the arrow is pointed.
- This should expose the inside of the CD drive.
