MacBook Pro 15" Touch Bar 2019 Teardown

Our search for the new 'material' in Apple's 15-inch MacBook Pro's butterfly keyboard unveiled two significant changes. Performed May 22, 2019.

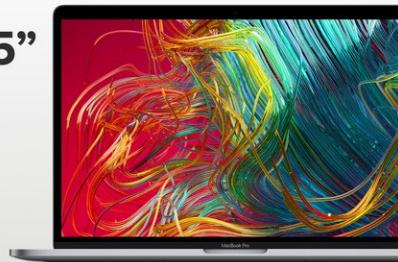
Step 1 — MacBook Pro 15" Touch Bar 2019 Teardown

Designed by Apple in California. Assembled in China. Model A1990. Rated 20.2V == 4.3A max.
EMC 3359. FCC ID: BCGA1990 and IC: 579C-A1990. Serial C02YL8DZLVCF

(i) Our teardown victim bears the familiar A1990 model number, but a new EMC number: **3359**.

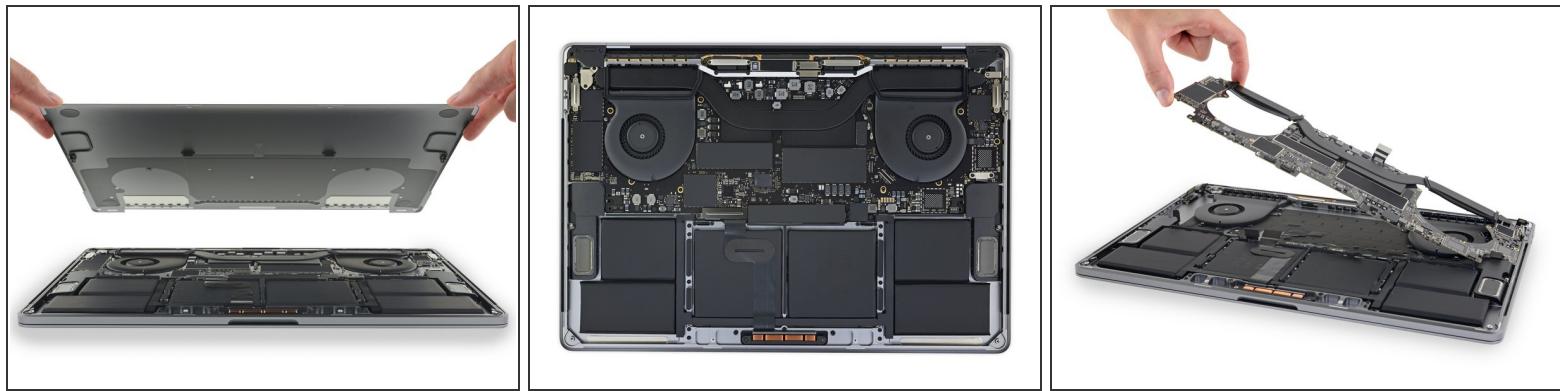
Step 2

If you *are* curious about how to get inside, it's exactly the same procedure as the 2018 edition ... which we [already have guides for!](#)
- As promised, this is looking *mostly* like a spec bump—the hardware appears visually indistinguishable from last time. Let's pull the board and look closer.

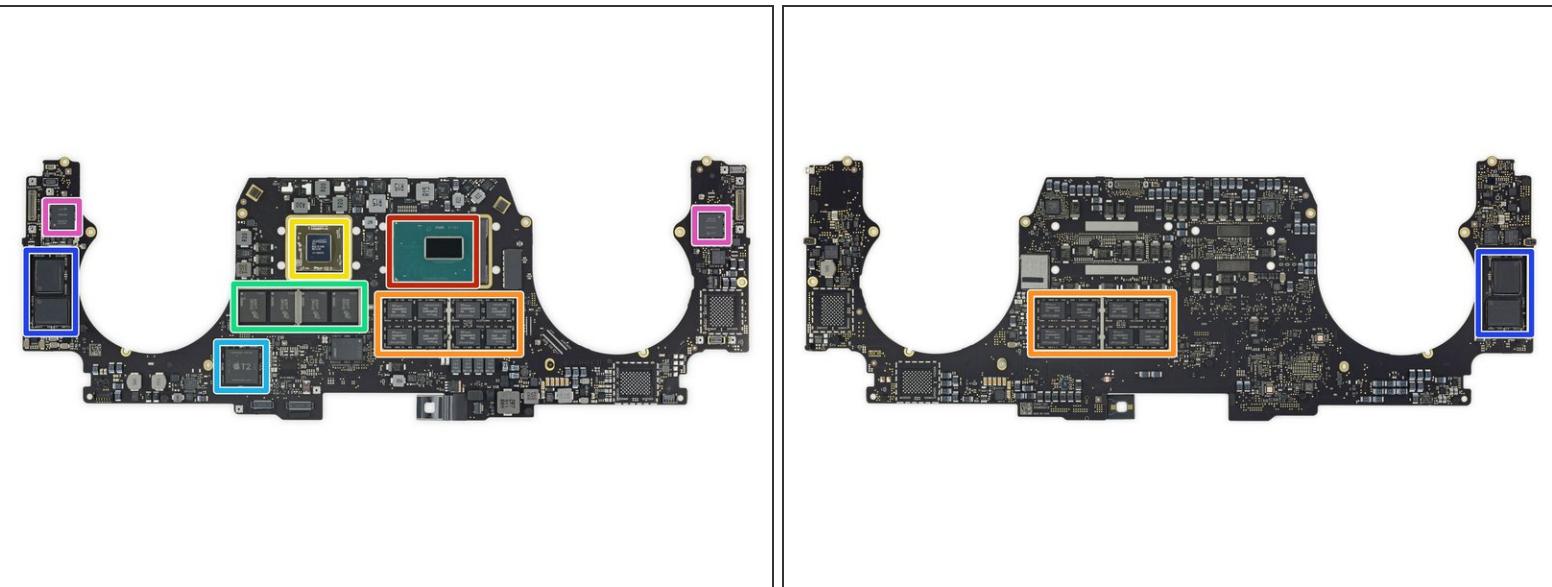
Step 3

- With zero modular components, there's no chance of upgrading any of this hardware. Speak now or forever hold your chips:
 - 9th-generation Intel Core [i7-9750H](#) 6-core processor
 - 16x SK Hynix [H5AN8G8NAFR](#) 8 Gb DDR4 SDRAM (16 GB total)
 - AMD Radeon Pro 555X GPU
 - 4x Micron [MT51J256M32HF-70:B](#) 8 Gb GDDR5 RAM (4 GB total)
 - Apple T2 APL1027 339S00533 coprocessor, layered over 1 GB Micron D9VLN LPDDR4 memory
 - Toshiba TSB3226AW8815TWNA1 and TSB3226XZ2939TWNA1 flash storage (256 GB total)
 - Intel [JHL7540](#) Thunderbolt 3 controller

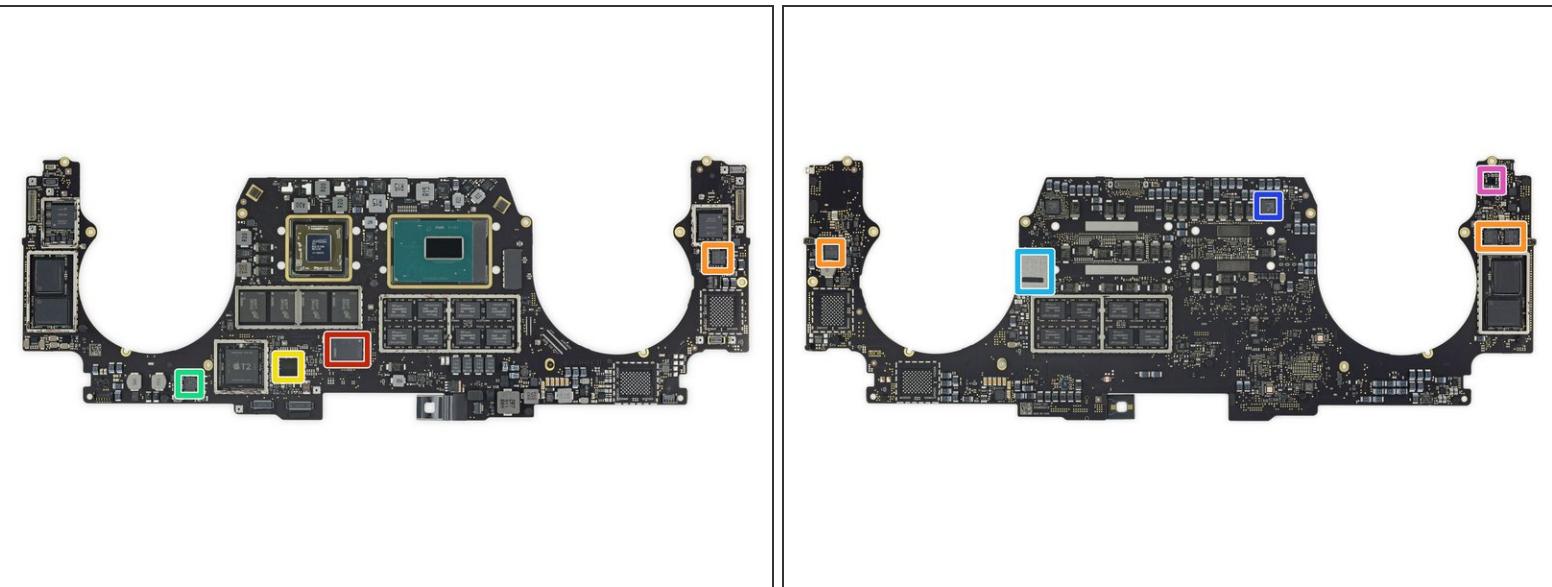
Step 4

- More chips for your perusal:
 - Intel [SR40F](#) platform controller hub
 - Texas Instruments CD3215C00Z (likely power controllers)
 - 338S00267-A0 (likely Apple PMIC)
 - TPS51980A power controller
 - 339S00458 (likely Apple Wi-Fi/Bluetooth module)
 - Intersil [6277A](#) PWM modulator
 - Cirrus Logic CS42L83A audio codec

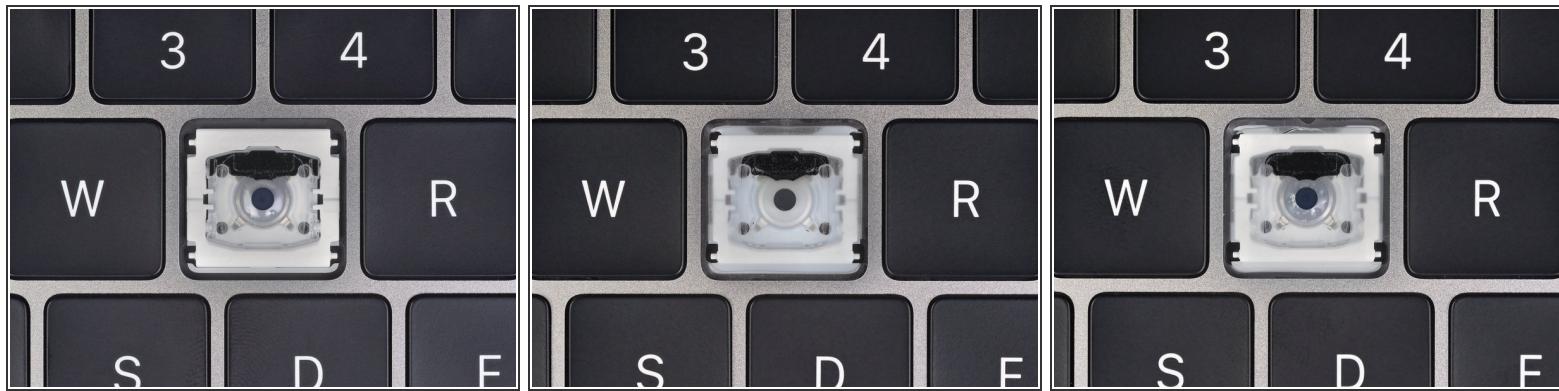
Step 5

- Onward to the keyboard! Let's recap this butterfly's metamorphosis so far.
- After making its debut in the 2015 [Retina MacBook](#), the butterfly keyboard landed on the MacBook Pro line for the first time in 2016 (pictured at left).
 - *(i)* Designed to be super thin while accommodating off-center key presses, the keyboard proved controversial because of its extremely short throw—but soon proved unreliable as well.
- In summer of 2018, [Apple launched a repair program](#), privately blaming dust for jamming the keys—and released updated models with a [silicone membrane](#) protecting the key switches (middle image). [But problems have persisted.](#)
- Lastly, 2019's butterfly switch revision keeps the silicone membrane, but tweaks the materials in the springy metal dome and the plasticky material that covers it.

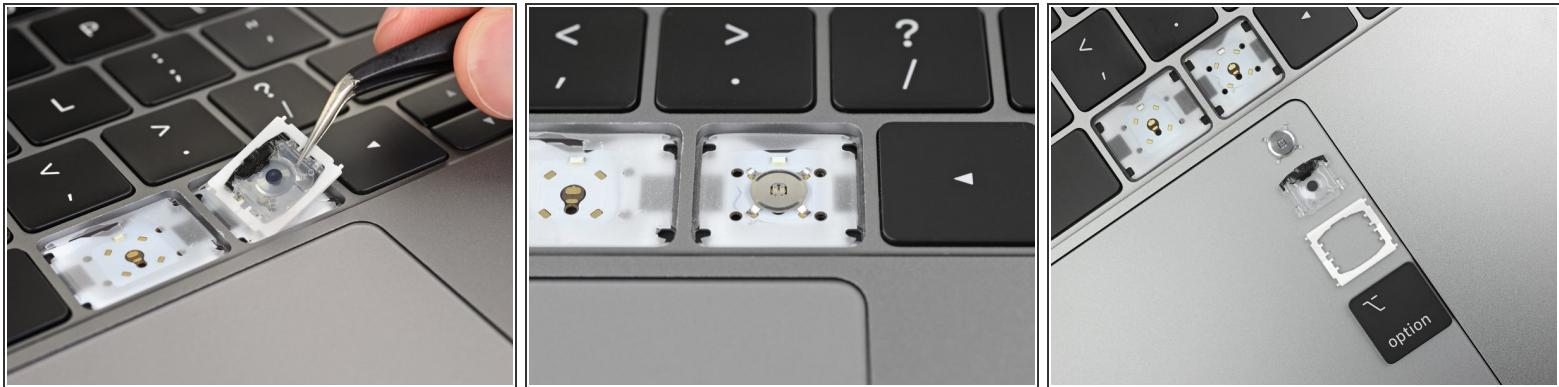
Step 6

- Now that we have some context, let's go layer by layer through the key components of 2019's butterfly switch:
 - Topping it all off is the key cap. This has a handy label to tell users which key is broken.

- The hinged white bracket is the "butterfly" mechanism controlling the key's motion—stabilizing it so as to travel up and down without tilting or wobbling.

- Nesting within that bracket is a transparent cover that flexes with each key press, while keeping contaminants away from the dome switch underneath. The black dot at its center concentrates the force of your key press onto the switch.

- The main character of this assembly is the springy [metal dome switch](#). It deforms when the key is pressed, bridging the board's six contacts—and then bounces back when you release the key.

- Underneath the dome switch are [six metal pads](#). A keystroke registers whenever the top center pad is shorted to any of the other five pads.
 - To wrap it up, the silicone membrane covers the butterfly mechanism to keep debris from getting in and jamming it.

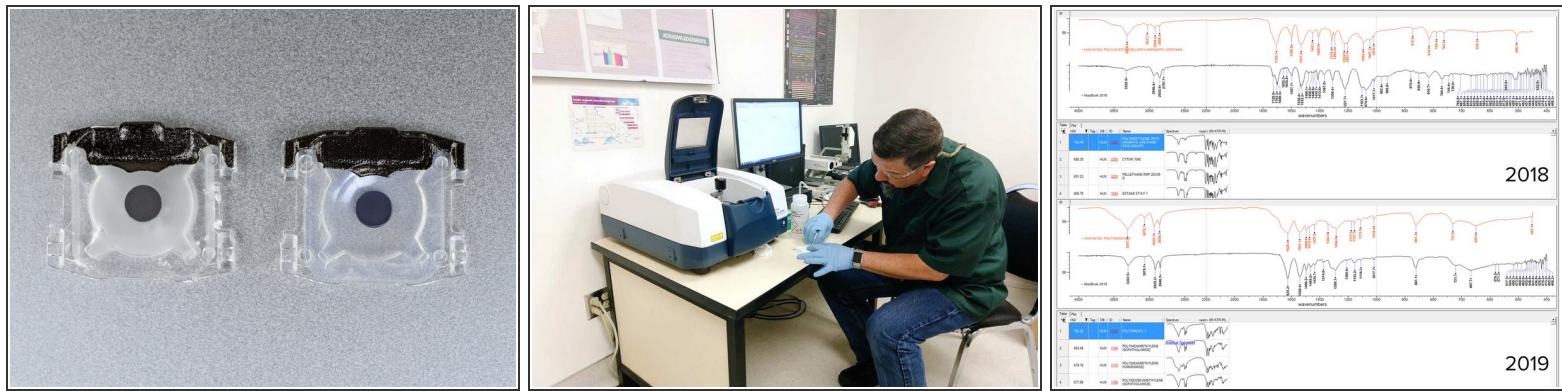
Step 7

- So, what changed this year? First, the transparent switch cover material.
 - The cover in the 2018 model is semi-opaque, somewhat tacky, and feels like silicone. The new model is clearer and smooth to the touch.

- To confirm that the materials are indeed different, we analyzed them using Fourier Transform Infrared (FTIR) spectroscopy. Thanks to Eric Beaton and [Cal Poly's Materials Engineering department](#) for their equipment and expertise!

- **(i) FTIR analysis** works by shining infrared light at a material and measuring how much light is absorbed and at what wavelengths. This data acts like a fingerprint that can be used to identify the material.

- **The differing peaks and valleys** on the [FTIR spectra](#) for the two samples show us that they are different materials. But what are they?
 - When comparing these FTIR spectra to that of known polymers, the closest match for the 2018 model is either poly(acetylene) with aromatic urethane side groups, or a type of TPU (which seems more likely). The 2019 model is a match for polyamide (commonly known as nylon).

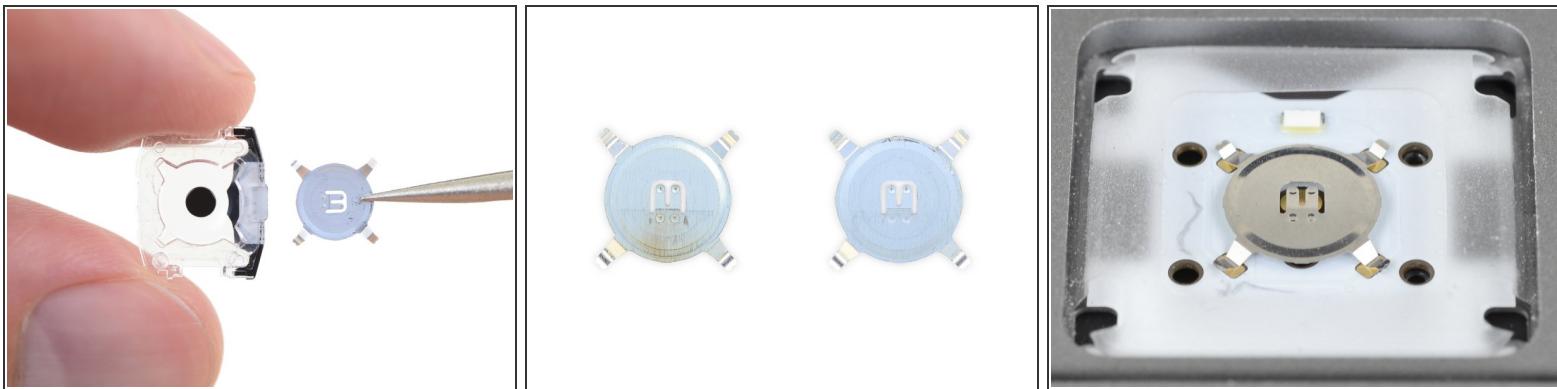
Step 8

- What else changed? We think the metal dome switch may have. Let's look closer.
 - The dome is like a really tiny [jam lid](#) or [Snapple cap](#)—you press down and it springs back up.

- If anything changes about the dome—if it's cracked or deformed—the key may behave erratically. Likewise, if the prongs break or bend, the key stops working.

- There are myriad possible reasons for this switch to crack or wear out—manufacturing defects, plain old fatigue, prolonged heat, moisture, outgassing from other components, and corrosion are all common culprits.

- These switches are also magnetized from the factory. Best guess as to their composition: ferritic stainless steel, with a thin polymer coating on the bottom. The difference in surface finish from the 2018 version (left) to the 2019 (right) indicates Apple may be using a revised heat treatment, or alloy, or possibly both.

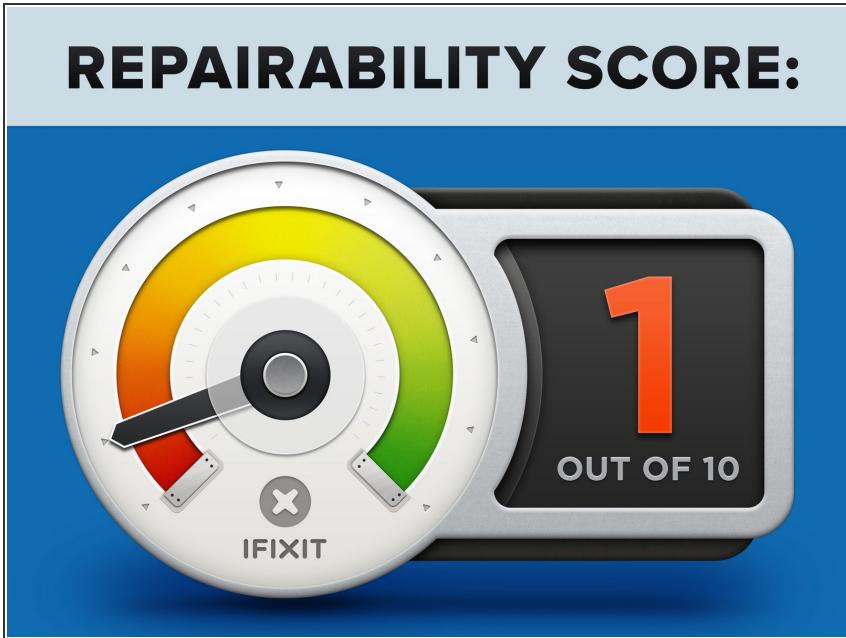
Step 10 — Final Thoughts

- The 2019 MacBook Pro 15" with Touch Bar earns a **1 out of 10** on our repairability scale (10 is easiest to repair):
 - The trackpad can be removed and replaced with very little drama.
 - The processor, RAM, and flash memory are soldered to the logic board. Repairs and upgrades will be impractical at best.
 - The top case assembly, including the keyboard, battery, speakers, *and* Touch Bar, is glued together —making all those components impractical to replace separately.
 - The Touch ID sensor doubles as the power switch, and is paired with the T2 chip on the logic board. Fixing a broken power switch may require help from Apple, or a new logic board.
