Magic Bullet NutriBullet Pro Rubber Gasket Replacement

Use this guide to replace a damaged rubber gasket on a Magic Bullet NutriBullet Pro for a tight seal that prevents leaks. If the seal is cracked or ripped it will continue to leak.

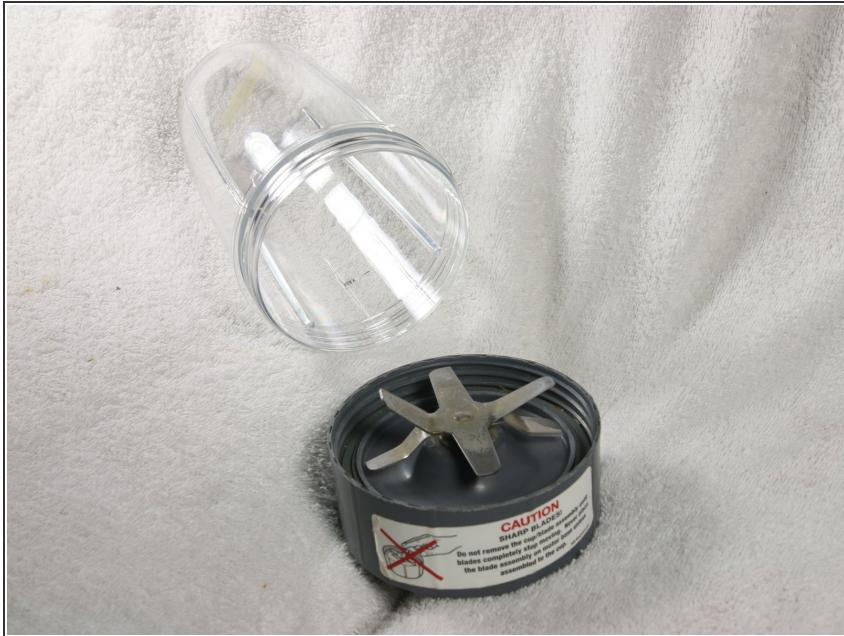
Step 1 — Rubber Gasket

- Unscrew the blending blade lid from the cup.

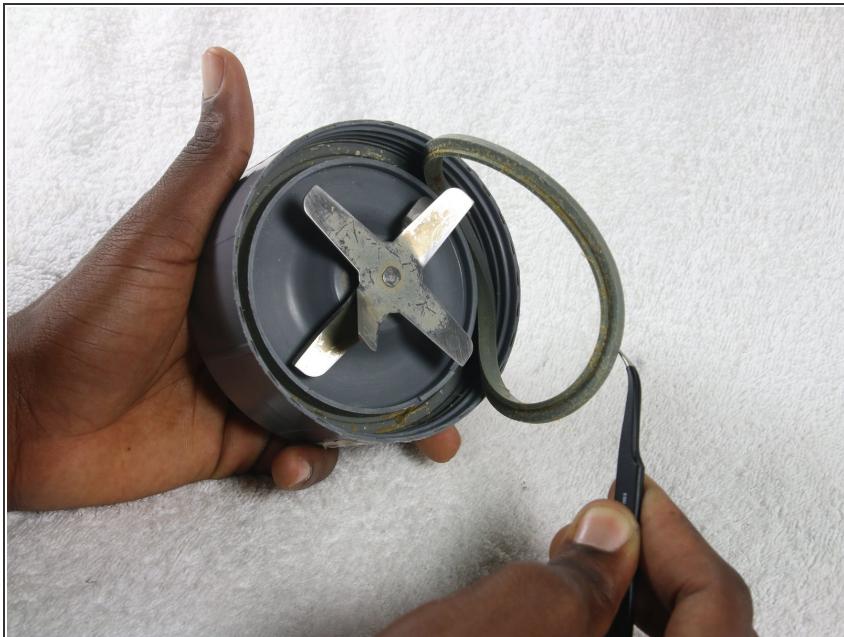
Step 2

- Use tweezers to peel back the rubber gasket that surrounds the inner ring of the lid.

To reassemble your device, follow these instructions in reverse order.
