Melitta Caffeo Solo drainage valve gaskets replacement

Replacement of the drainage valve gaskets in a Melitta Caffeo Solo

Written By: VauWeh

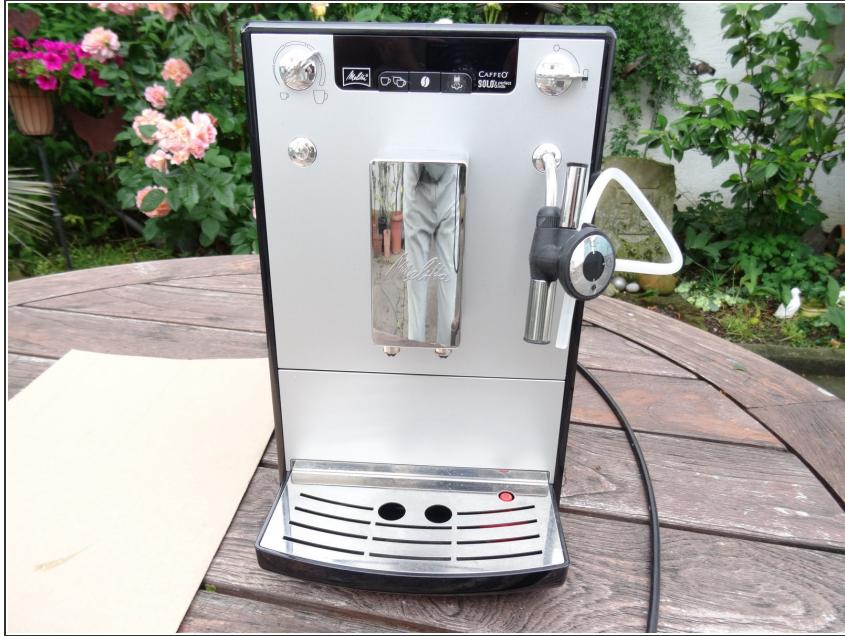
Step 1 — Open the Melitta Caffeo Solo

⚠ Pull out the power cord!

- Remove the water tank and drainage tray.
- Remove the side cover and remove the brewing unit.
- Remove all coffee beans.

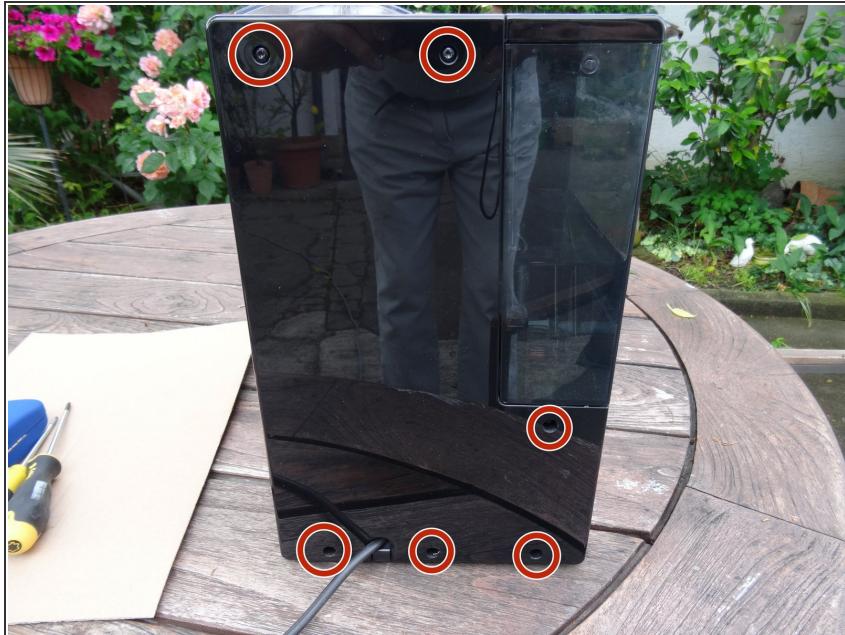
Step 2

- Unscrew and remove six Torx T10 on the rear.
- Lever the rear cover off. It will most likely be quite stuck and you will need to apply some force. You must use plastic lever tools to prevent damaging the cover.

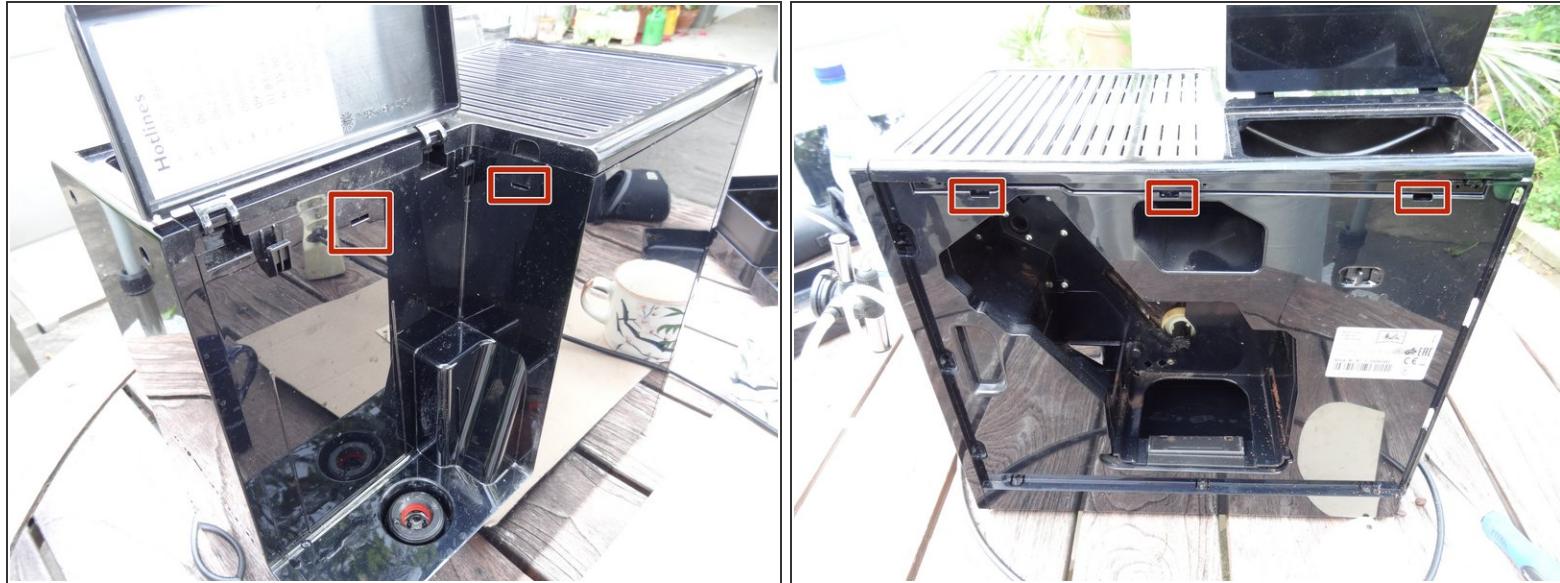
Step 3

- Press carefully into the slits on the sides using a minus screwdriver or a flat metal spatula, to release the clasps on the upper surface. These may be well tight and you have to use some force.
- You should have created a separation between the upper surface and side panels. Now lever the upper covering away using a plastic tool. This may be quite stuck and you may apply some force.

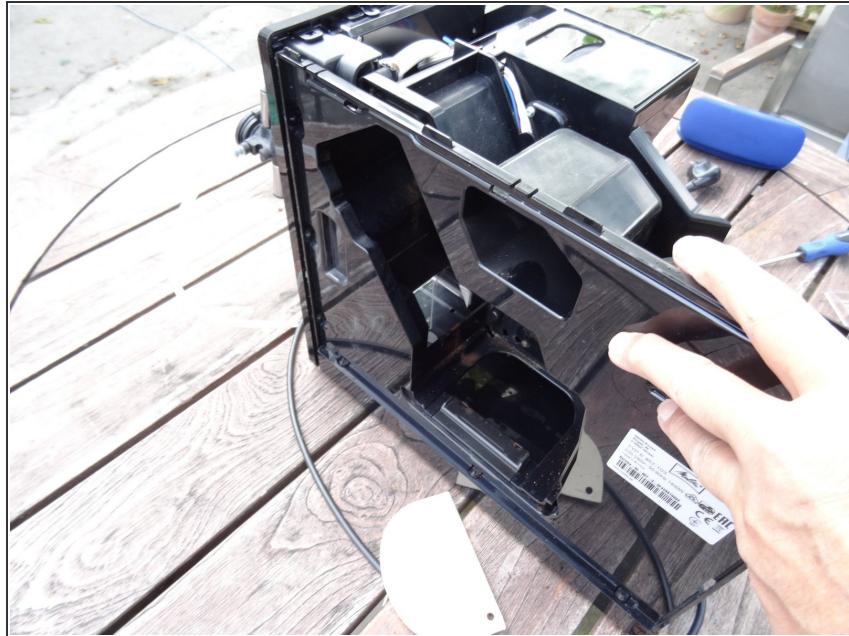
Step 5

- Place a plastic tool into the crack between the front panel and the right side panel and widen it. Then push the side panel to the back. This may be quite stuck and you may need to apply some force.
- Remove the side panel.

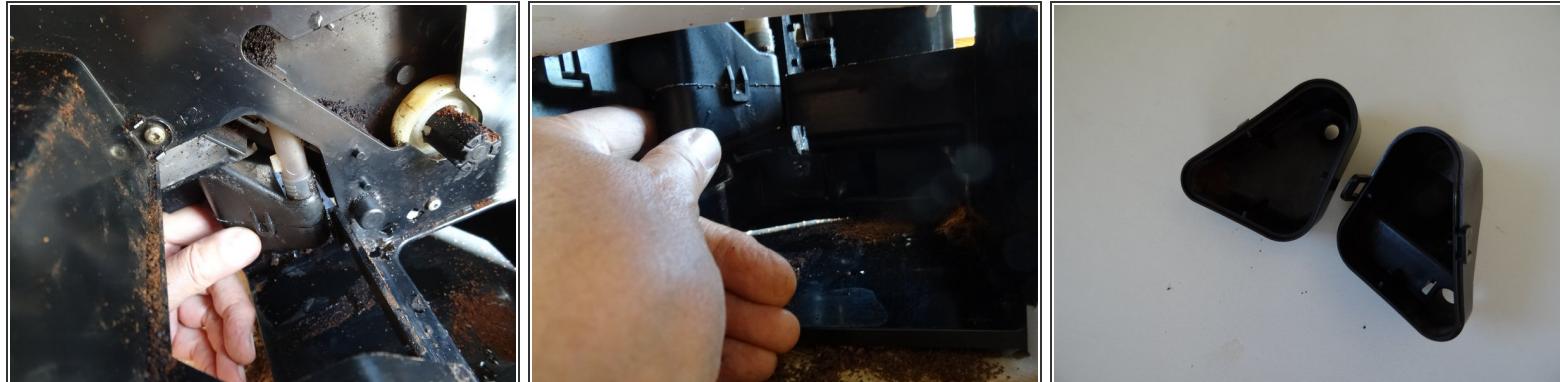
Step 6 — Gear Drive

- Rotate clockwise the expansion box about 60 degrees and pull it out.

(i) The expansion box is frequently filled with coffee oils or grounds. Clean it from time to time. It can easily be separated into two halves.

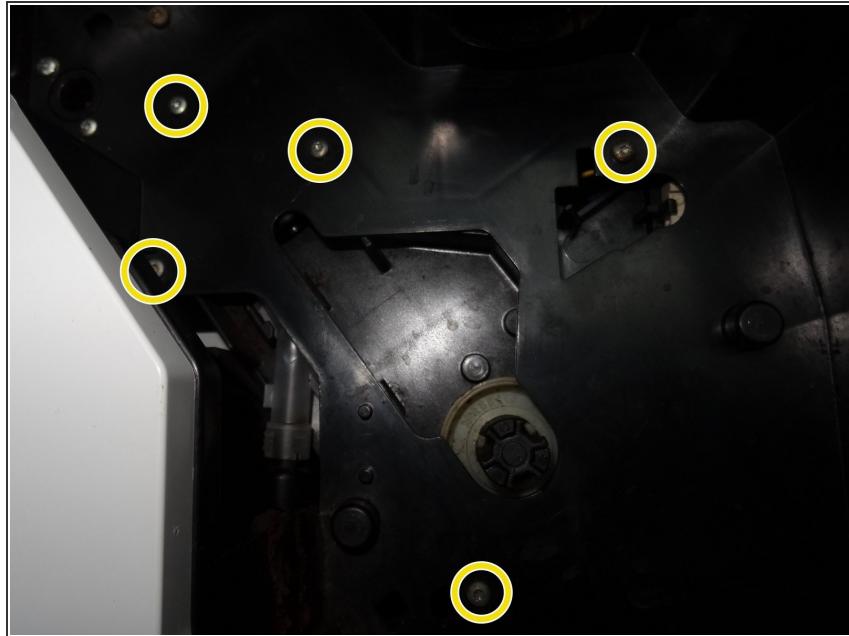
Step 7

i The drainage valve is directly plugged to the gear drive. The drive is fixed with five Torx T10 screws on the center panel behind the brew group.

- Remove the five Torx T10 screws holding the gear drive in place.
