# Mercedes W123 Sway Bar Link Replacement

The rear sway bar is connected to the hub assembly by what is called a sway bar link. Over the years the boots that protect the joints split, allowing in dirt and moisture, eventually ruining the joint. This can create a lot of noise from the rear.

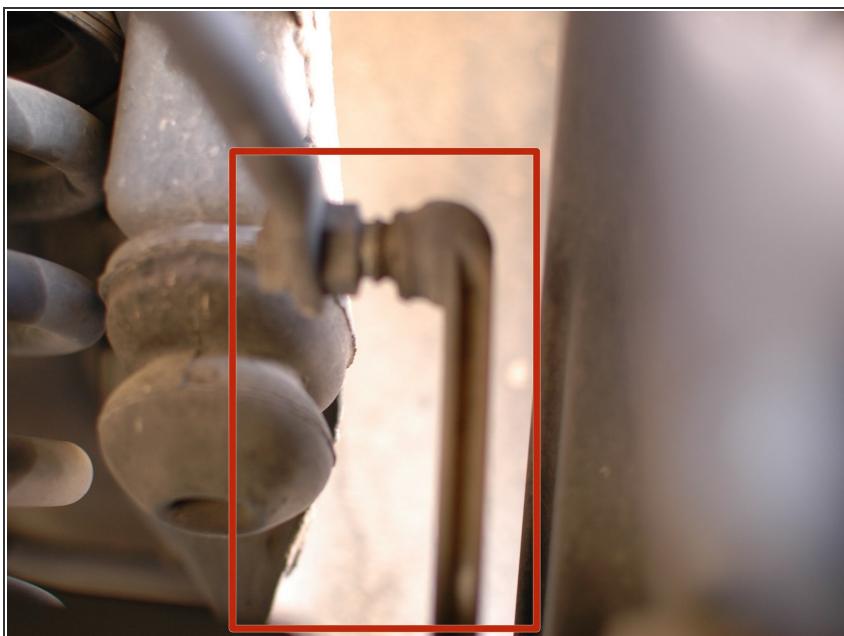
## Step 2

- You can see here the sway bar link where it attaches to the sway bar. It's hidden partially behind the brake shield. It's tricky to take a good picture of...
- The threaded portion of the link goes through a hole in the sway bar end and is held in place by a nut.

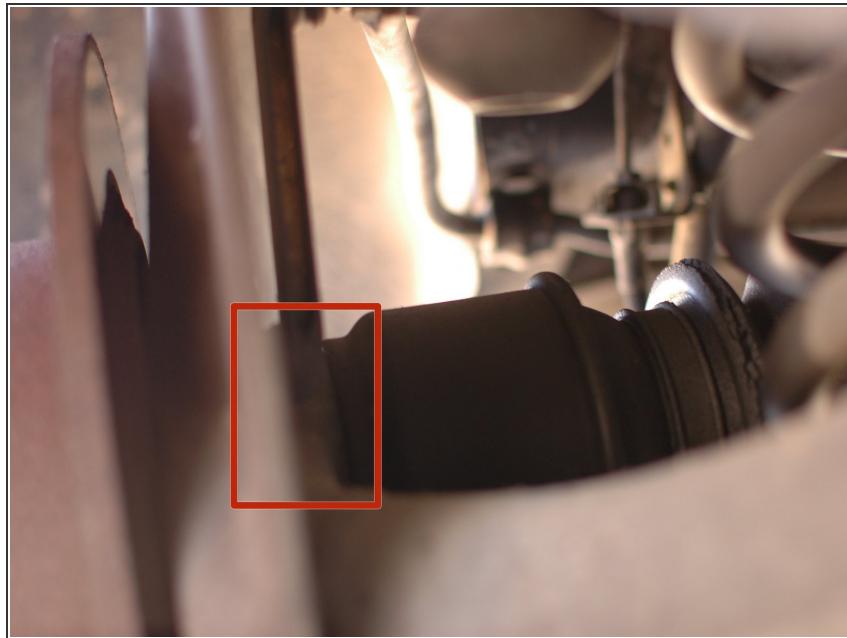
## Step 3

- At the bottom, it screws in to the hub assembly.

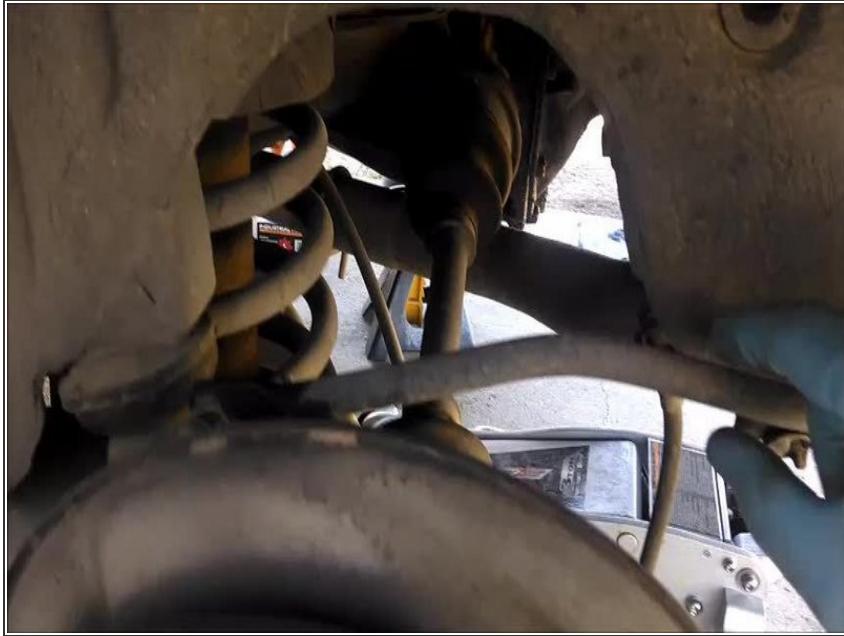
## Step 4

- View this video to hear what a bad sway bar link sounds like when you move the sway bar around. If yours sounds like this is definitely time to replace it.

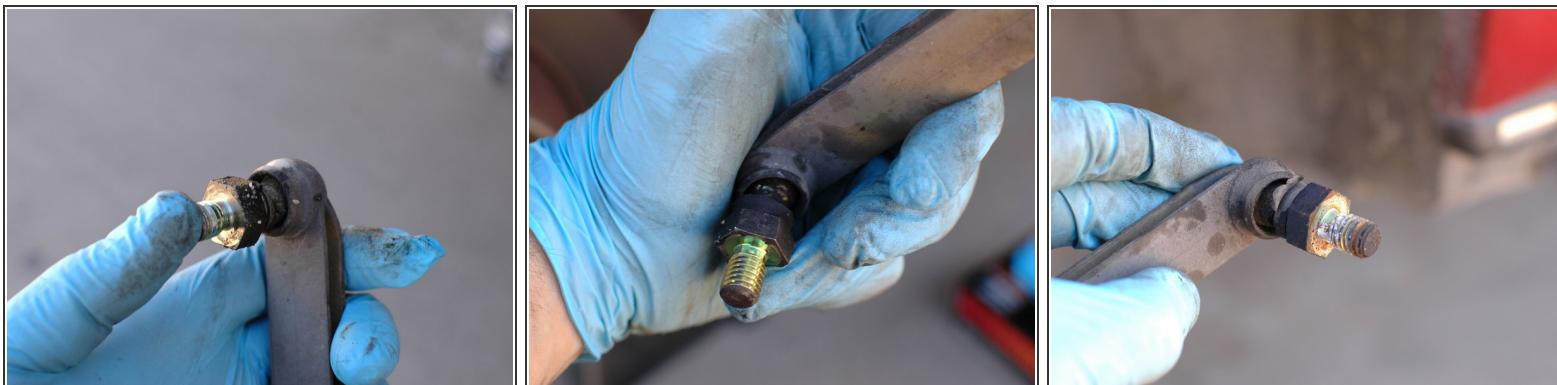
## Step 6

- Pictured are examples of the joints on the two sway bar links that were removed from this 1985 300D. Each one is split or even missing.
- You can see how this exposes the joint to moisture, dust, and road debris; this quickly ruins the joint.

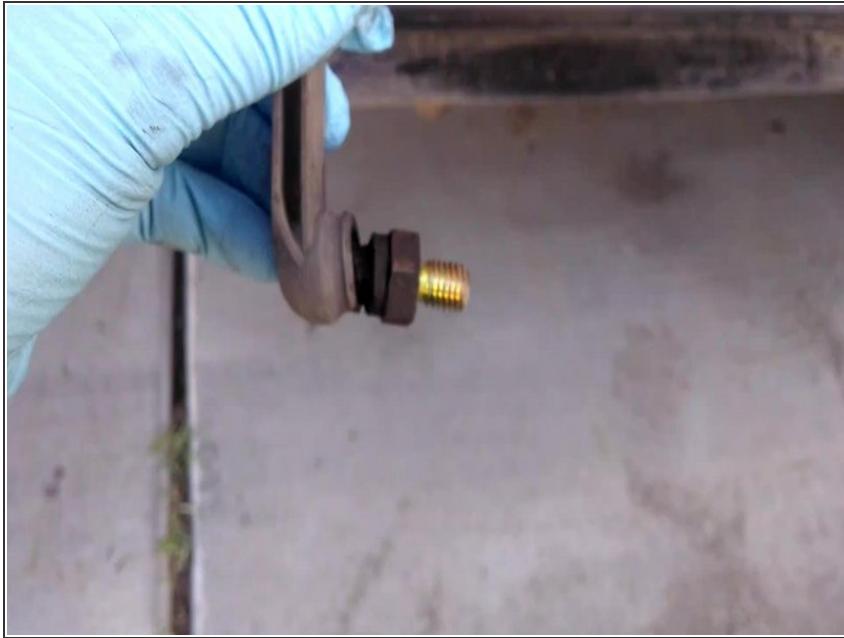
## Step 7

- Watch this video to see how loose the bottom joint on this sway bar link was. It was half of the culprit for the clunking. The other side was just as bad.
