Mercedes W123 Turbo Elbow Seals Replacement

To get air from the air cleaner housing to the turbo, Mercedes installed a plastic elbow in between. This is sealed at both end with rubber seals. Check to see that yours are installed properly and are not dry and brittle.

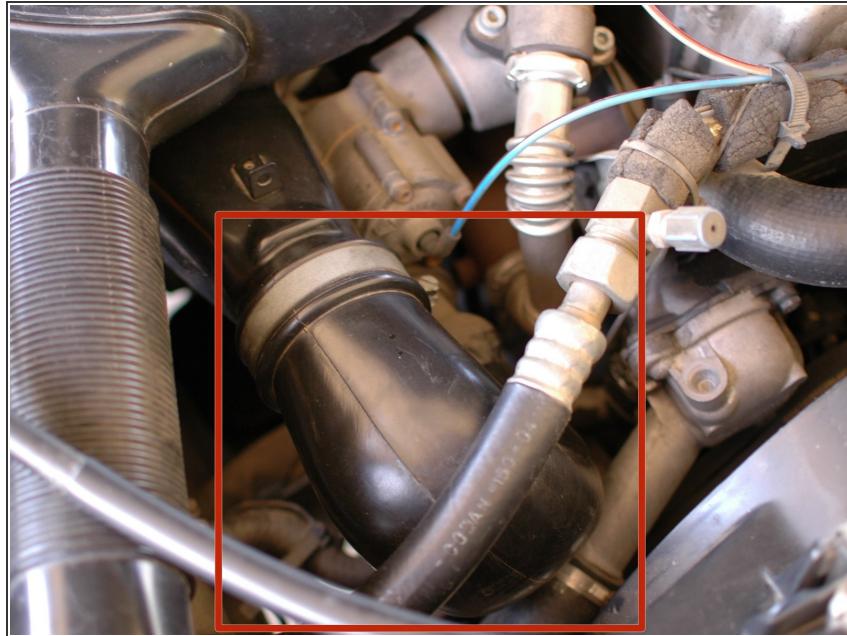
Step 1 — Turbo Elbow Seals

- Open your hood.
- Find the turbo elbow, just in front of the air filter housing, attached to its lower outlet.

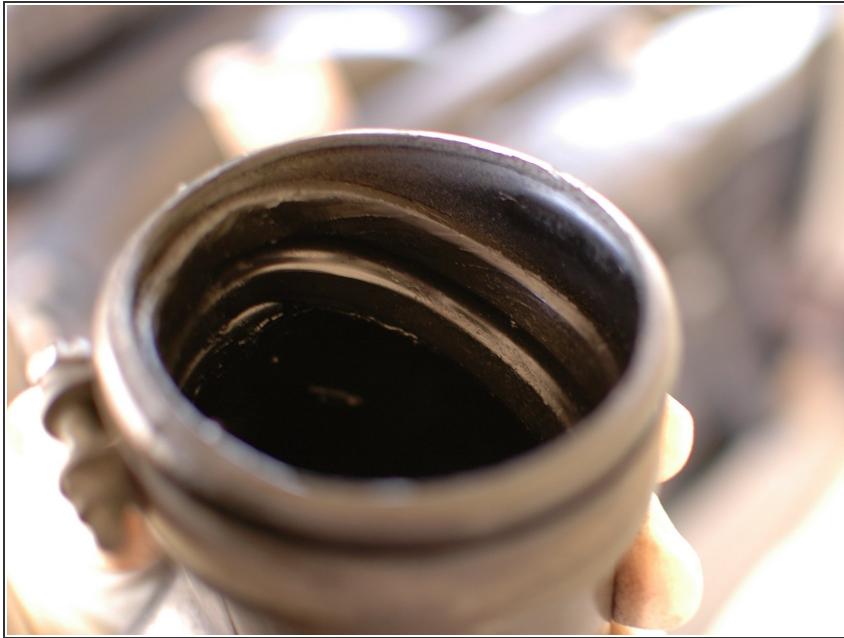
Step 3

- The turbo elbow can now be pulled off.
- Start by inspecting the upper seal. As you can see, this one was installed improperly. It was pushed back in to the elbow during installation. This is typical, and due to a Mercedes design issue.

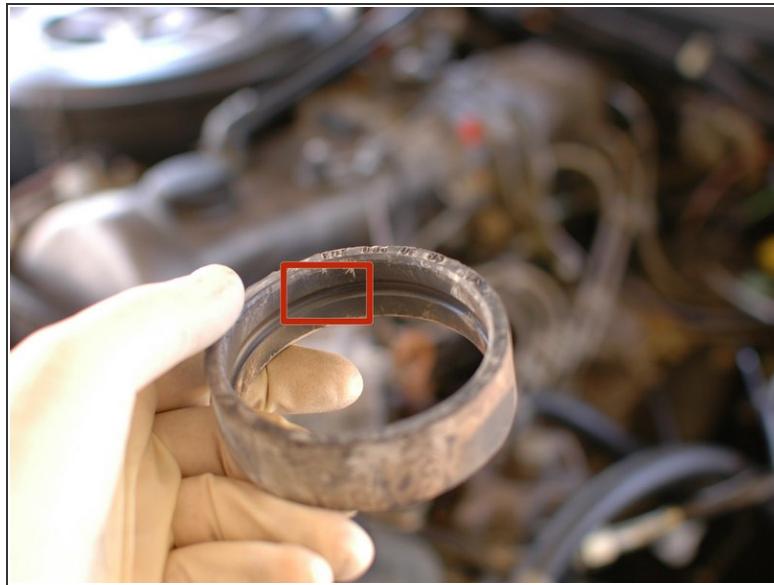
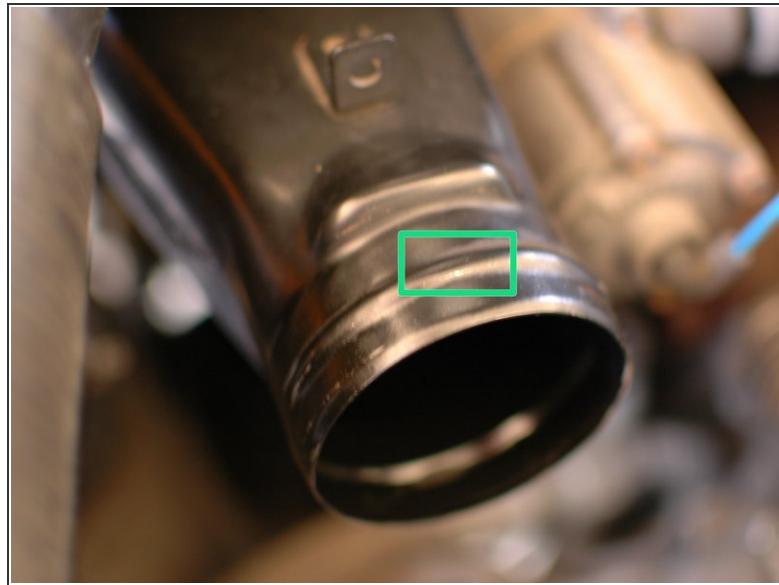
Step 4

- Allow a brief discussion of the design issue...
- The seal for the upper elbow has a groove built in to it.
- The neck on the air filter housing where this seal goes has a matching ridge.
- This prevents the new seal from easily slipping on to the neck and it often gets pushed back in to the elbow, preventing a proper seal.
- A potential fix for this will be addressed later in the guide.

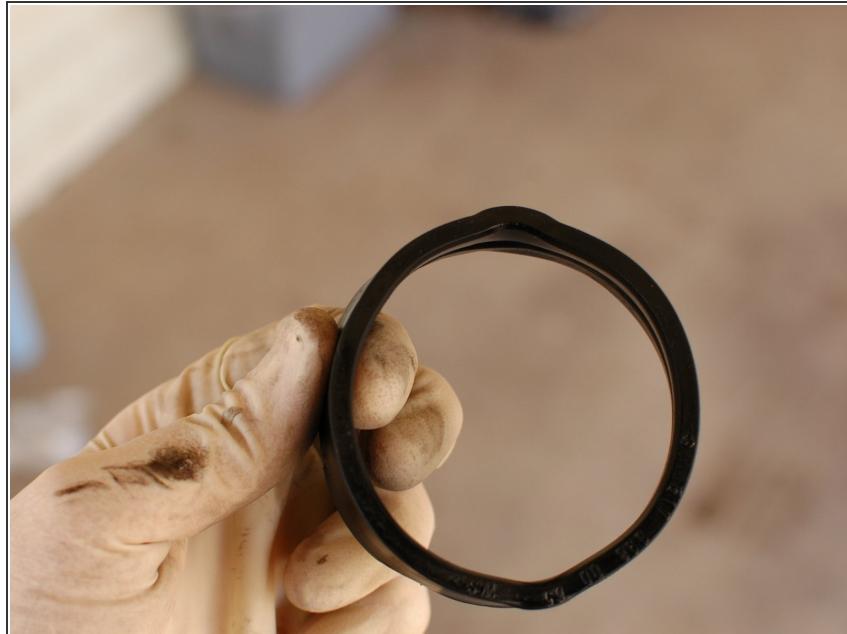
Step 5

- Remove the upper seal now. Needle nose pliers work well for this.
- As you can see, the old seal was deformed due to its improper installation.

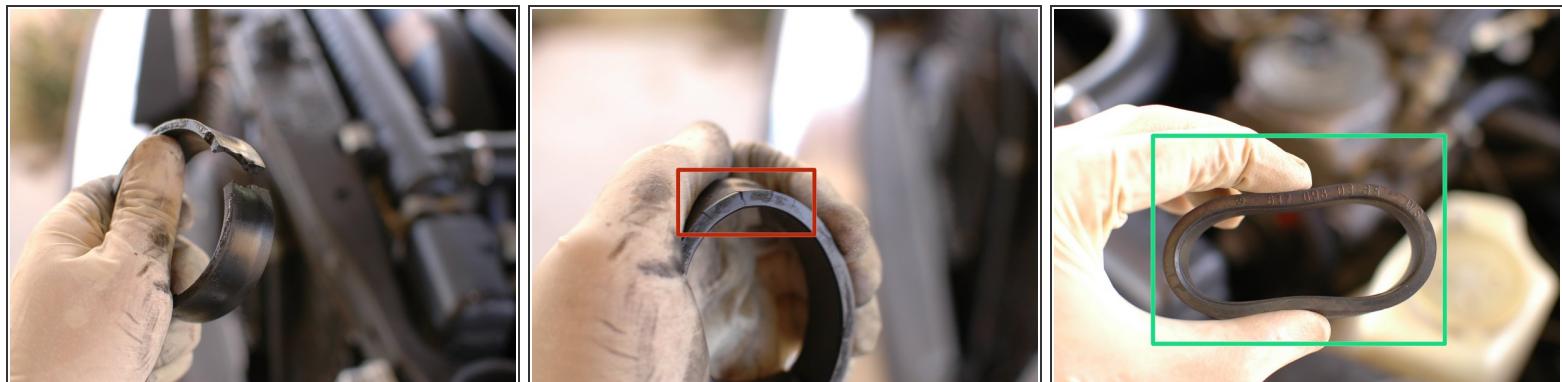
Step 6

- Now remove the lower elbow seal.
- The old one on this car was so old and brittle it would not bend for removal. It had to be broken in half using a needle nose pliers.
- Notice that the unbroken side of the old seal shows visible cracks when squeezed.
- Compare this with the new seal.
