Microsoft Surface Book 2 Teardown

Microsoft Surface Book 2 teardown done on 11/17/2017.

Written By: Michael Degnan

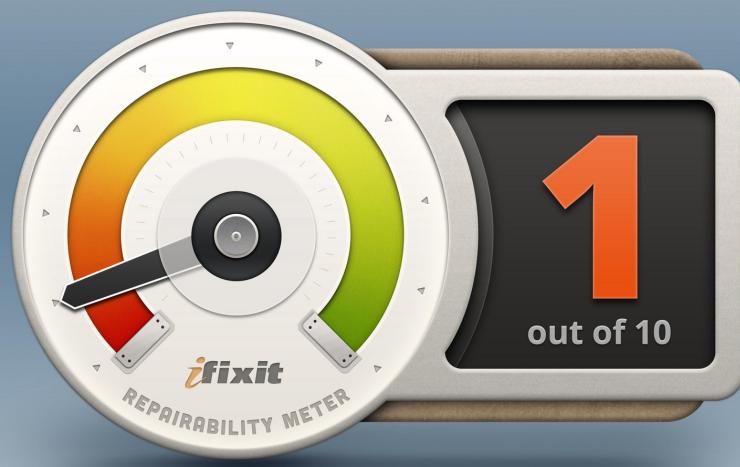
REPAIRABILITY SCORE:

- After the difficult opening procedure, the SSD can be replaced.
- The display assembly consists of a fused glass panel and LCD, and is difficult to remove and replace.
- The processor and RAM are soldered to the motherboard.
- Strong adhesive holds many components in place, including the display, base cover, and both batteries.
- Many components are on the backs of their respective boards, requiring motherboard removal to replace simple components.
