Microsoft Surface Go Teardown

Teardown of Microsoft's entry-level tablet, the 10" Surface Go. Performed August 2, 2018.

Written By: Jeff Suovanen

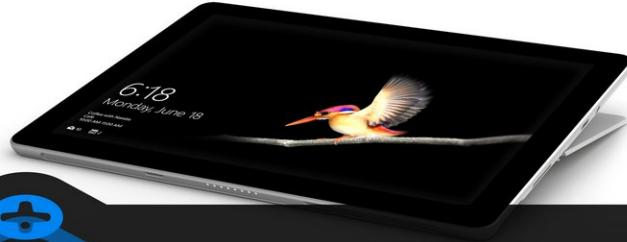
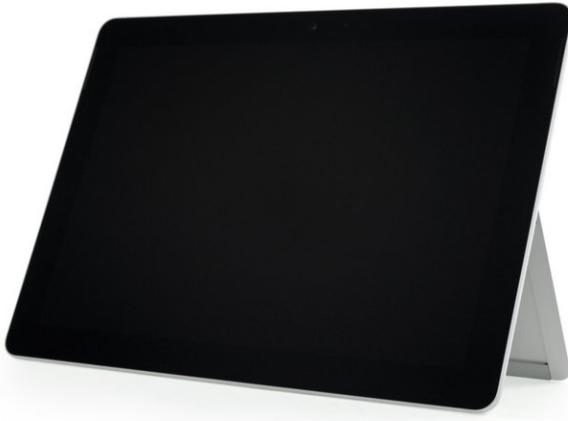
Step 1 — Microsoft Surface Go Teardown

- As always, our teardown begins with a cursory inspection:
 - 10" IPS multi-touch display with 3:2 aspect ratio and 1800 × 1200 resolution (217 ppi)
 - Dual-core 1.6 GHz Intel Pentium Gold 4415Y processor with integrated Intel HD Graphics 615
 - 4 GB RAM (8 GB optional)
 - 64 GB eMMC storage (128 GB NVMe SSD optional), with additional storage via microSDXC
 - 8 MP primary camera with 1080p video; 5 MP / 1080p selfie camera

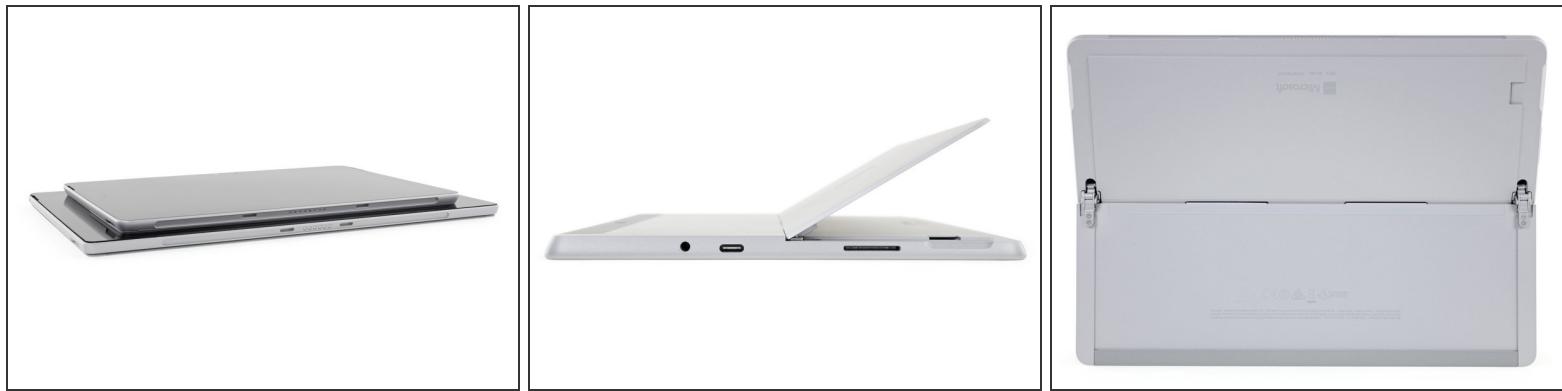
Step 2

- Compared to the Pro, the Go looks to have smoother curves, rounder edges, and a vaguely more iPad-y aesthetic.
- The Surface Go doesn't believe in the [fewer-ports-is-more-ports](#) trend. This tablet packs a USB-C port, headphone jack, a couple proprietary connectors, *and* an SD card reader.
 - Hunting for that SD port, we accidentally [woke](#) the sleeping Go—presumably a magnetometer notices when the magnet-toting kickstand moves.
- Peeking between the [slightly redesigned hinges](#), we spy FCC info, the model number (1824), and storage and memory specifications.

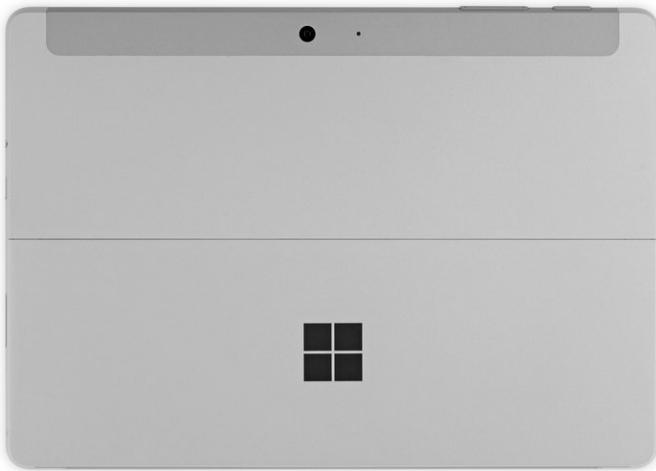
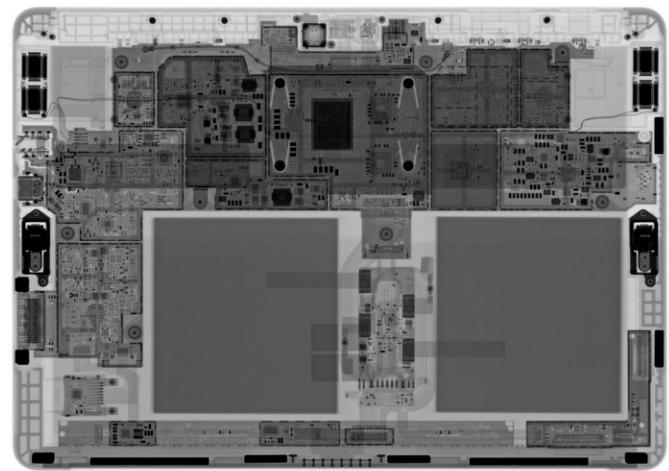
Step 3

- There's more than one way to teardown. Our way takes a while, so our friends at [Creative Electron](#) give us the X-ray version.
- Preliminary intel: two battery cells, lots of circuit board—and no visible heat pipes! Looks like the Surface has been on a low-copper diet.

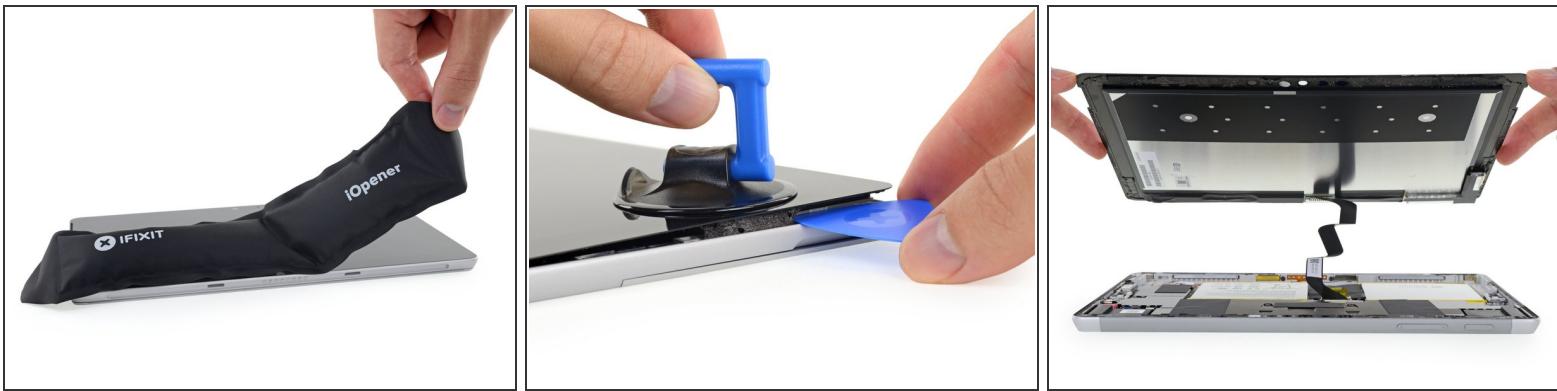
Step 4

- If we've learned one thing after five years of Surfacing, it's how to open these things.
- Our well-used [iOpener](#) brings the heat, then a [suction handle](#) and [opening picks](#) ([just a few this time](#)) attack the ample adhesive.
- *(i)* We encounter the same kind of goopy glue as before, but the smaller, sturdier display makes the opening procedure seem a little less [scary](#).
- The display's off, and we're pleased to see that Microsoft allowed it a fairly long leash.
- *(i)* A long display cable makes it easier to disconnect the display without damaging the cable, for safer and easier display removal.

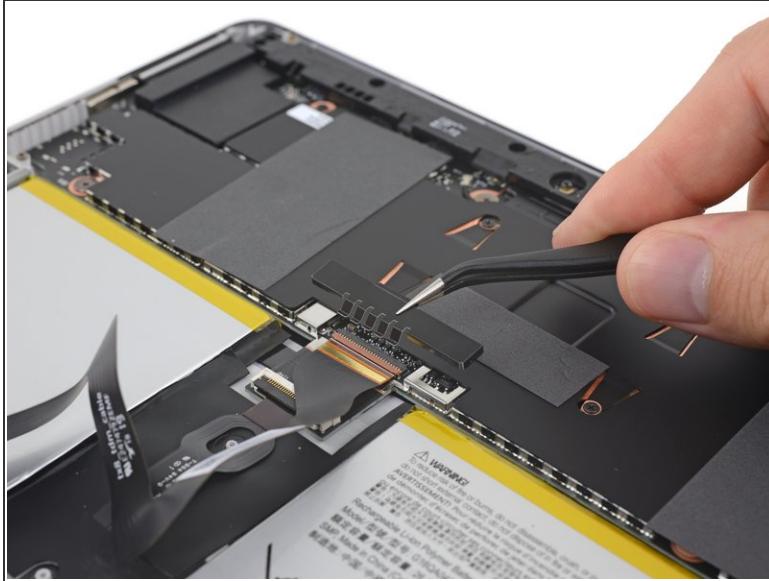
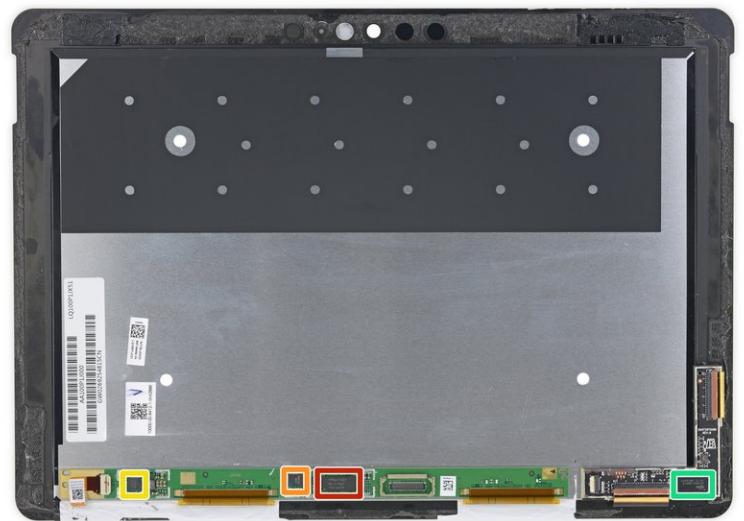
Step 5

- One last obstacle before the display is free—an EMI claw shield guarding the display ZIF connector.
- With the display free, we turn our attention toward the bottom edge, and discover a few display chips in their natural environment:
 - Likely MegaChips [S15 series LCD timing controller](#)
 - i7248 H717690
 - 18996MB N746547
 - KTH6212MAYS

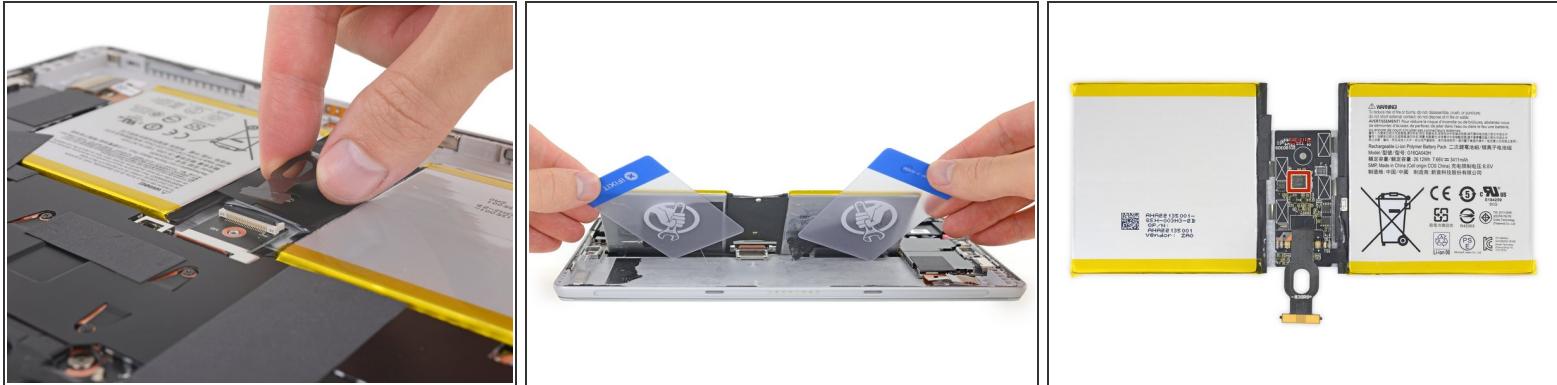
Step 6

- To our great surprise, the Surface Go has an immediately disconnectable battery! With no need to fully remove the motherboard, repairability is looking up.
- Or is it? Removing the battery is just like [the bad ol' days](#)—two giant pads of adhesive put up a staunch fight against our [adhesive remover](#) and plastic cards.
- **(i)** Glued-in batteries prevent consumers from easily extending the life of their device, and they increase costs for recyclers at the end of the device's life.
- The battery in the Go is a lot smaller, at 26.12 Wh, than any [of its pro-level predecessors](#)—even the similarly sized [iPad 6](#) packs a 32.9 Wh powerbank.
- A Texas Instruments [BQ40Z50](#) series Li-ion battery pack manager is the brains of this operation.

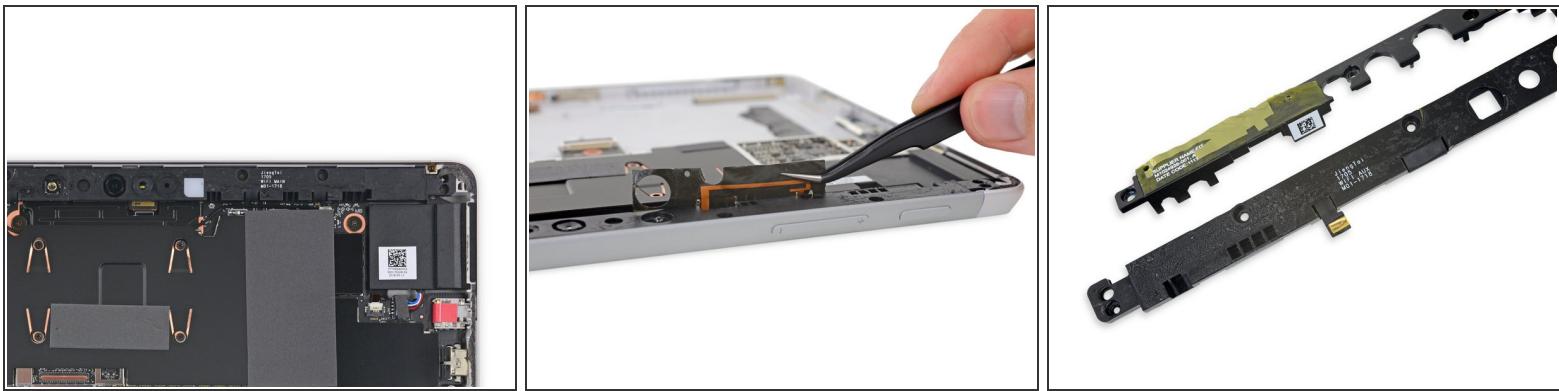
Step 7

- Turning our attention to the Wi-Fi antennas, we fully expect to find them mangled after that hack-and-slash display separation.
- Having the display cover glass [glued right over the top](#) of the Wi-Fi antennas has wreaked havoc on many a Surface Pro repair attempt. Most times, the antennas don't survive display removal.
- This time, we have to keep looking... and looking.
- These antennas are actually tough to spot, and seem miraculously unscathed. That's one of our poor [5th-gen Surface Pro antennas](#) up top, for comparison.
- They've definitely been redesigned—perhaps with slightly less of a nail-biting repair experience in mind?

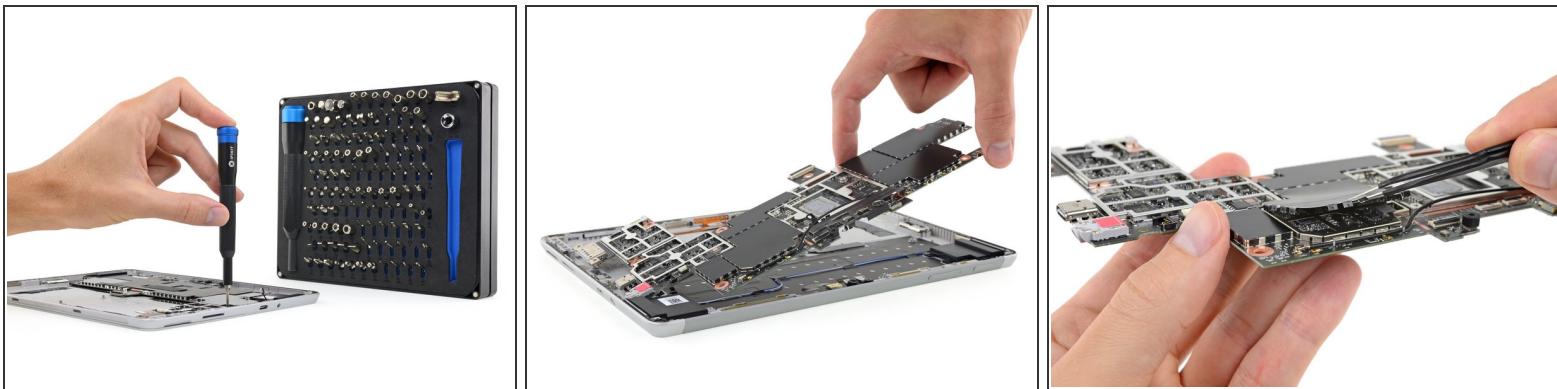
Step 8

- Our journey beneath the Surface doesn't get any easier as we move on to the motherboard.
- Thankfully there's no glue here, but we're forced to excavate our way through seemingly endless layers of shields, tape, and hidden screws in order to unearth the board.
-

Luckily, we have our [Manta Driver Kit](#) to keep us company, and to deal with any fasteners we find.
- Finally, we relieve the motherboard of the last of its restraints, and free it from its metal and plastic prison.
- Even with the motherboard free, we keep digging, through shielding and fabric stickers, to find the silicon that lies hidden underneath.

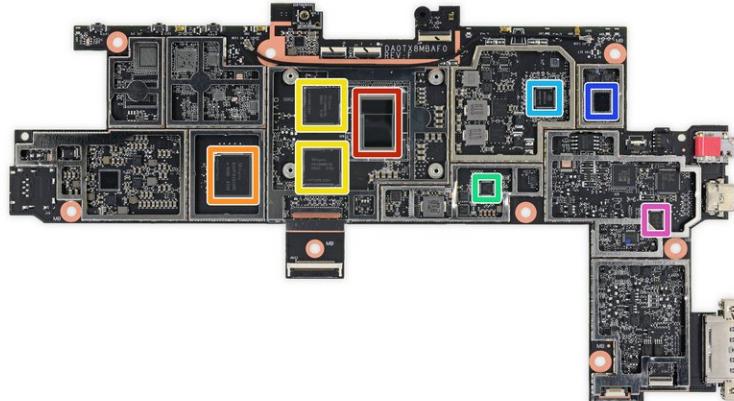
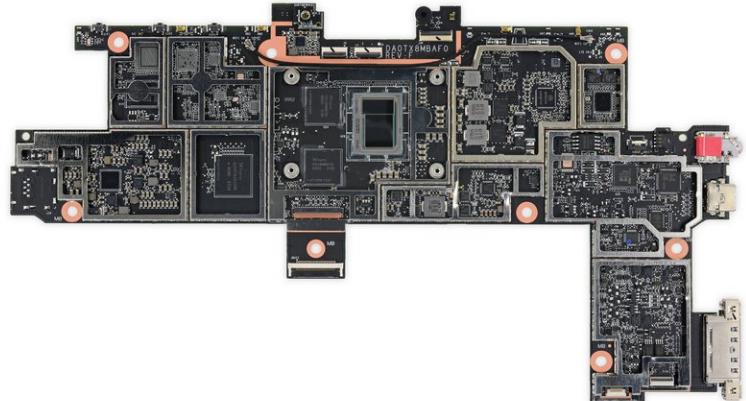
Step 9

- At last, we're rewarded for our hard work with a treasure trove of silicon:
 - Intel Pentium [4415Y](#) processor
 - SK Hynix [H26M74002HMR](#) 64 GB eMMC5.1 NAND flash memory
 - 2x SK Hynix H9CCNNNBKTAL 16 Gb LPDDR3 SDRAM (4 GB total)
 - Texas Instruments [BQ25700A](#) battery buck-boost charge controller
 - ON Semiconductor [NCP81216](#) phase controller
 - Qualcomm [QCA6174A](#) Wi-Fi/Bluetooth SoC
 - Parade Technologies PS87430 (likely [USB host switch](#))

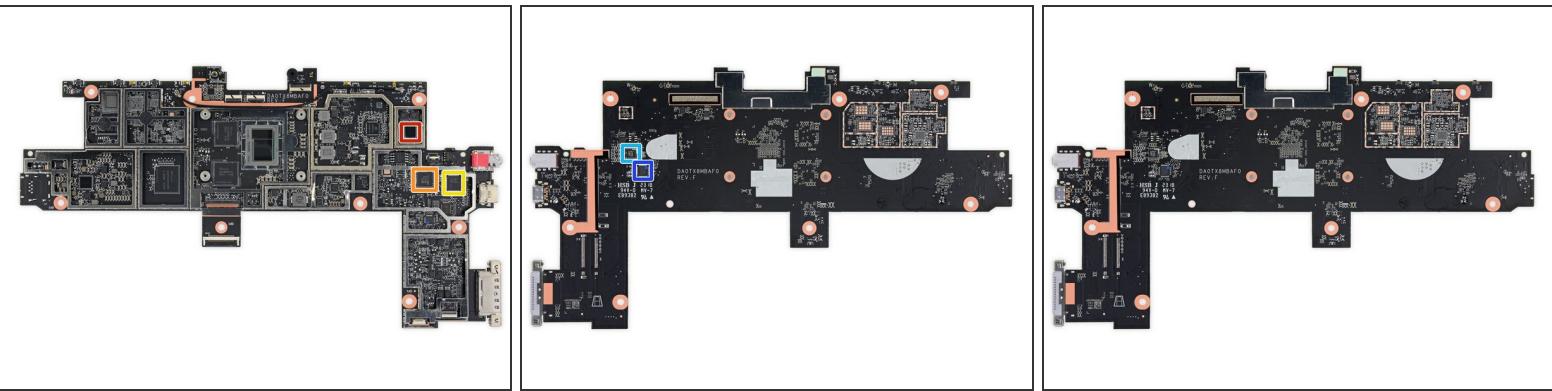
Step 10

- More front-side chips:
 - Qualcomm [QCA6174A](#) Wi-Fi/Bluetooth SoC
 - ITE Tech Inc. [IT8987](#) LPC bus controller
 - Realtek [ALC298](#) audio codec
- Back-side chips:
 - NXP P3003
 - Atmel [ATSAMD20E](#) ARM microcontroller

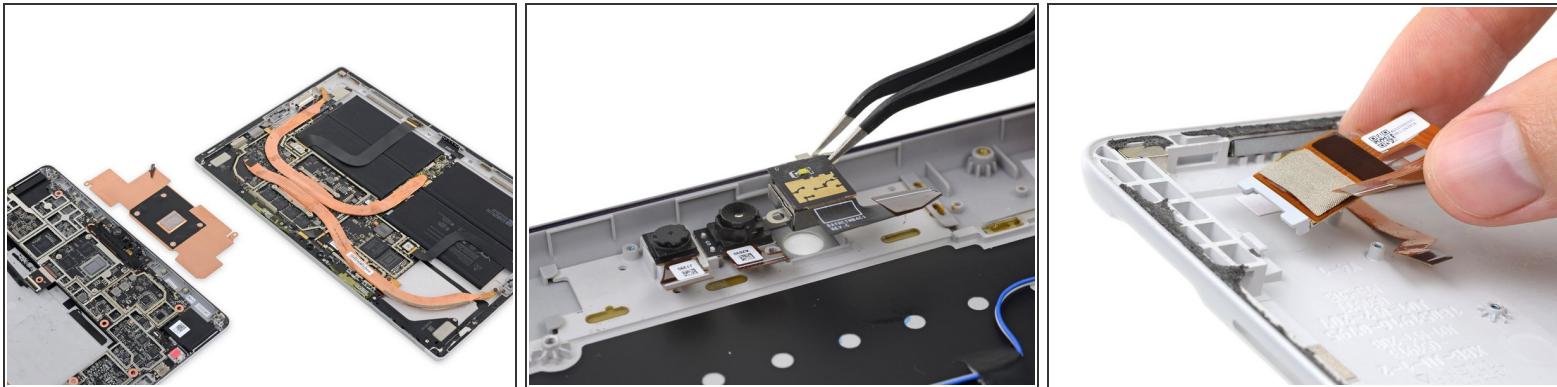
Step 11

- All that silicon, and yet this Go is fan-less and heatpipe-less. This thin copper shield and some thermal paste will have to do the heat sinking for this would-be PC. (Then again, you can always [run it in a freezer...](#))
- It's certainly a radical departure from those thick copper tentacles we found on the 5th-gen Pro, on the right. Hopefully it'll be enough for the Go's power-sipping, non-Turbo'd processor.
- Now to pluck the final strings of this teardown. Such as: the Windows Hello camera, the 5 MP front-facing camera, and the 8 MP rear-facing camera (complete with piggybacked LED) all sitting in a row.
- Finally, the modular microSDXC port with Realtek 5227S [card reader controller](#)—which is *technically* upgradable storage!

ⓘ Not exactly the kind of upgradability we were hoping for, but we'll take what we can get.

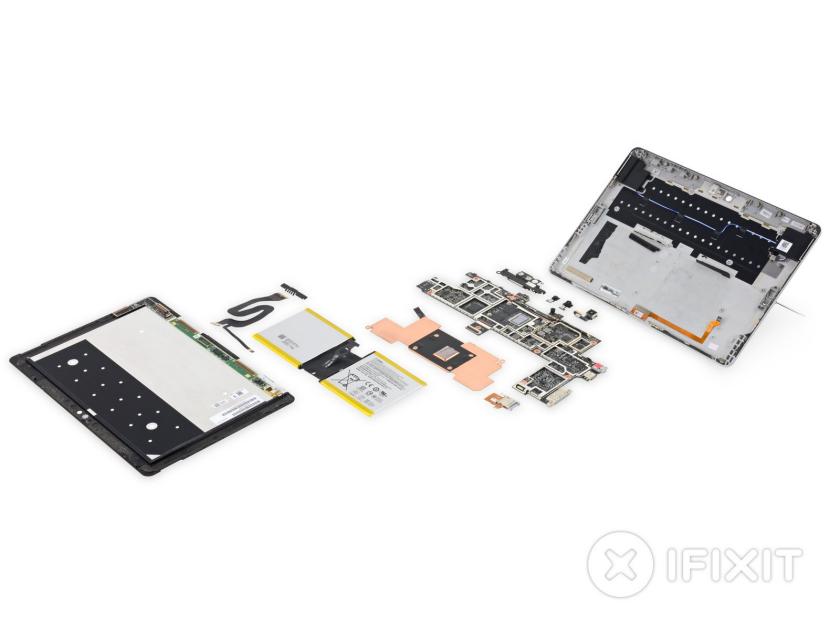
Step 12

- Here are all the bits lurking beneath the Surface. Thanks for joining us!

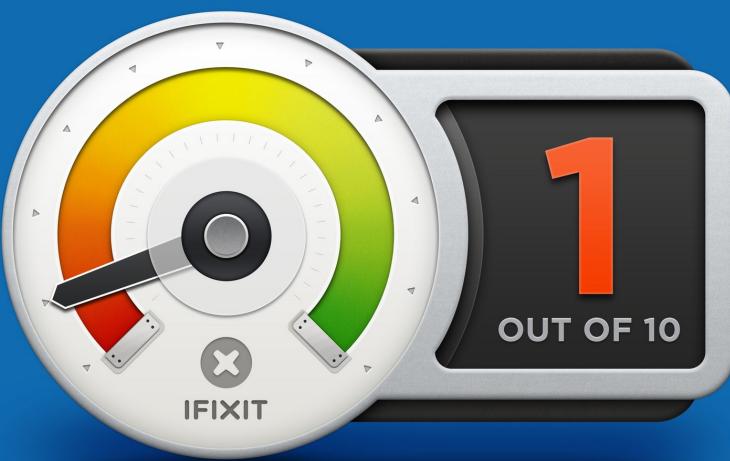
REPAIRABILITY SCORE:

- The Microsoft Surface Go earns a **1 out of 10** on our repairability scale (10 is the easiest to repair):
 - The smaller form factor seems to make the glass easier to remove without breaking, but it's still terrifyingly hard.
 - If this is expected to replace a PC, the lack of upgradability will severely limit the device's lifespan.
 - The lack of modularity, especially on high-wear ports, makes repairs unnecessarily expensive.
 - Adhesive holds many components in place, including the display and battery.
 - Replacement of any part requires removal of the display assembly, an easy (and expensive) part to damage.
