Microsoft XBOX 360 Quick Charge Kit Bad Capacitor Replacement

Failed Xbox Quick Charge Kit not continuing to charge, or charging at all. LED off or intermittent when unplugging & re-plugging charger from power source.

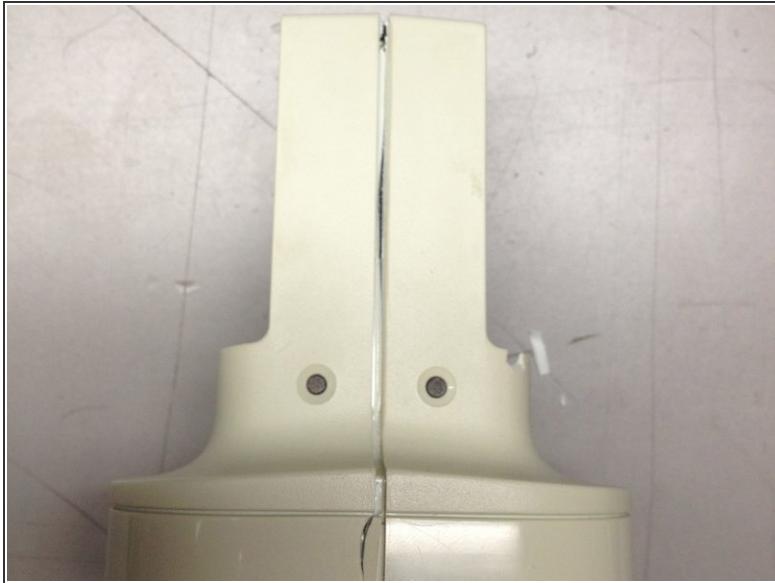
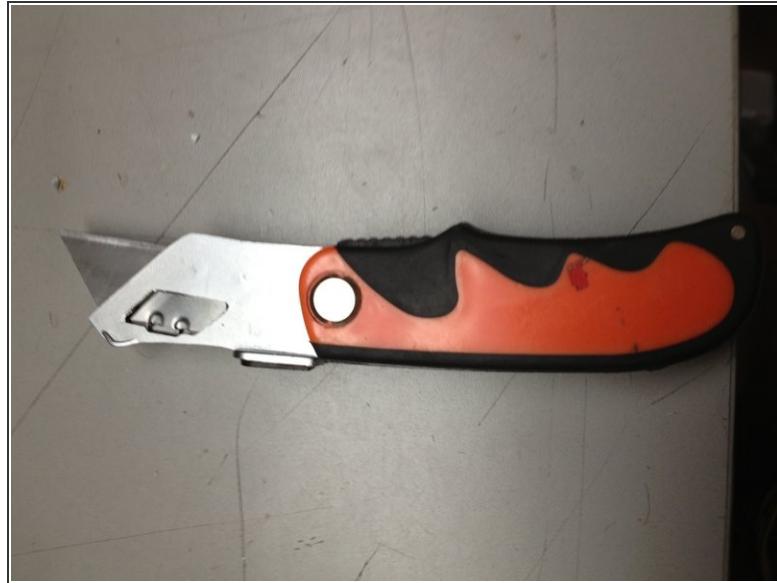
Step 1 — Bad Capacitor causing charge to fail

- Unit is glued together, making disassembly somewhat difficult. Using a utility knife, repeatedly score the plastic, top to bottom and all the way around, in the seam on the face, rear and bottom of the charger. The knife will begin to penetrate the charger.

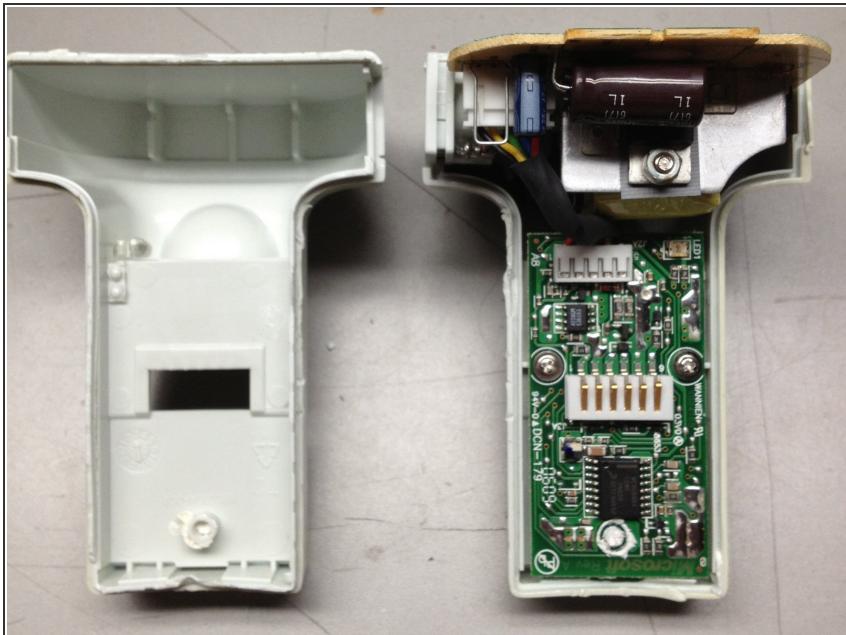
Step 2

- Using a spudger or similar stiff plastic tool, begin prying around the unit in the line that you previously scored, avoid having the tool go in to the device and damaging components. Eventually it will split apart.

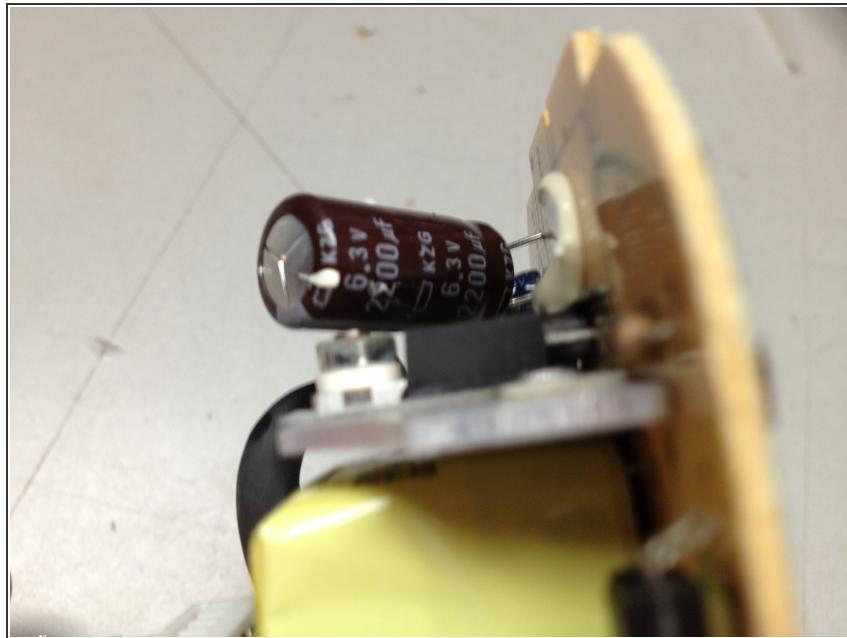
Step 3

- Note the bulging top of the failed capacitor. It's a 2200uF 6.3V available at any local TV repair shop.
- De-solder it from the board noting the polarity. The side with the grey line is the negative that faces the heat sink.
