Written By: Chris Hopper

## INTRODUCTION

## Step 1 — Trigger Assembly

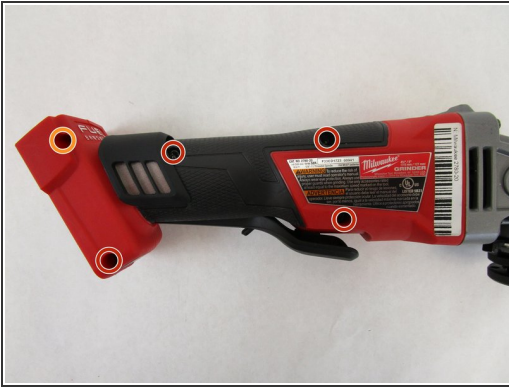
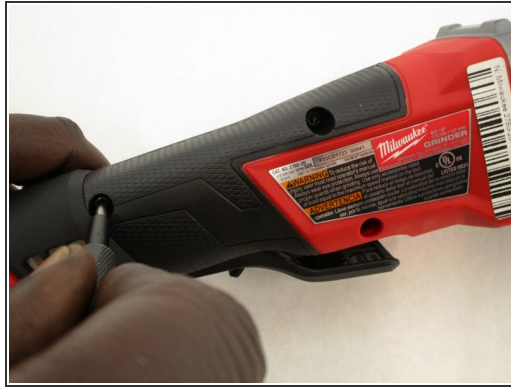
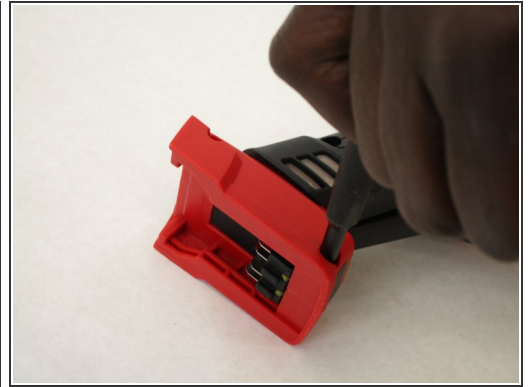
- Using a Torx T20 screwdriver, unscrew the four 16mm screws from the case.
- Switch to the Torx T10 screwdriver, and remove the last 16mm screw from the hilt.

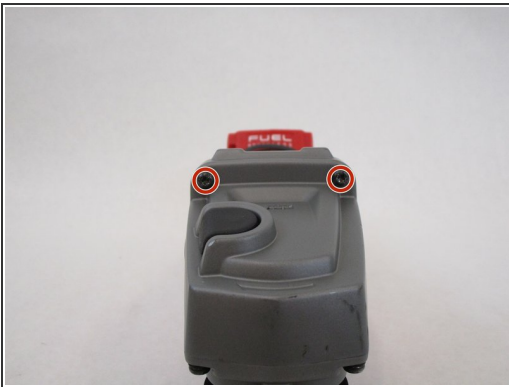
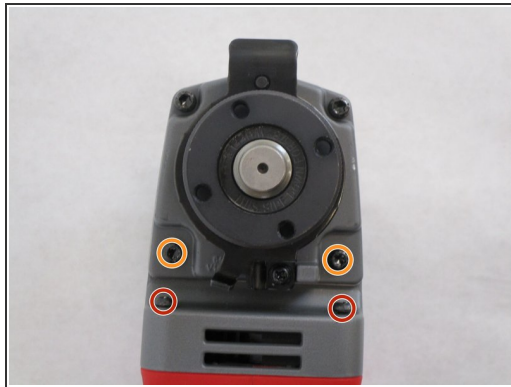
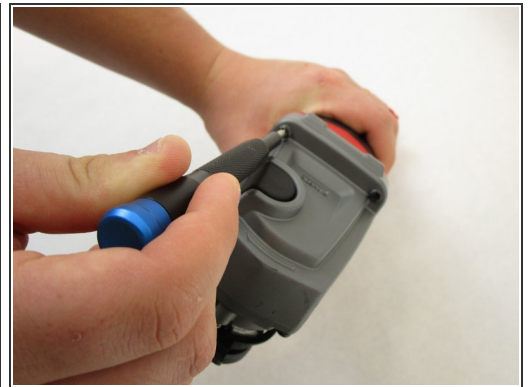
## Step 2

- Using the Torx T20 screwdriver, unscrew the four 28mm screws located at the bottom (and top) of the gearcase assembly.
- Remove the two 12mm screws with a Torx T20 screwdriver in order to get to the others.

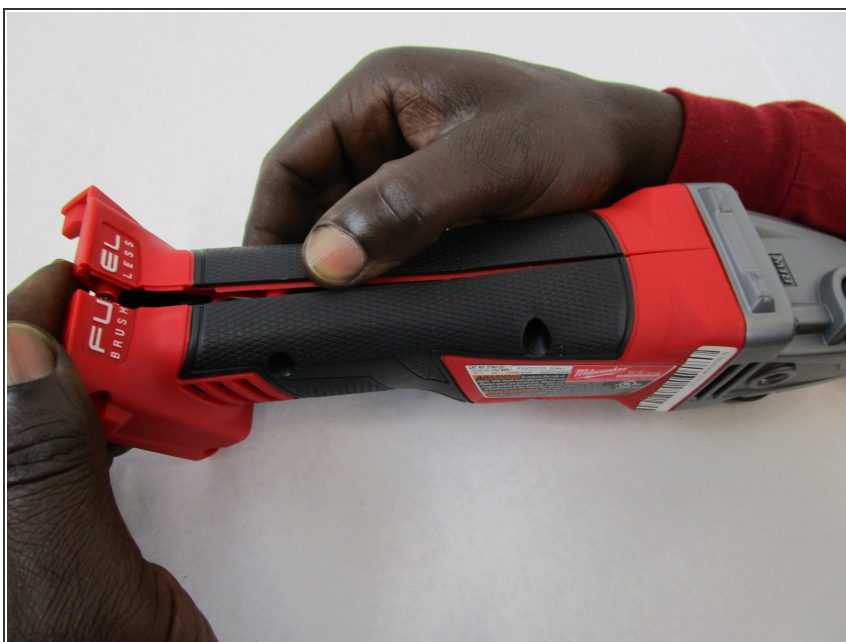
### Step 3

- Pull apart the housing handles.

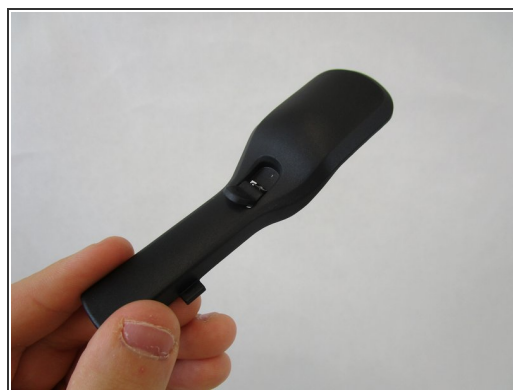
### Step 4

- Lift the trigger assembly off of its mount.
- Dispose of the old trigger assembly and install the new one.
