# Olevia LT23HVX Power supply repair

Olevia LT23HVX not powering on

It is apparently a common problem with the Olevia LT23HVX that the power supply fails. The condenser on the power supply PCB are very frequently failing.

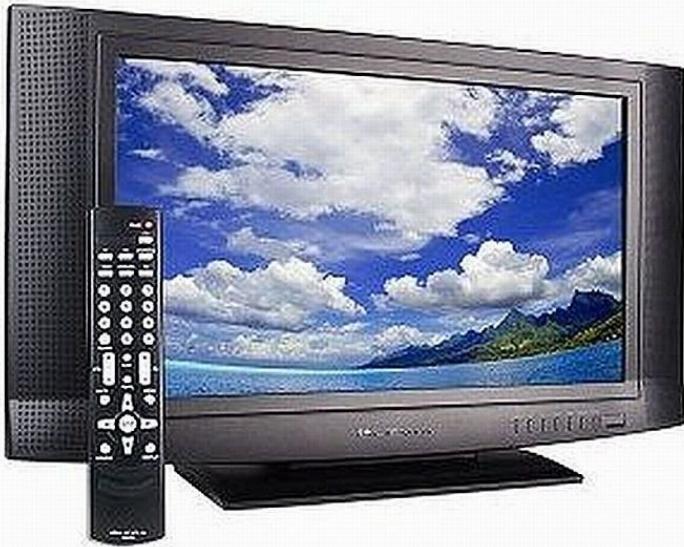
## Step 1 — Olevia LT23HVX Power supply repair

- Okay, so I read about the Olevia LT23HVX after I purchased one for a very decent price on an auction site. After all, as a member of the ifixit forum, I can fix almost anything. I have the support....

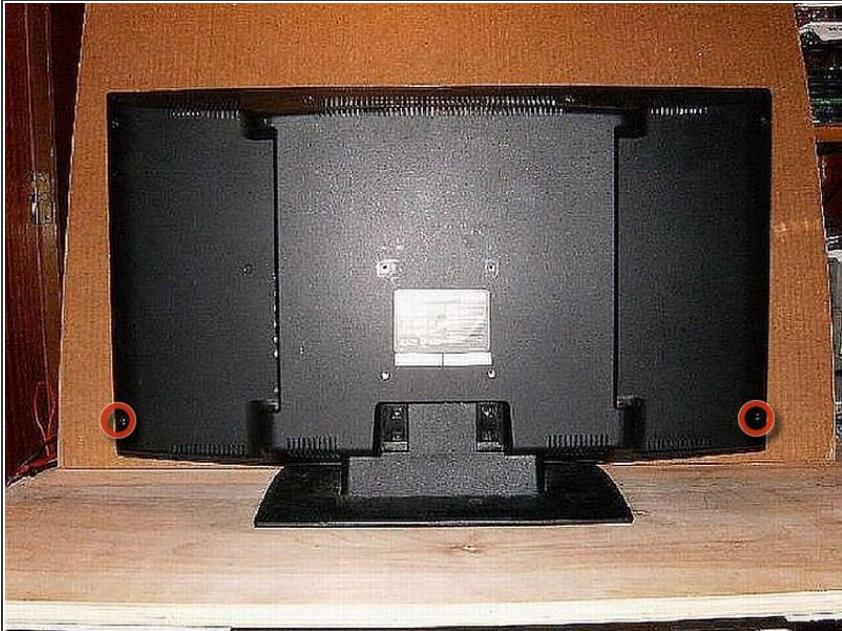
- The first thing to do is to remove the screws that hold the back on. There are arrows on the plastic that show which screws to remove. Word of wisdom, if you have some screws missing, it is because somebody already opened it. This was the case with my TV monitor. So, you never know what surprise is going to await you.
- Also remove the 4 small bolts that hold the stand to the back.

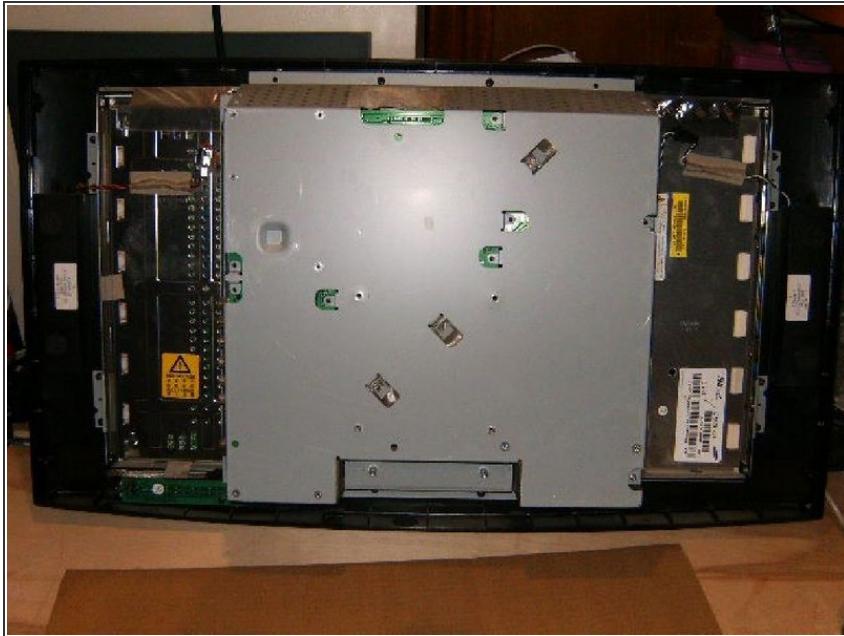
- Once the back is unscrewed it can be separated. It is only pressed to the front part slightly and should come off pretty easy. There is now a grey metal box that holds the printed circuit boards.
- At the top left and right, are two sets of cables that enter the metal box. Those are the speaker wires. Unclip the connectors.

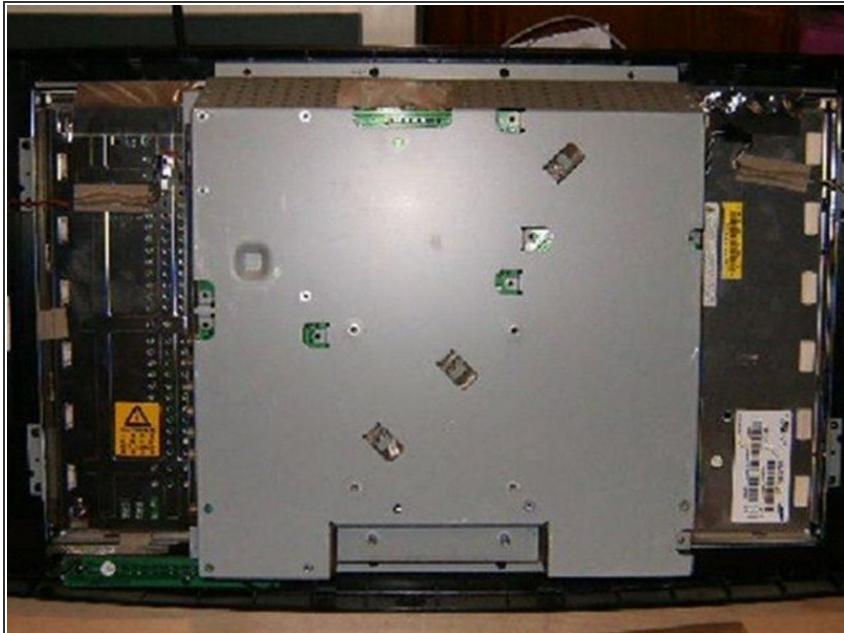
- The grey metal box is held in place with at least 4 screws. Again, there are arrows pointing to the screws that need to be removed.
- On the bottom left is a ground wire that is wrapped around a shielded cable. Ensure that it is not binding with the metal case.

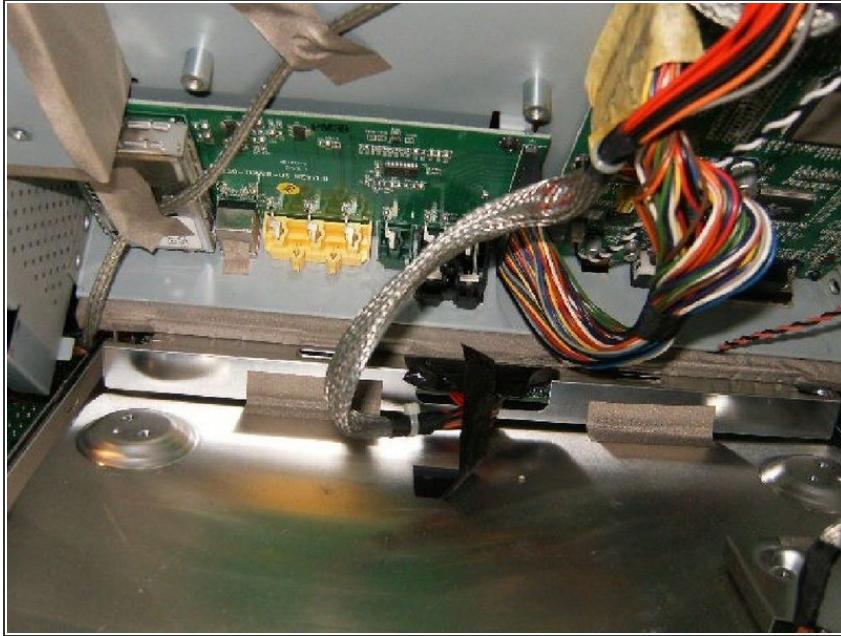
- Tilt the gray metal box from the left to the right. Do not try to pull it off.
- Once you tilt it, you will see a wiring harness that is connected to the box via some tabs. Pull those gently apart, remove the shielded cable.
- The harness is terminated via a connector to the side. Unplug the connector by GENTLY pulling on the side of the plastic. Do not pull on the wires.

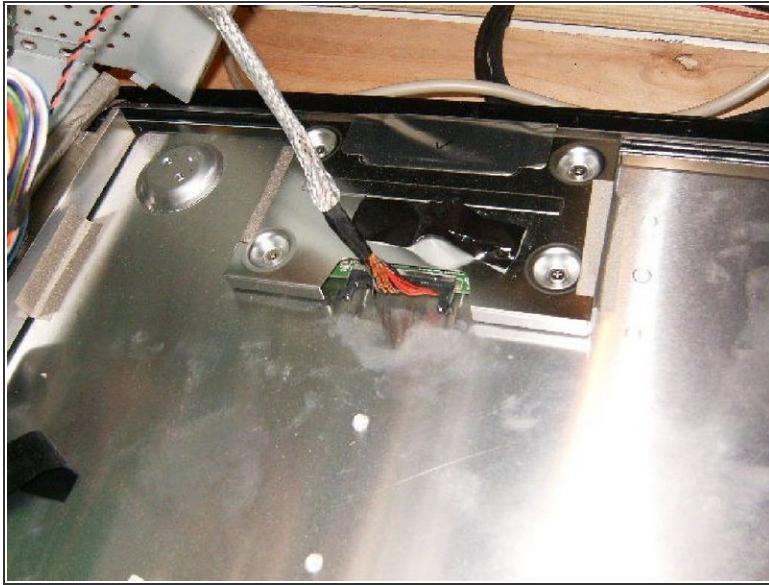
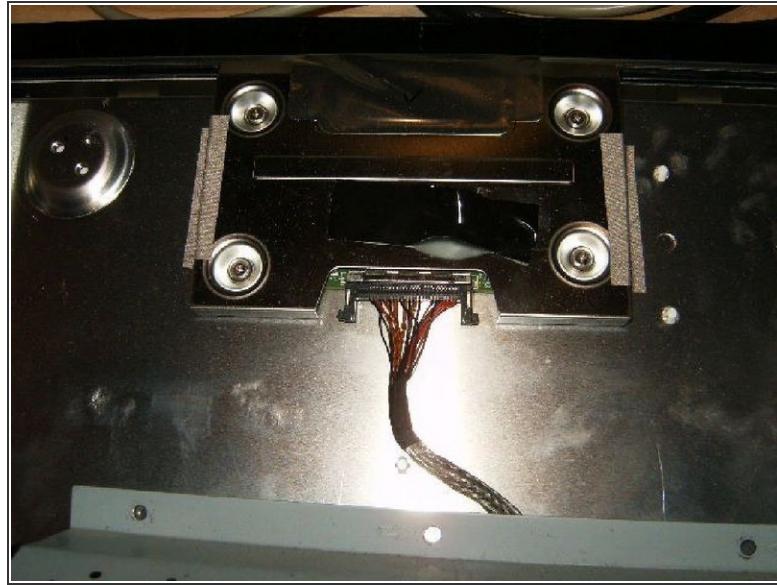
- The next wiring to remove terminates to the top to another connector. This one is a little trickier and must be removed by squeezing the tabs on the side while pulling the connector.
- In my case, due to a broken clip on the side of this connector I opted to leave it connected. That way, I can not totally remove the metal cover, but will have to turn it over.
- Once the wiring harnesses are disconnected and they are off the metal tabs, tilt the metal cover to the left. Check continuously that all the wires are off and nothing gets hung up.

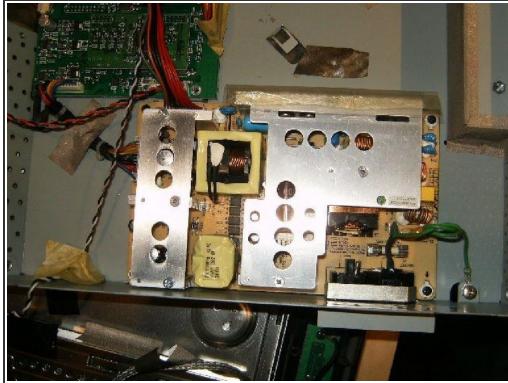
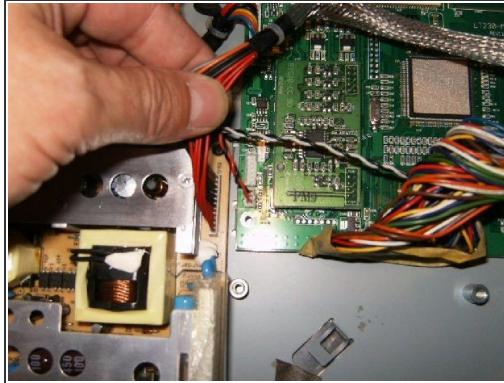
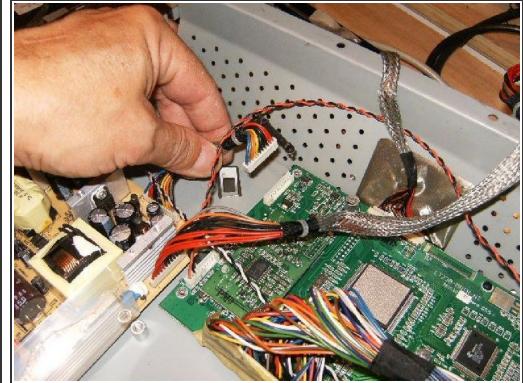
- You should now be looking at the PCB's The power board is the one that has the switch on it, as well as two heatsinks.
- Remove the wiring harness on the top right side.
- Remove the connector from the inverter board, as well as the ground wire.
- Remove the green cable from the power board to the housing.
- Remove the connector from the top right and top side. They will only fit one way. No reason to mark the location.
- The two heatsinks can be removed either now or later.

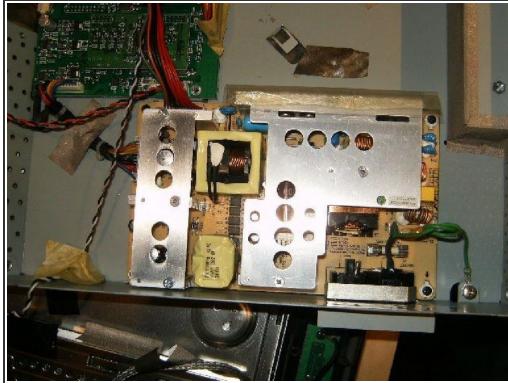
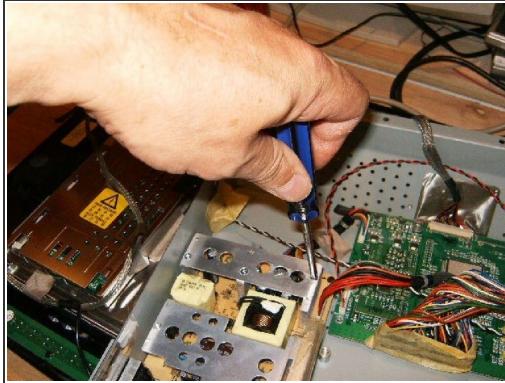
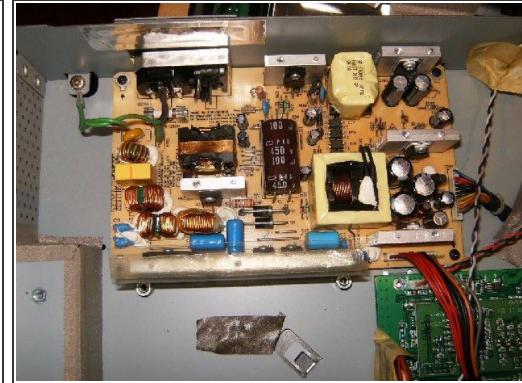
- Once all wiring harnesses are removed, and the green ground cable is off the chassis, remove the powerboard. It is held in place with four small screws, one on each corner.
- The power board should now be disconnected from the monitor. On the side furthest ways from the switch, is a transformer. Next to it, there are a total of 7 condensers and 3 heatsinks. It is those condensers that are failing due to heat.

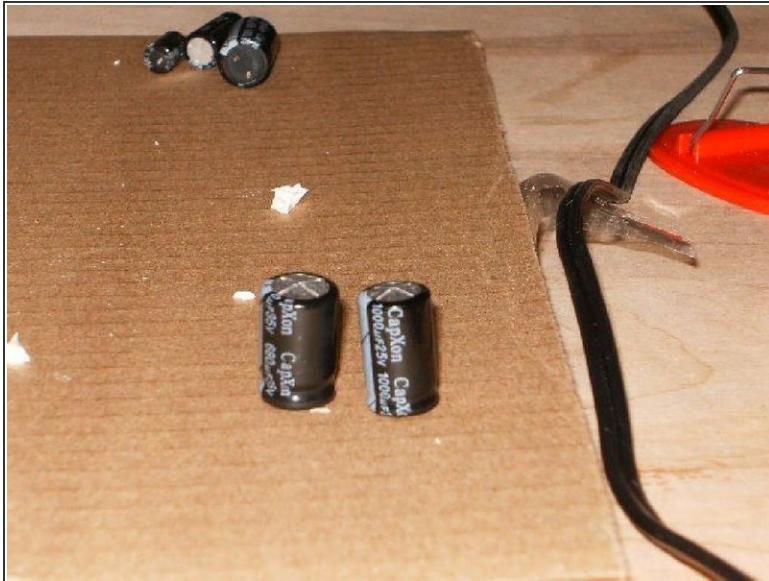
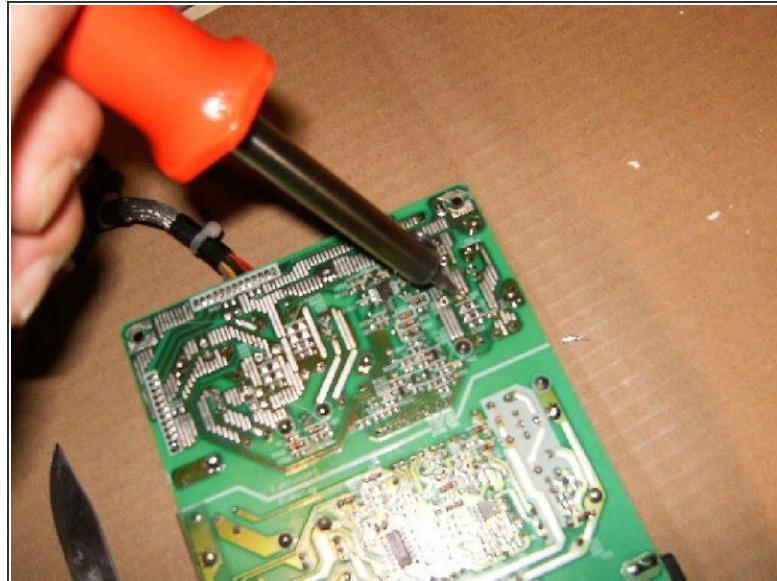
- Take a closer look at the tops of the condensers (here is the view of one that was removed) The tops are most likely bulging on at least 5 of them. Plan to replace all 7 on that side.
- Unsolder the condensers from the board. In this repair a 30watt soldering iron and solder sucker was used. The solder sucker can be substituted with soldering wick.

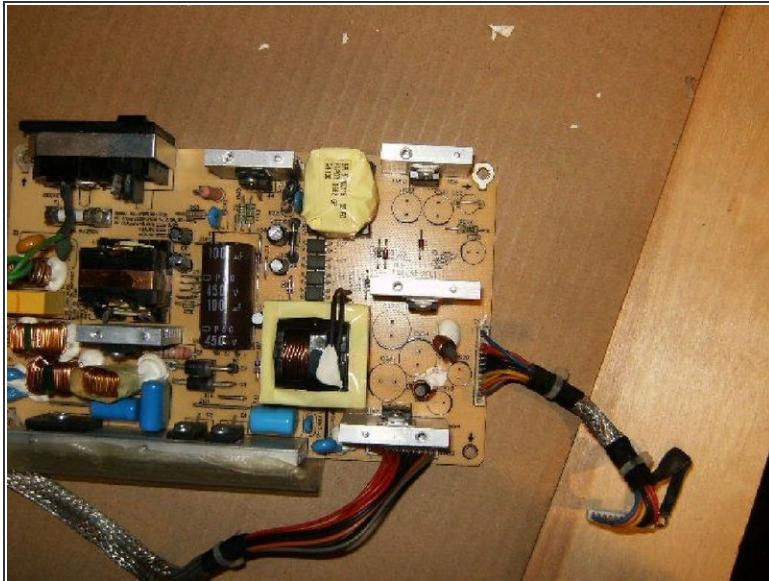
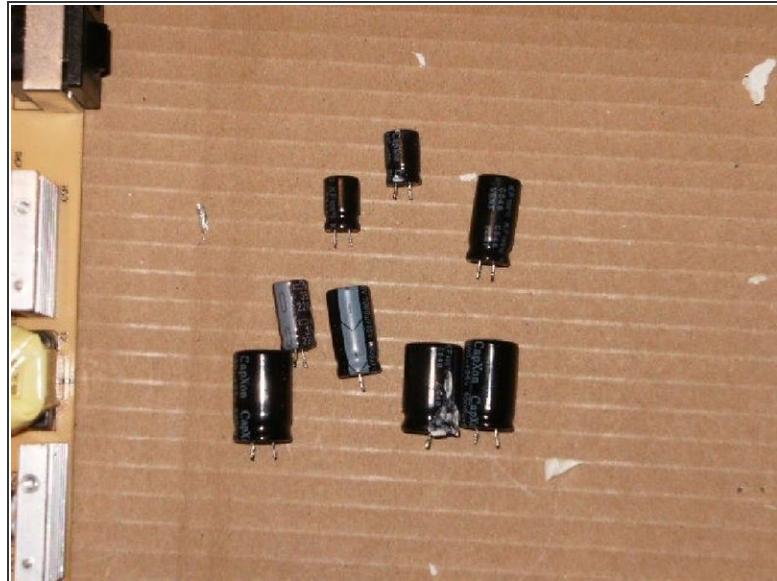
- This is what the board looks like with the faulty condensers removed.
- Here are the faulty condensers. Replace those with new ones. For this repair, new ones were obtained through Mouser..com.
- CS19 = 220uF 35V CS20 = 220uF 25V CS21 = 1000uF 16V CS22 = 1000uF 16V CS23 = 1000uF 25V CS24 = 680uF 35V CS25 = 680uF 35V All are radial lead electrolytic capacitors.

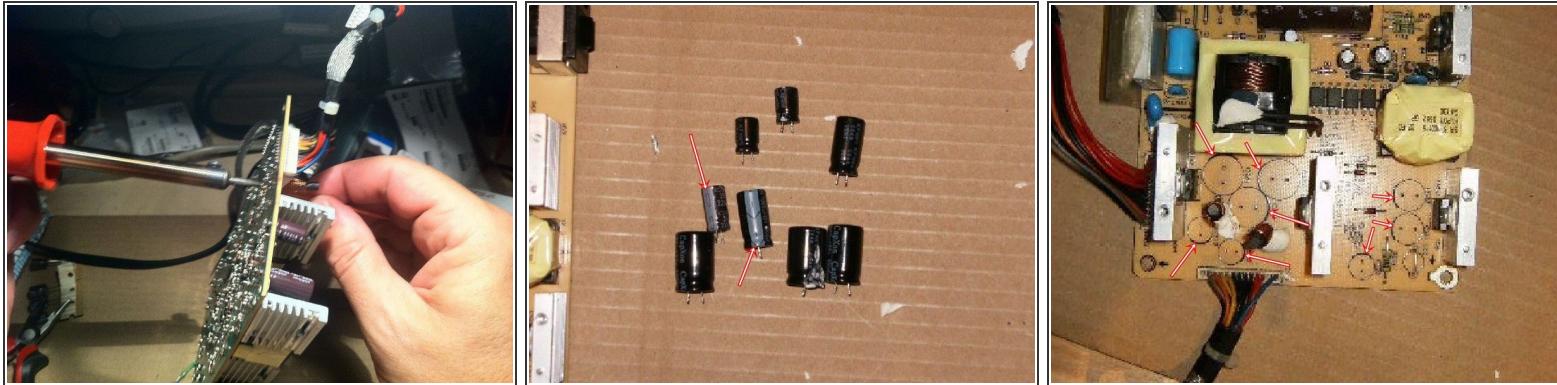
- Solder all the capacitors in their respective places. On the logic board, where the capacitors are located, is an outline of a circle with one part of the circle being heavier. It corresponds with the negative lead of the condenser.
- There is a heavy stripe on the condenser, pointing to the negative lead. Polarity will be maintained by matching those.
- Once all the capacitors are replaced, double check the board to make sure everything is properly mounted.
- Now reassemble the Olevia following the instructions in reverse order.

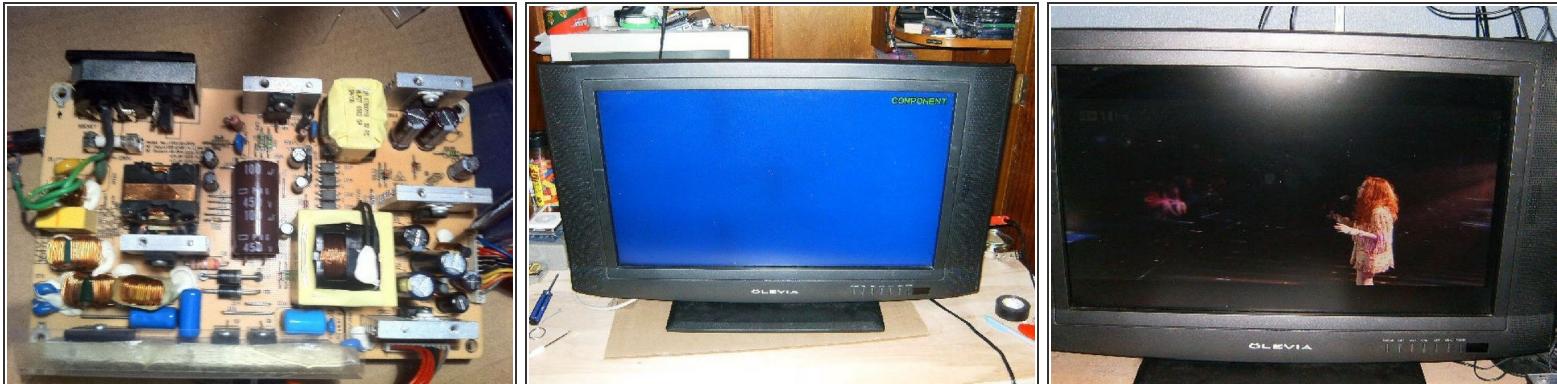
- Once reassembled, connect your TV monitor either as TV or a computer monitor. This is what the final result should look like.
