# Panasonic Compact Shaver ES4815 Motor Replacement

A fix guide to replace the motor for a Panasonic Compact Shaver ES4815 in a few easy steps.

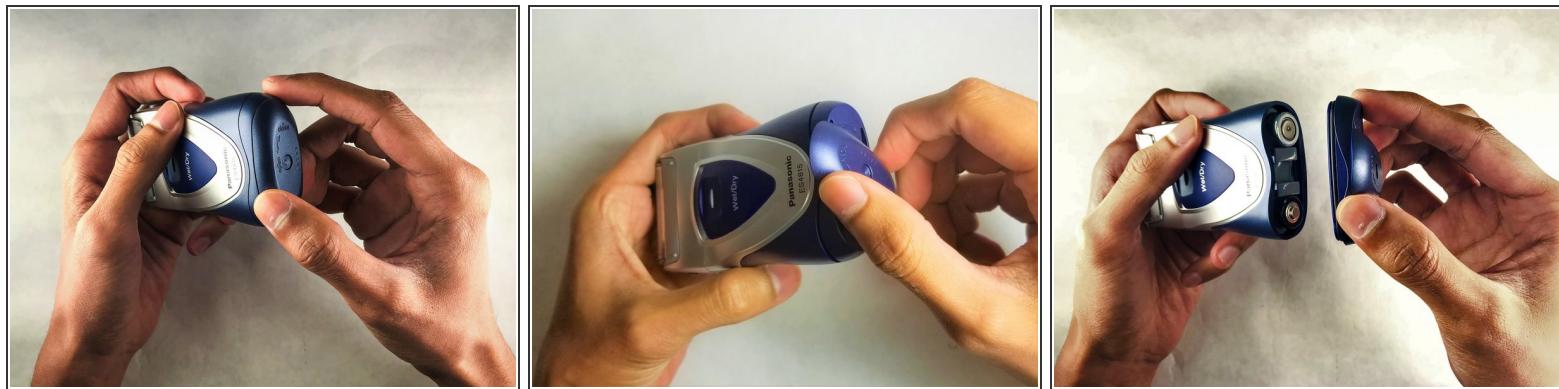
## Step 1 — Battery

- Twist the release cap to expose the batteries.

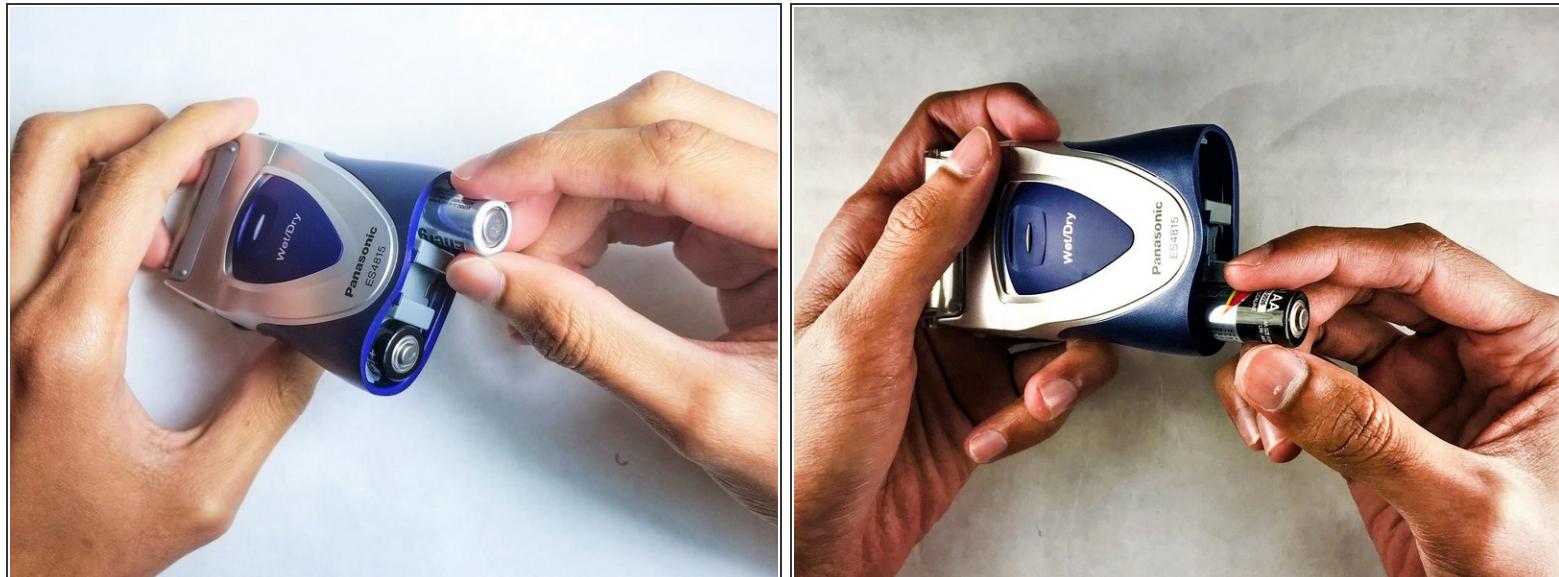
## Step 2

- Remove the batteries.

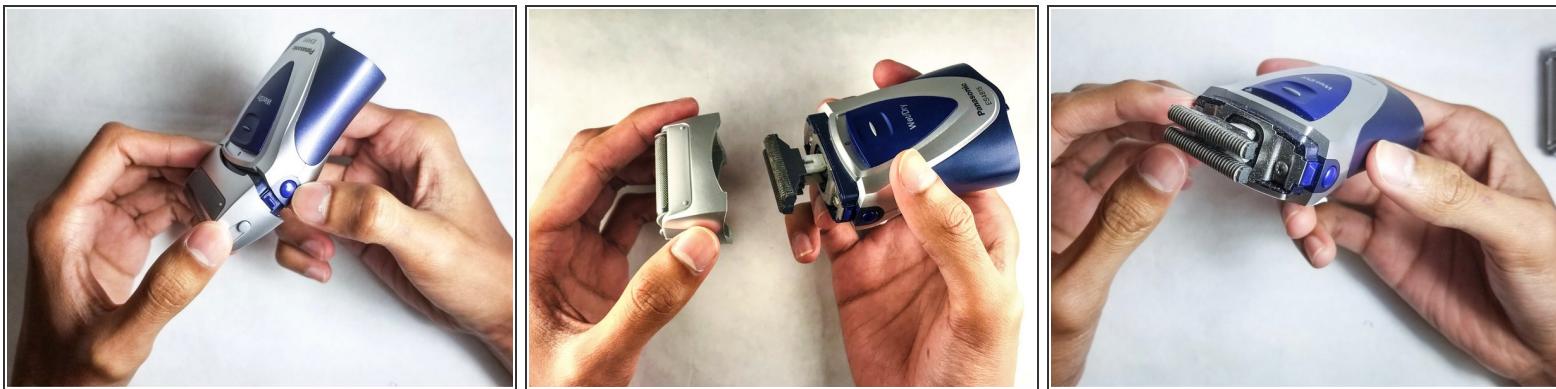
## Step 3 — Motor

- Remove the razor guard by pushing its release buttons and pulling.

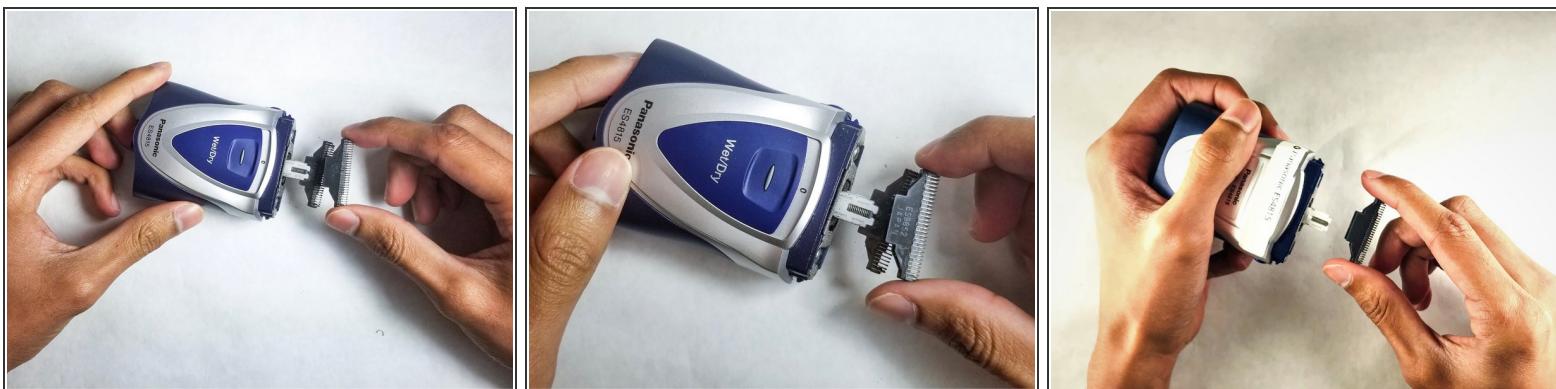
## Step 4

- Carefully pull out the inner blades.

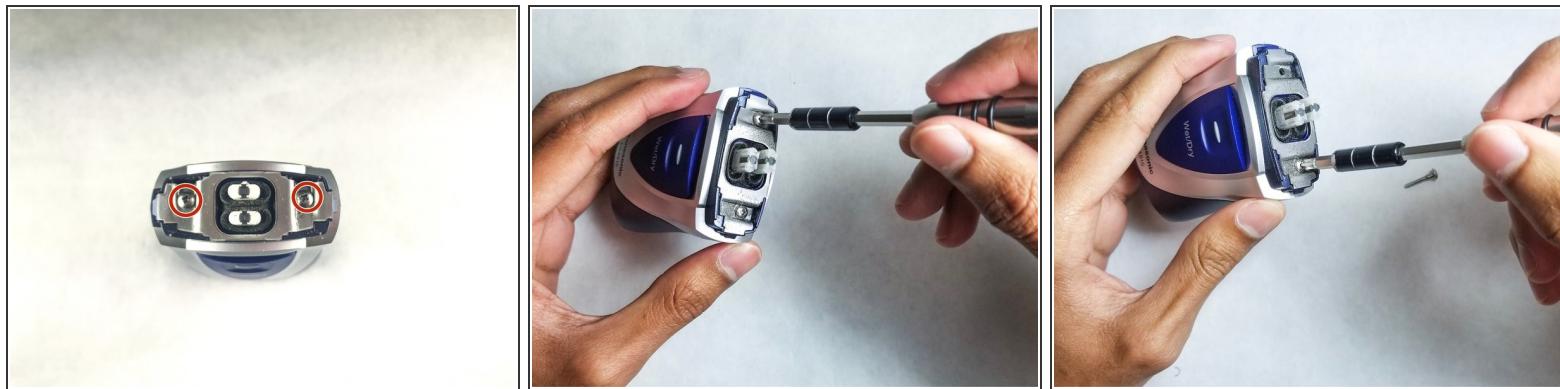
## Step 5

- Remove the two 1.9mm Phillips #0 screws from the inner blades.

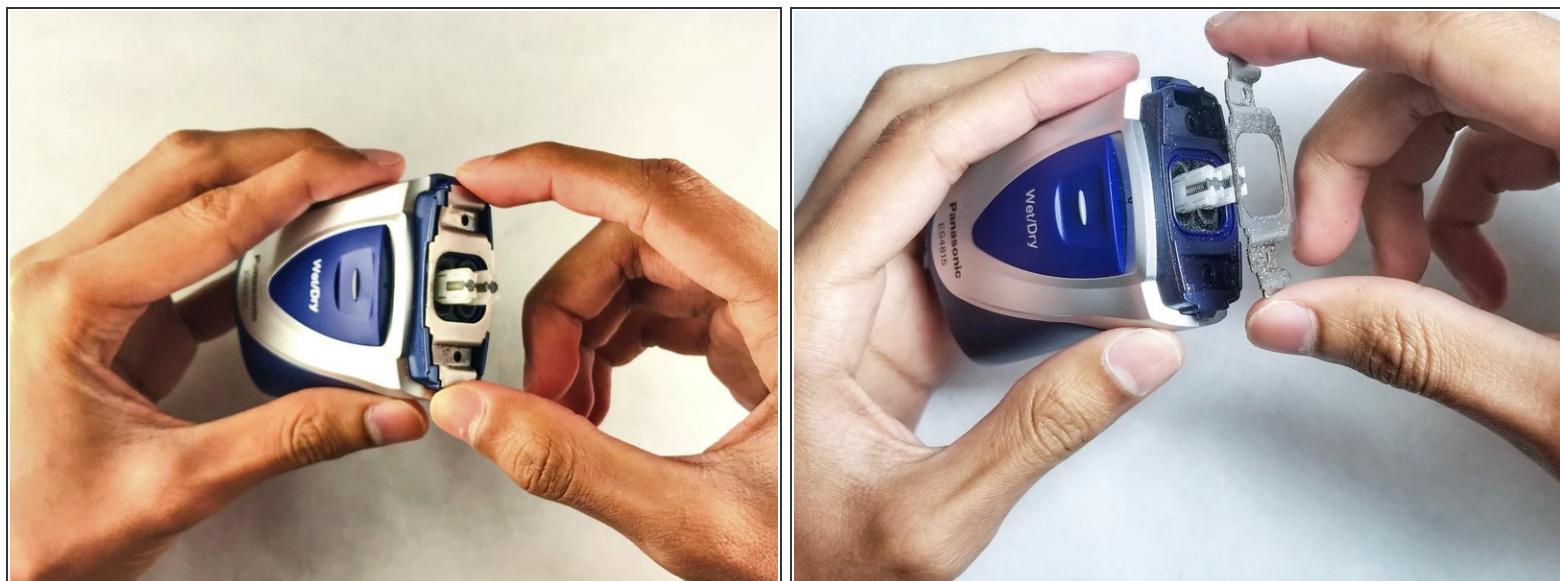
## Step 6

- Remove the metal plate.

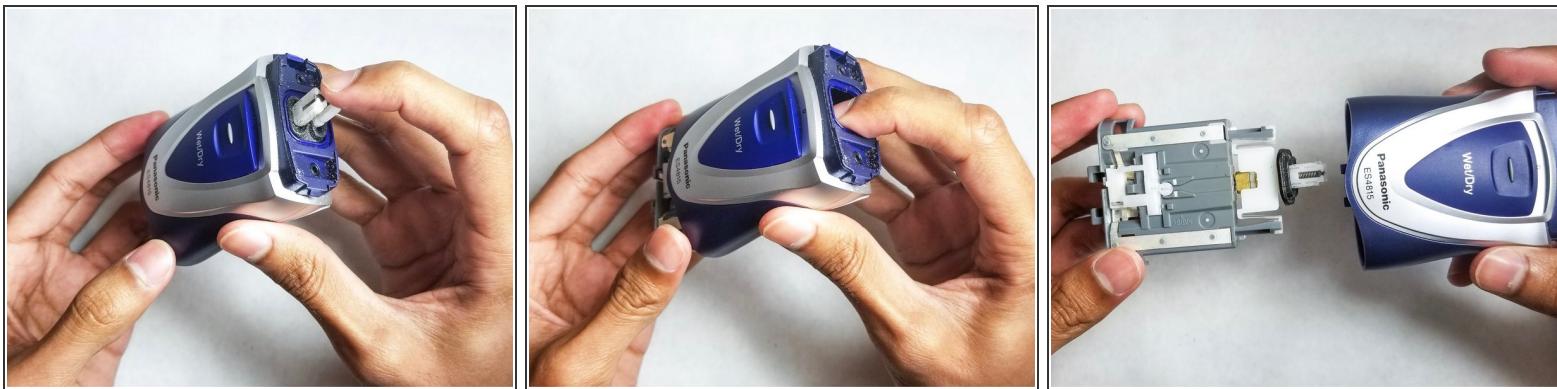
## Step 7

- Pull the outer casing with one hand while holding the inner battery casing with the other hand.

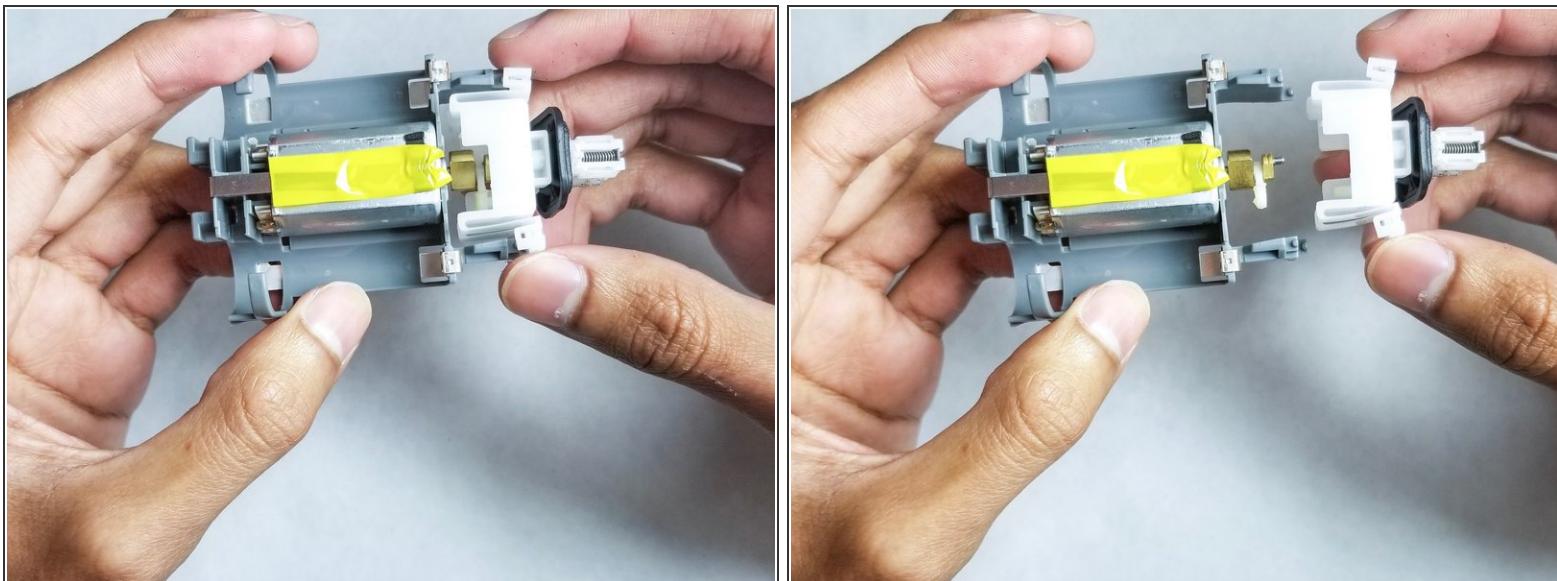
## Step 8

- Detach the white plastic blade base from the tip of the motor by pulling it.

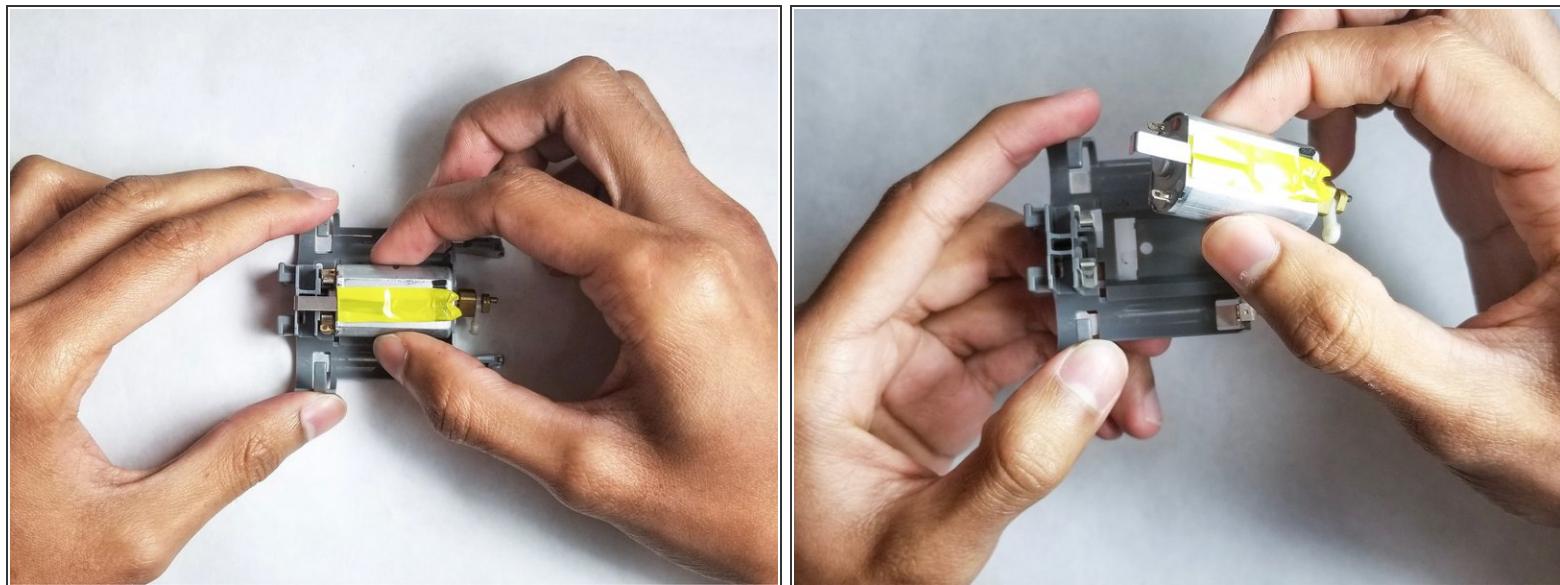
## Step 9

- Detach motor from gray plastic holder by pulling it.

To reassemble your device, follow these instructions in reverse order.
