Philips TT2021 Bodygroomer Series 5000 On / Off Switch Replacement

The razor can not be switched off or switched on anymore?

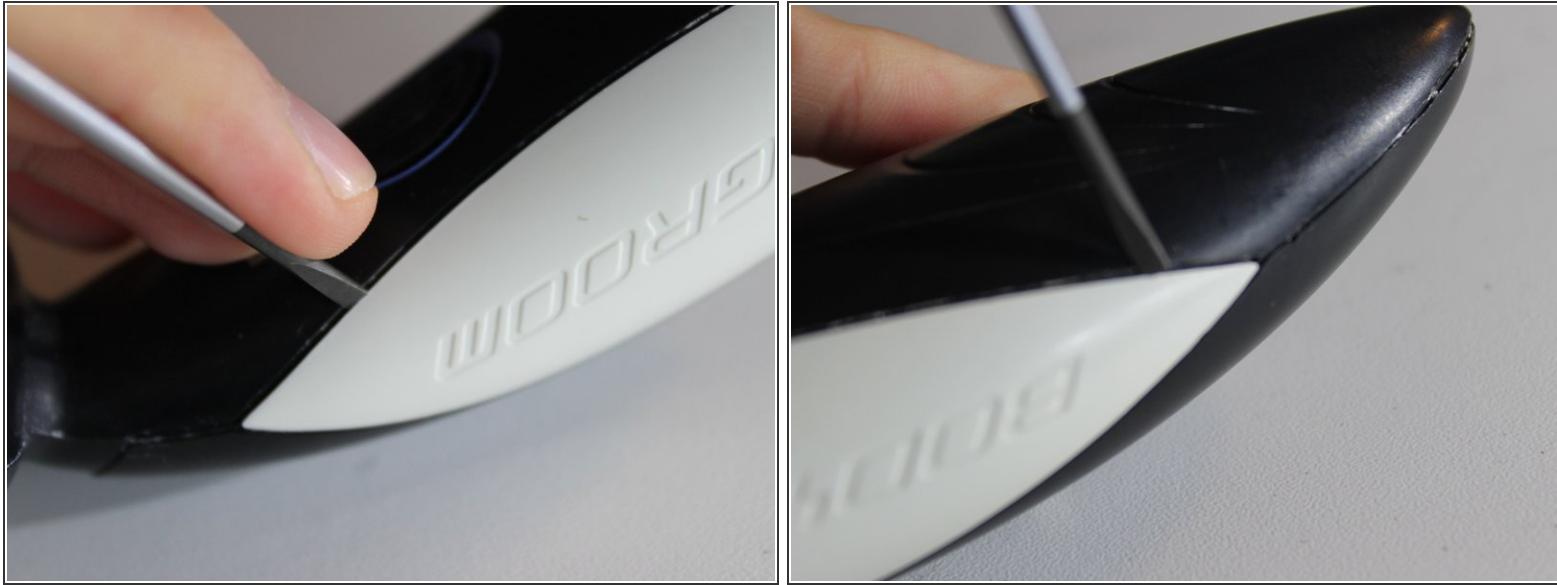
Step 1 — On / Off switch exchange

- First remove the white side parts with a thin slotted screwdriver (everything is just "clipped")

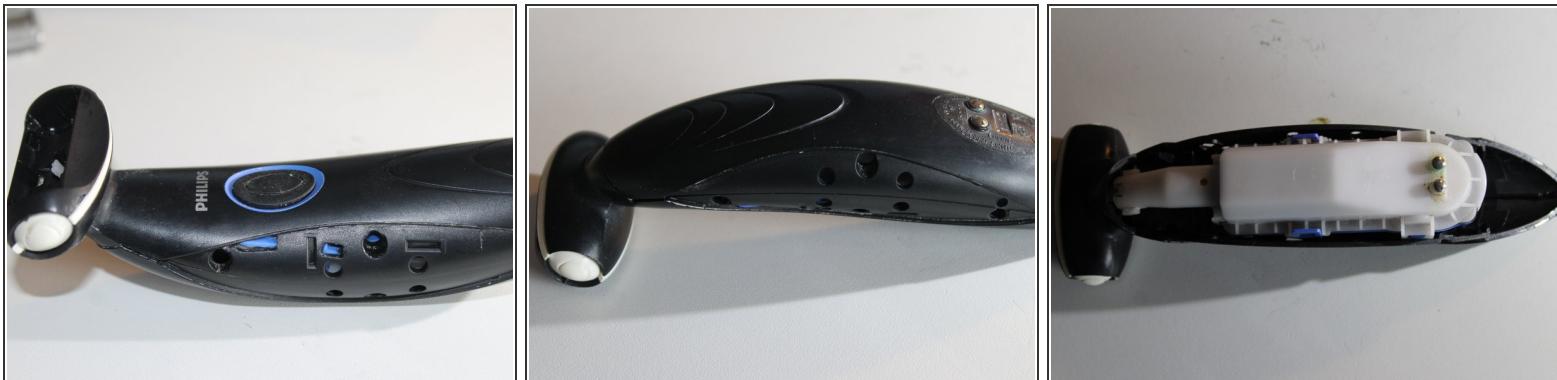
Step 2

- Next, open the black plastic case (also like the white parts with a thin slotted screwdriver)

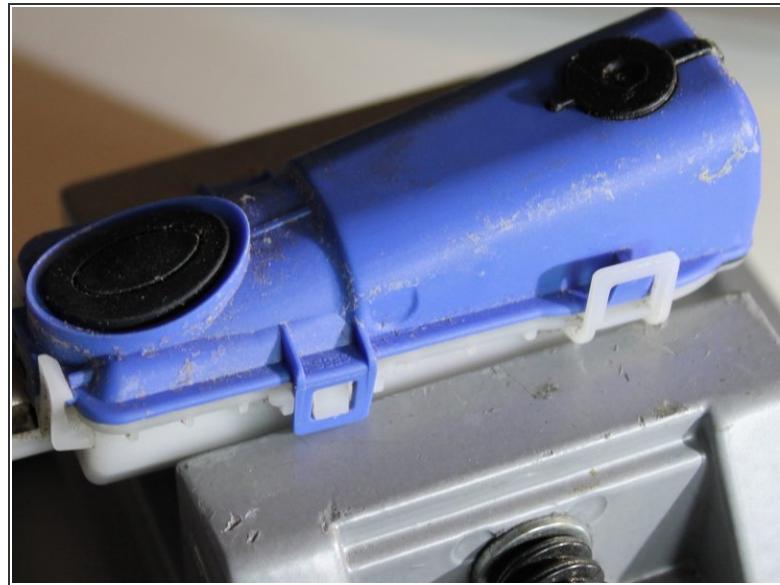
Step 3

- The capsule has on the outside only 5/6 points where the upper and lower shell are connected.
- Next, the "waterproof capsule" must be removed and opened.

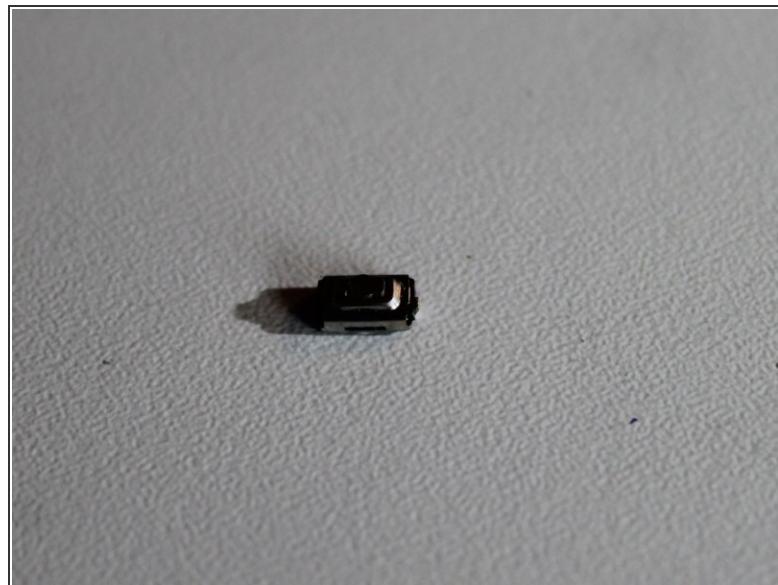
Step 4

Most likely it is due to the micro-button !!! This seems to be relatively inferior.

- Now, when the capsule is open, you can already see the "culprit" (The small button to the right of the large IC chip)
- Now carefully desolder this button
