Pioneer FH-X730BS Disk Drive Replacement

This guide shows you how to replace a Pioneer FH-X730BS disc drive.

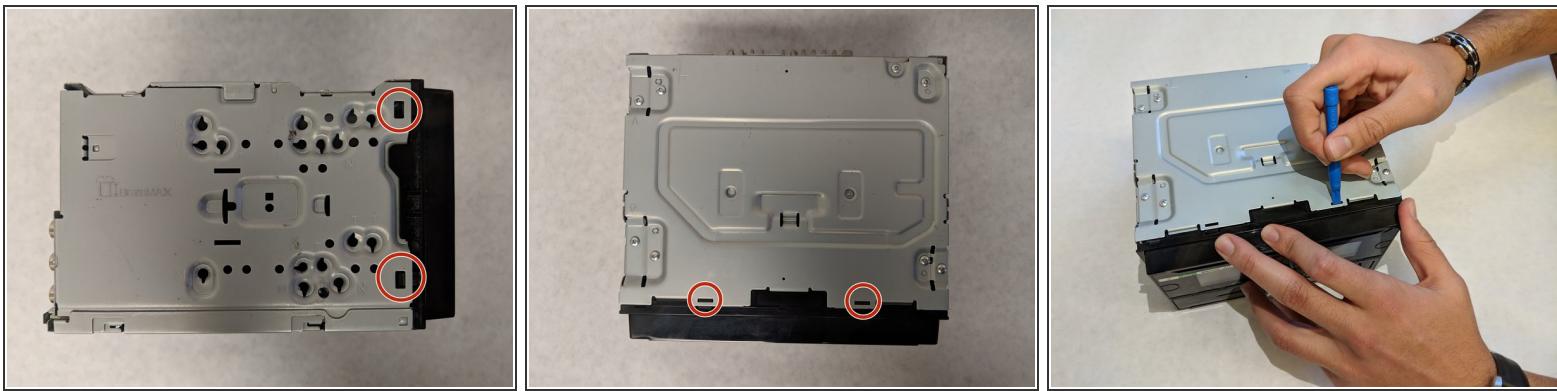
Step 1 — Disk Drive

- Apply pressure to the tabs on each side using the plastic opening tool.
- You will need to pull the face away from the frame while unhooking the tabs.

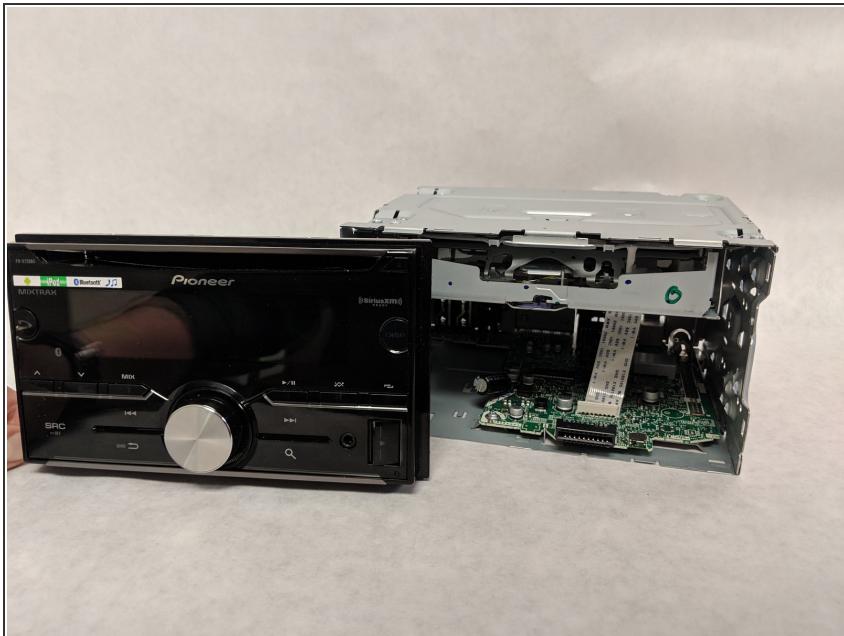
Step 2

- After removing the stereo face from the frame, it should look similar to this.

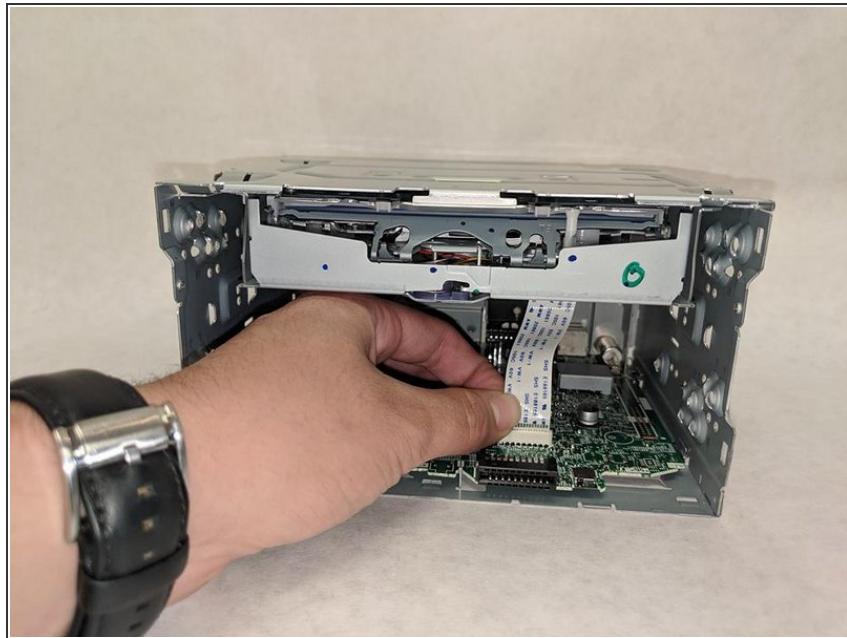
Step 3

- Remove the ribbon wire from where it is being held in place. This can be done by applying force upwards.

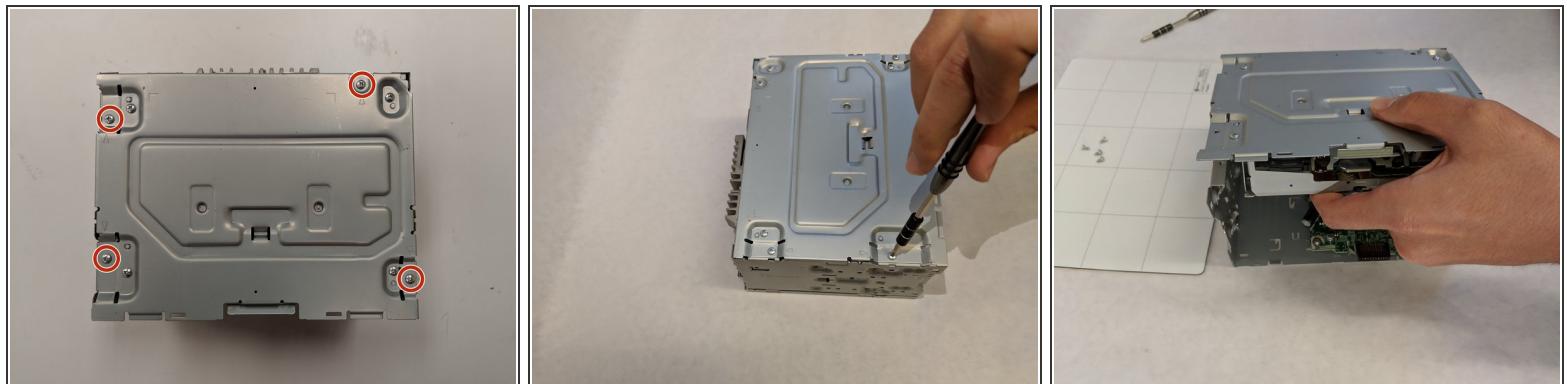
Step 4

- Unscrew the four 7.3 mm outer screws on the top to remove the top face from the rest of the frame.

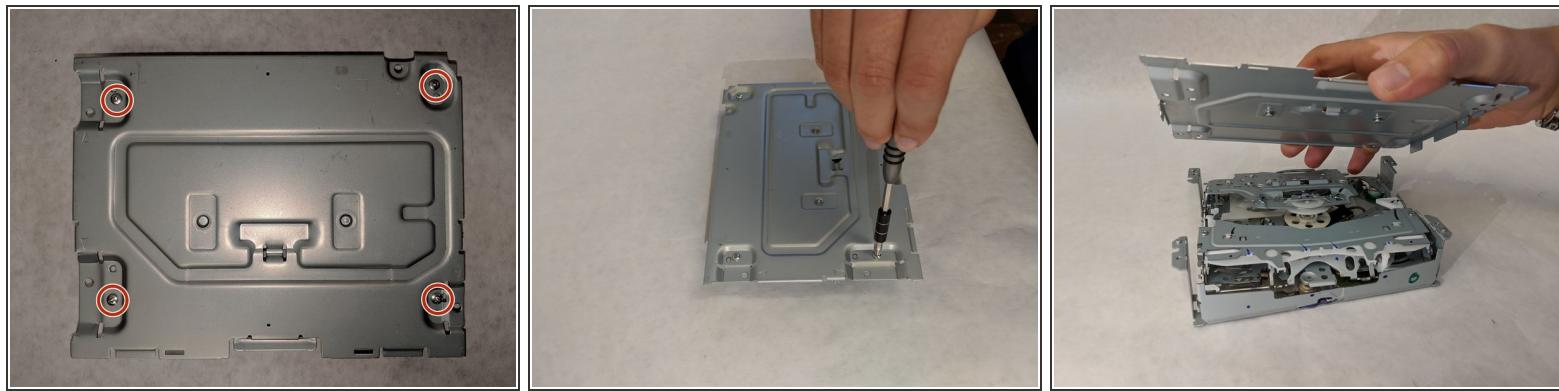
Step 5

- Unscrew the four inner screws that are 7.3 mm long using a Phillips #1 head screw driver to remove the disk drive from the top face plate.
- Replace the old disk drive with a new one.
