# Pioneer FH-X730BS USB Port Replacement

This guide will show you how to replace the USB port on the Pioneer FH-X730BS.

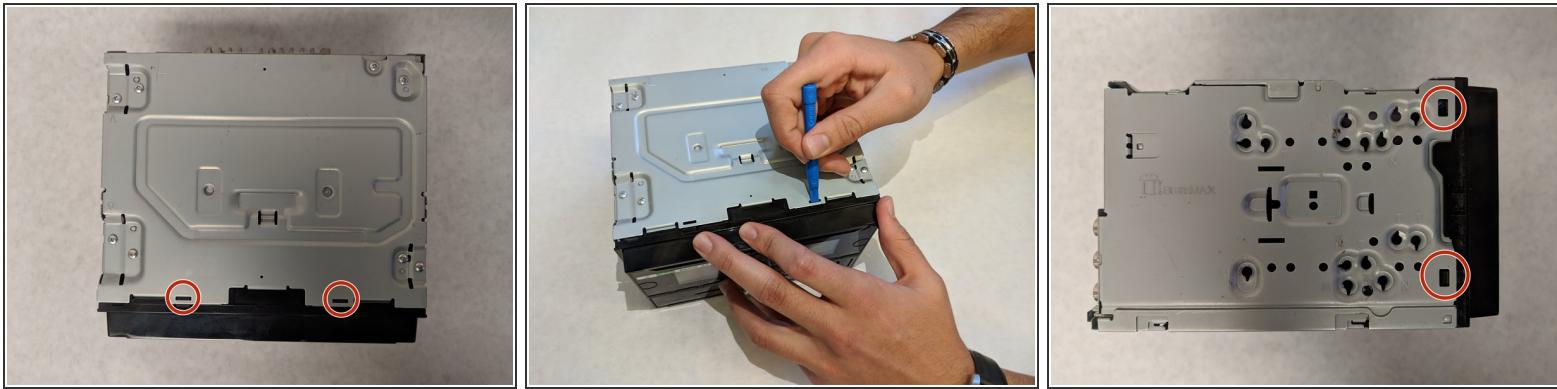
## Step 1 — Deck Buttons

- Apply pressure to the tabs on each side using the plastic opening tool.
- You will need to pull the face away from the frame while unhooking the tabs.

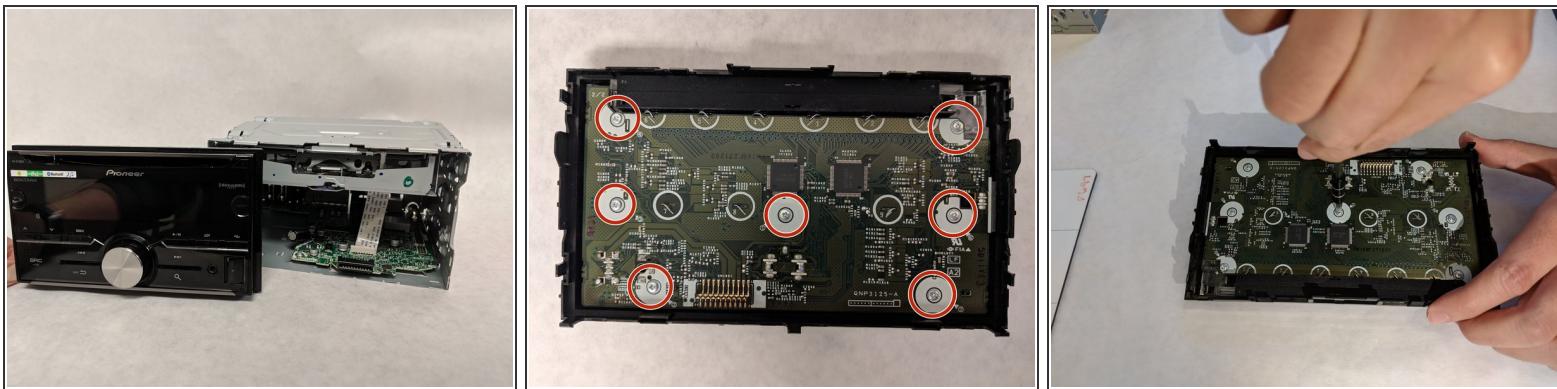
## Step 2

- After removing the stereo face from the frame it should look similar to this.
- Remove the seven 11.2mm Phillips #1 screws on the rear side of the stereo face.

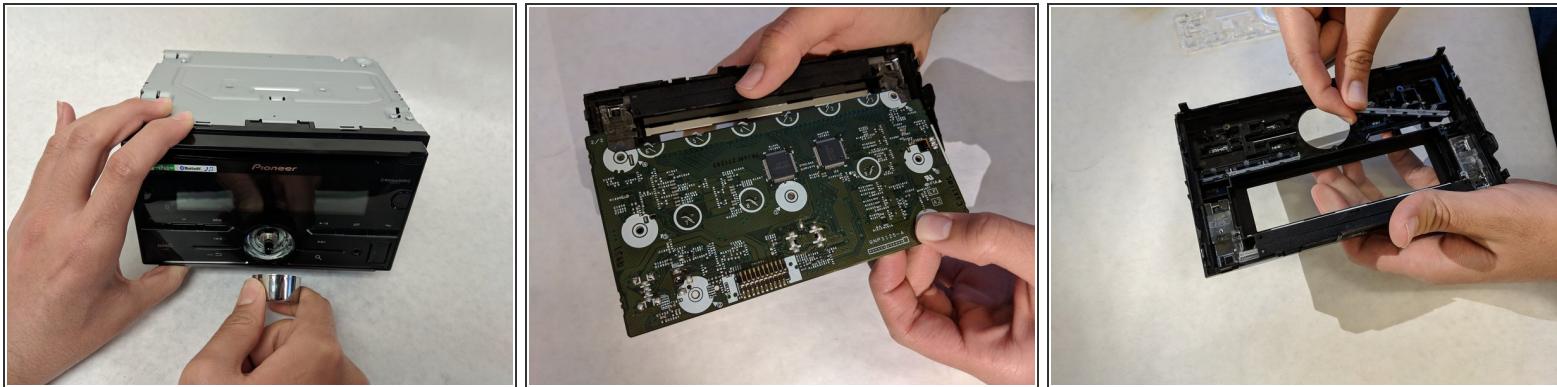
## Step 3

- Remove the volume knob by pulling it towards you and pull the motherboard out of the face.
- The audio buttons can now be taken out. You can flip the face downwards and tap the audio buttons.
- You can now insert the replacement audio buttons into the face.

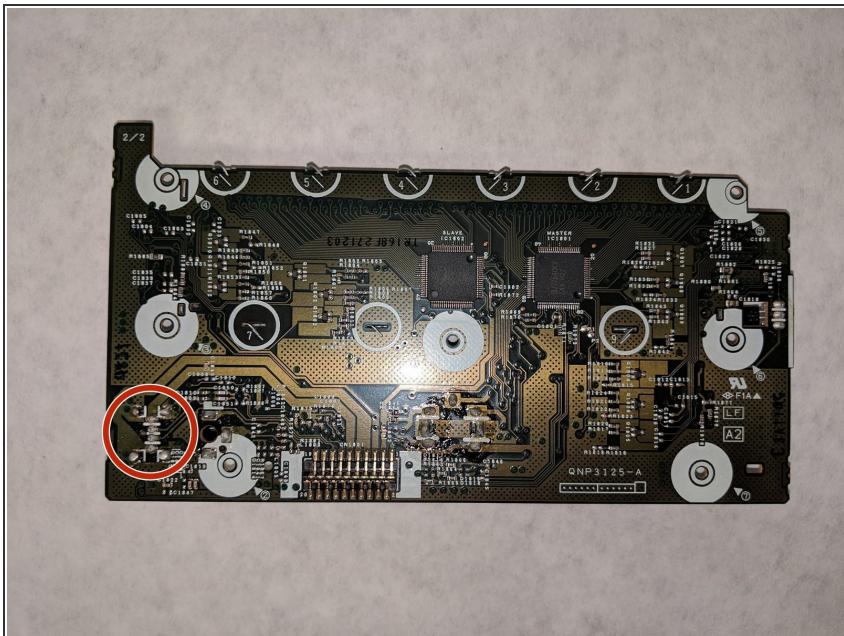
## Step 4 — USB Port

- Here you are able to desolder the USB ports from the circuit board and solder a replacement USB port on.

The end of the soldering iron will be hot.
